APPENDIX E

GEOMORPHOLOGICAL MONITORING REPORT Prepared by Steve Vrooman, Keystone Restoration Ecology September 2013

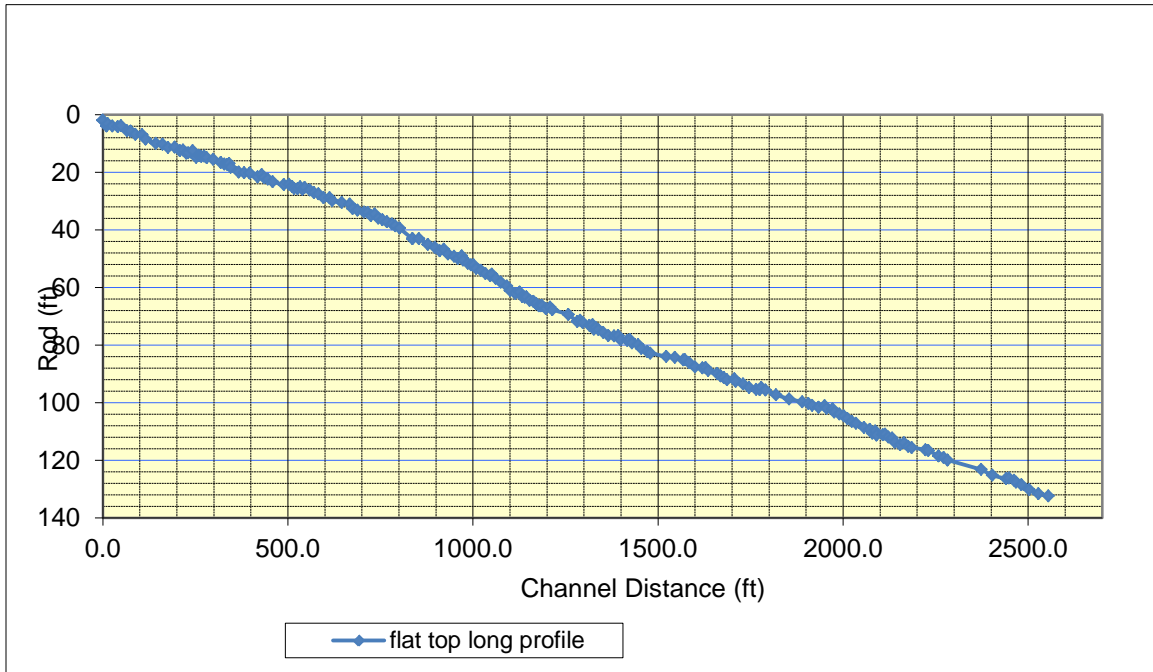
West Flat Top, Section 33: A longitudinal profile was taken of 2700 feet of the channel at the Section 33 restoration site. This small channel runs along Henkel Road, the access road to the site, and is relatively narrow and steep with a 5% slope. Structures such as one rock dams and rock rundowns were used to raise the grade of the channel and re-irrigate the narrow floodplain.

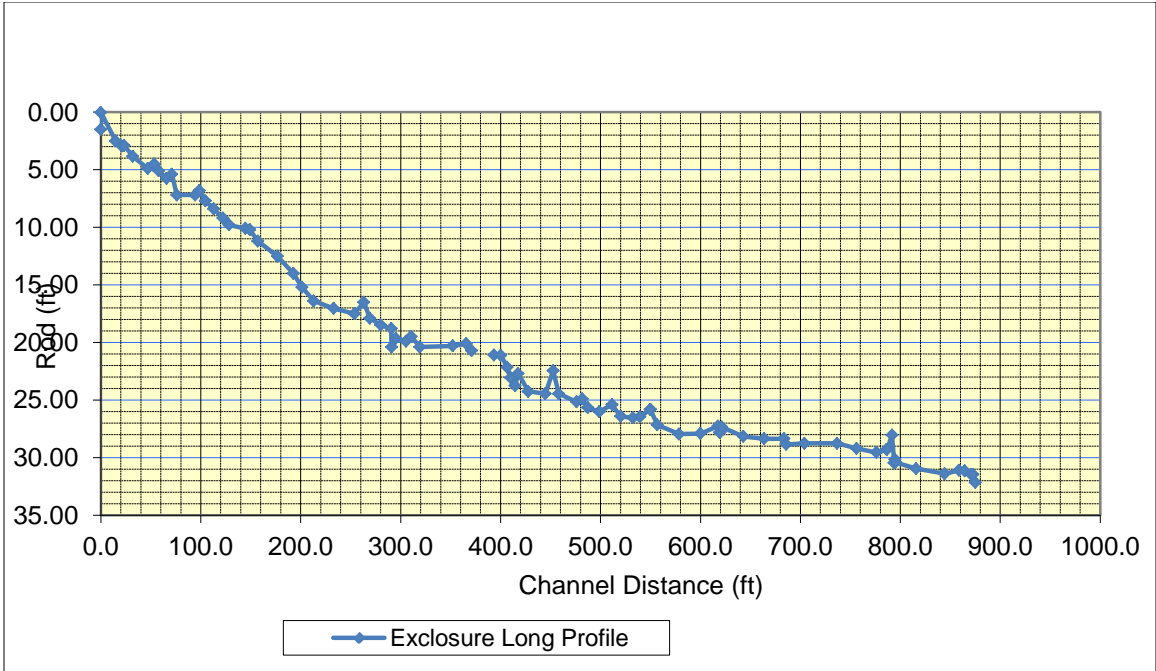
The longitudinal profile of the exclosure from fence line to fence line along the channel.

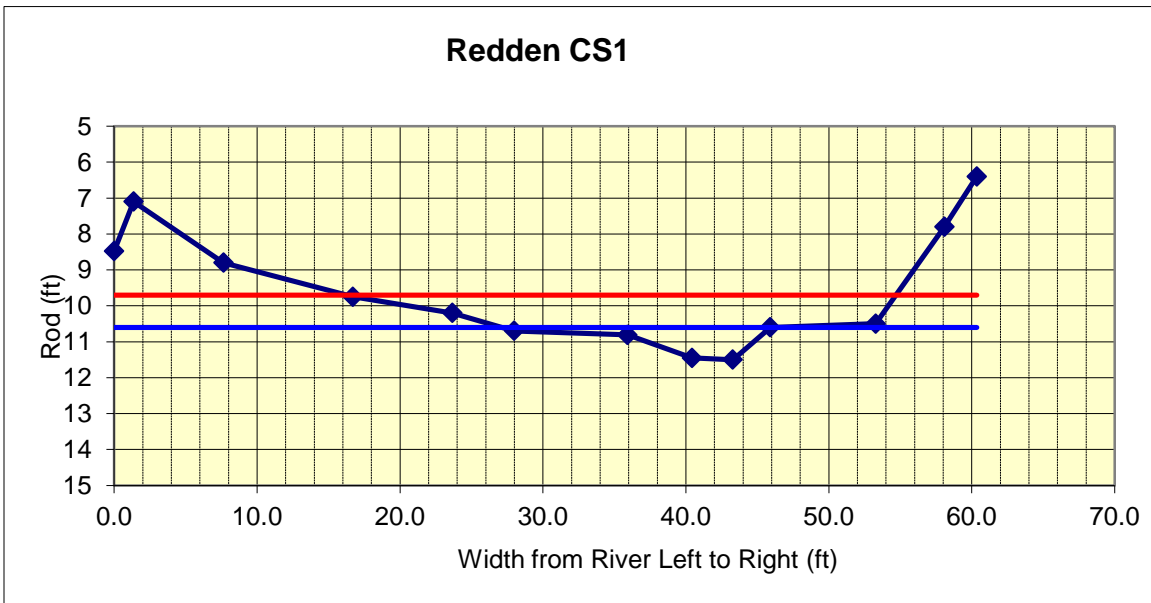
This site has filled in with sediment, and has a healthy channel shape with a floodplain.

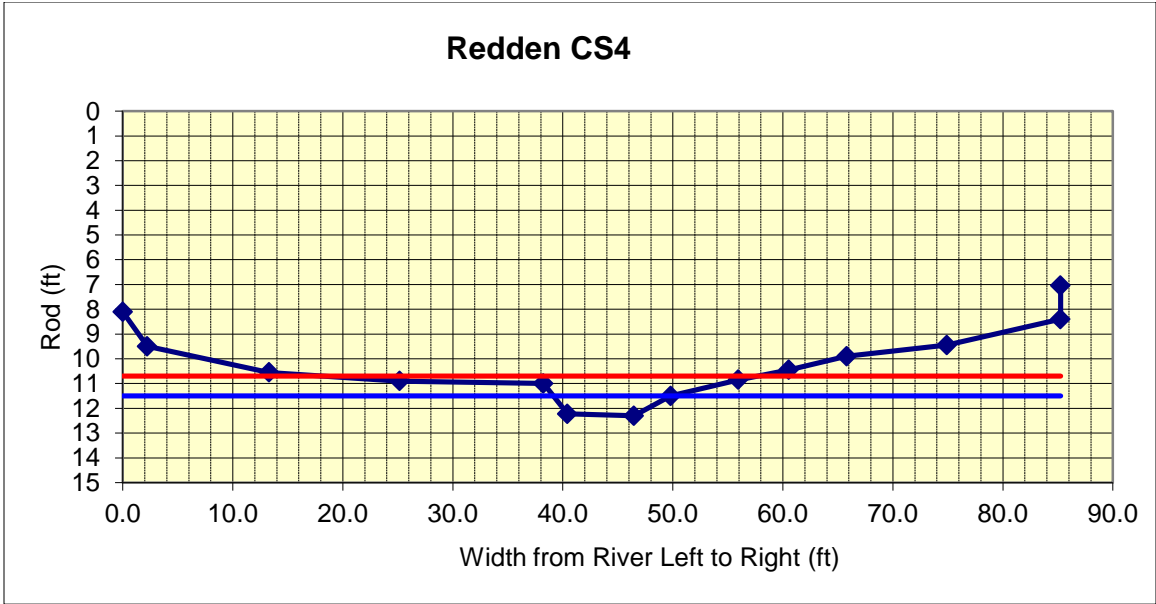
This cross section was taken low in the watershed at a point where the channel begins to braid around some willows. Raising the grade at this point could irrigate much of the former wet meadow between stations 10 and 40 on the cross section.

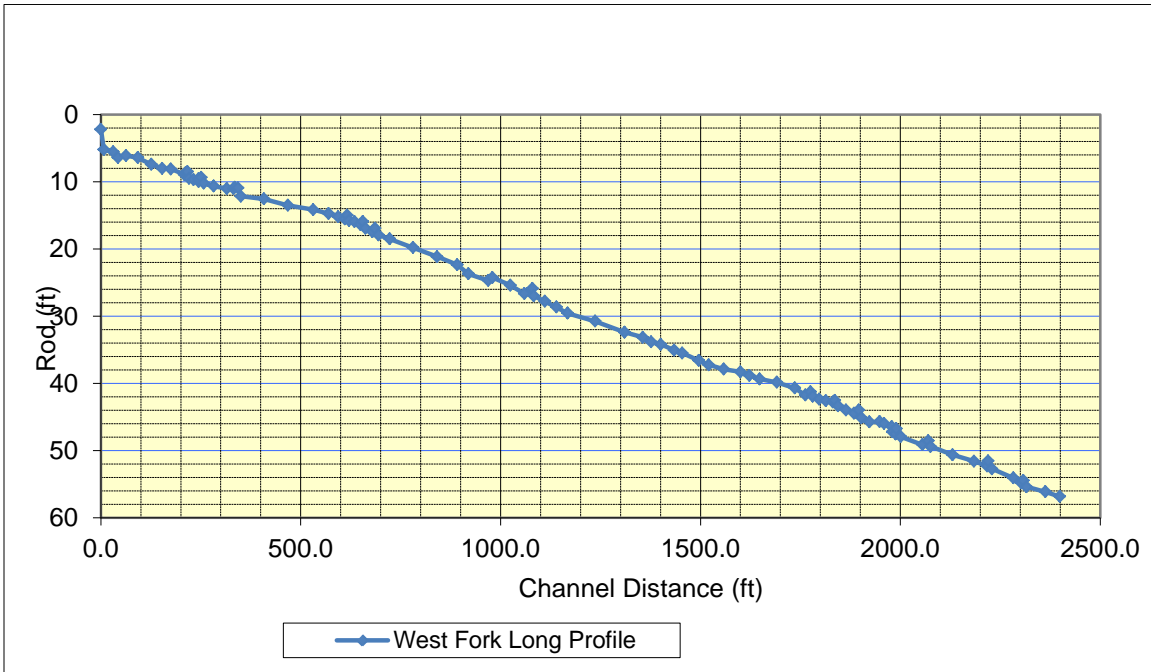
This longitudinal profile has an average 2.3% slope, the upper portion is a small channel through wet meadows. Due to the geology of the area, the lower portion runs through a natural gully between steep colluvial slopes.

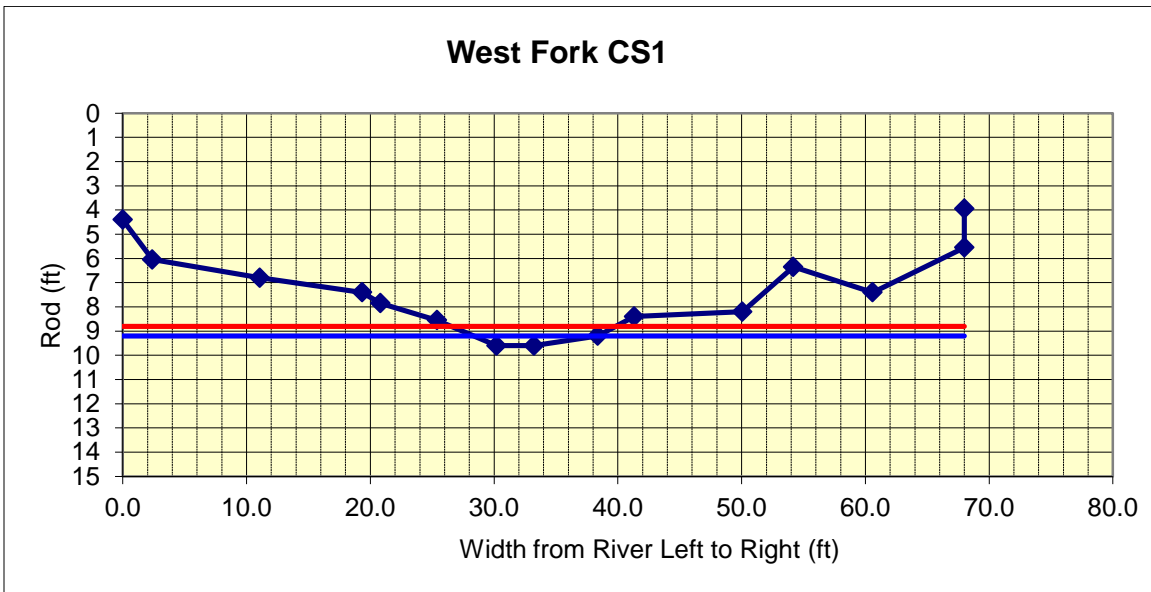
This cross section was placed in a location where we expected a large amount of sediment to fill in between several one rock dams.

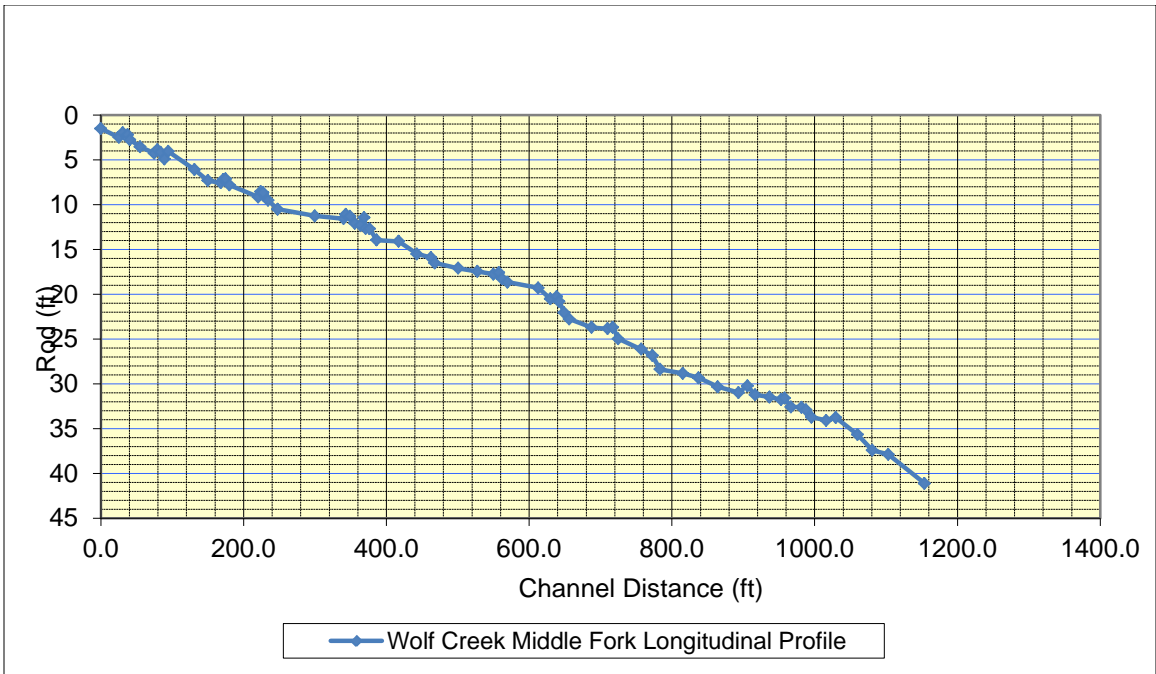
This profile shows the locations of many of the structures as “high points” in the profile. This profile is the tributary channel beginning at the road and running downstream to wide valley with the spring, where the Middle Fork begins.

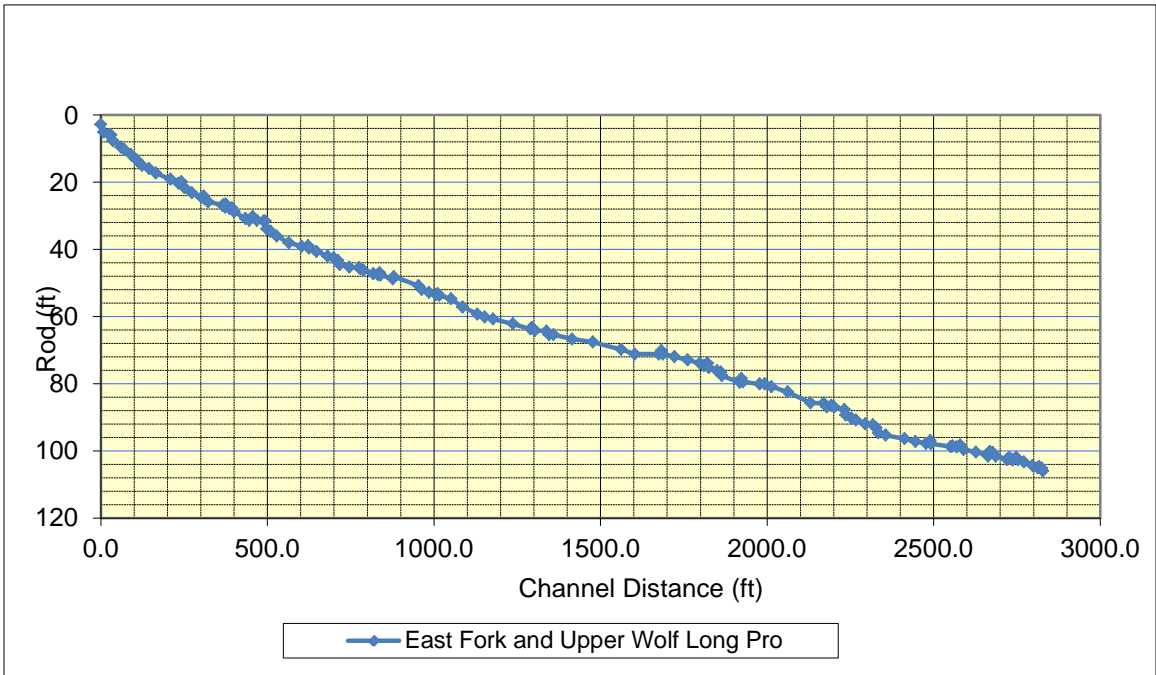
This profile starts at the spring at station 0, the wetland at the confluence runs from about 1000 to 1300. The culverted crossing is at 1350, where the Upper Wolf Reach begins, and runs downstream to the beginning of Lower Wolf Reach.

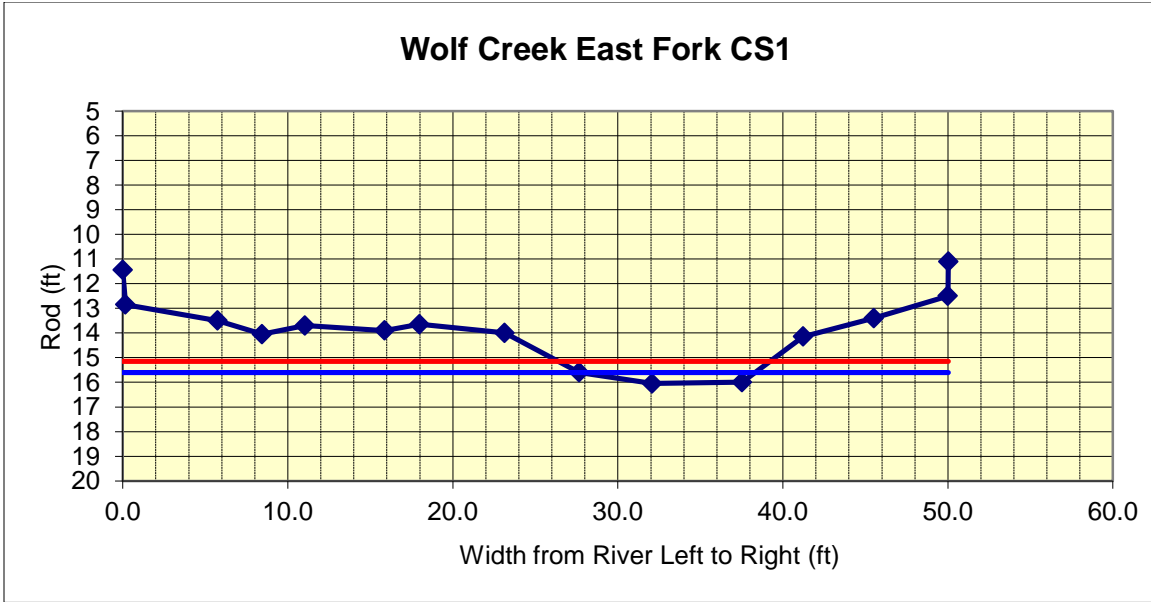
This cross section was taken in a narrow portion of the channel, upstream from the spring. However, the form of the channel may indicate that this area was once a slope wetland without defined channel through it (old channel to left at station 8 feet).

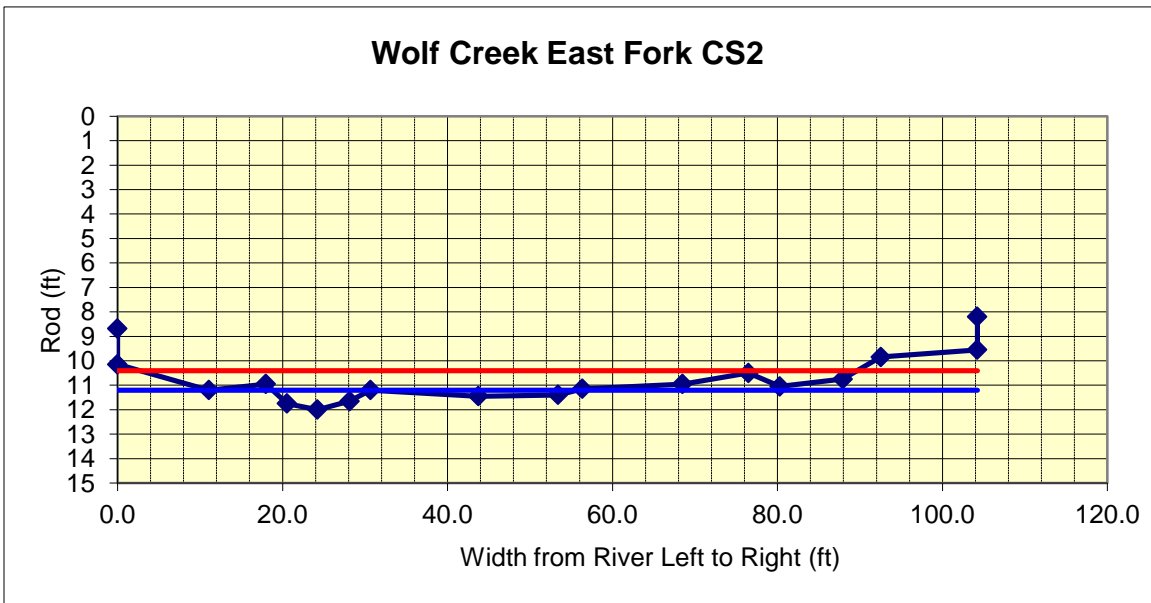
This cross section was taken where the channel enters the wide valley with the spring; this cross section runs across an alluvial fan feature with multiple channels in it. This cross section should continue to “aggrade” or gain elevation due to the braiding of the channel and accumulation of sediment from the growth of the alluvial fan.

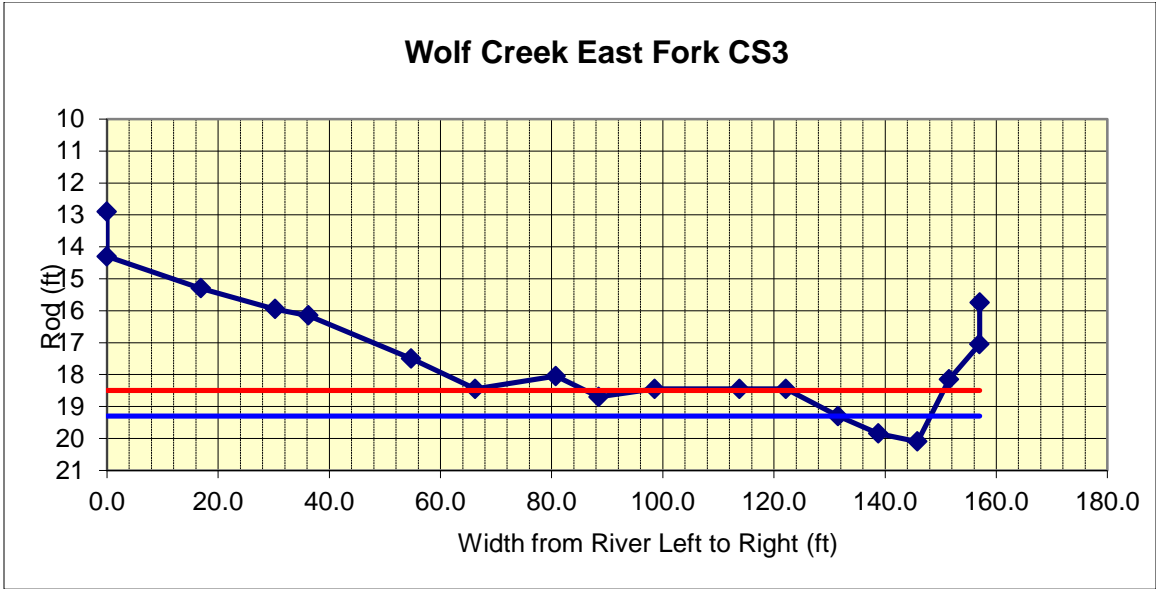
This cross section was taken at the end of the “spring valley”, showing several channels which could contain the flow from the spring. Presently, the spring is flowing at station 150 on the cross section, in the lowest elevation channel.

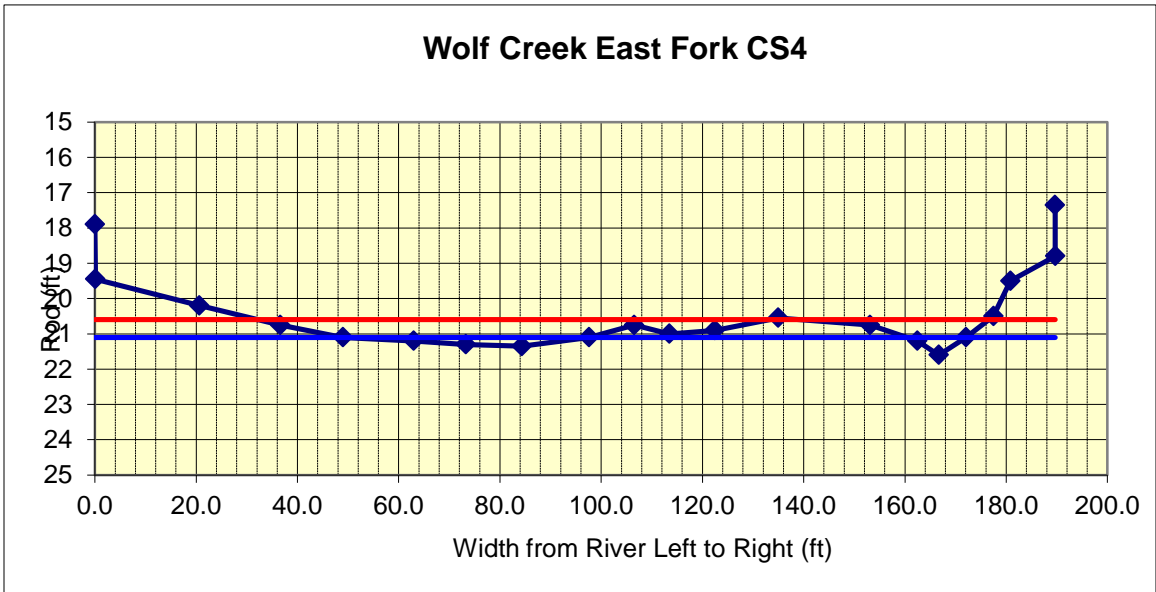
This cross section was taken near the confluence with Upper Wolf Creek, where the water spreads across the wetland. The water has spread throughout this cross section after the work was done in 2012. There is water in channels from station 60 to station 170.

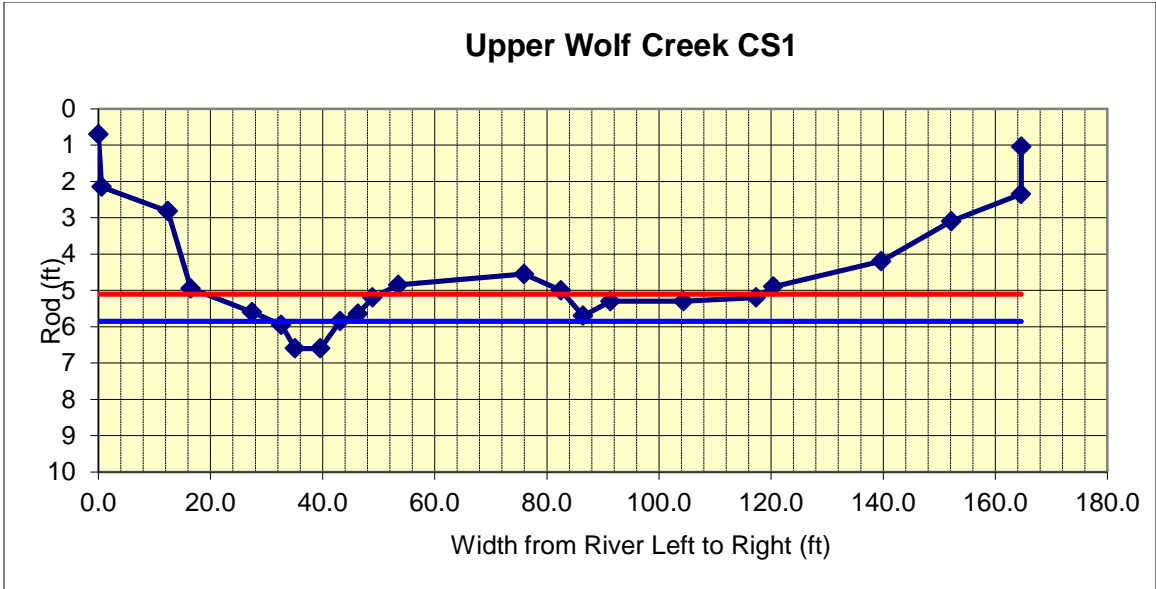
This cross section was taken above the first large “Media Luna” structure in the main channel of Wolf Creek, several hundred feet below the culvert. The water has already been spread across the valley and is not flowing in the lowest channel at station 40. The Media Luna runs from about 85 to 115 on the cross section.

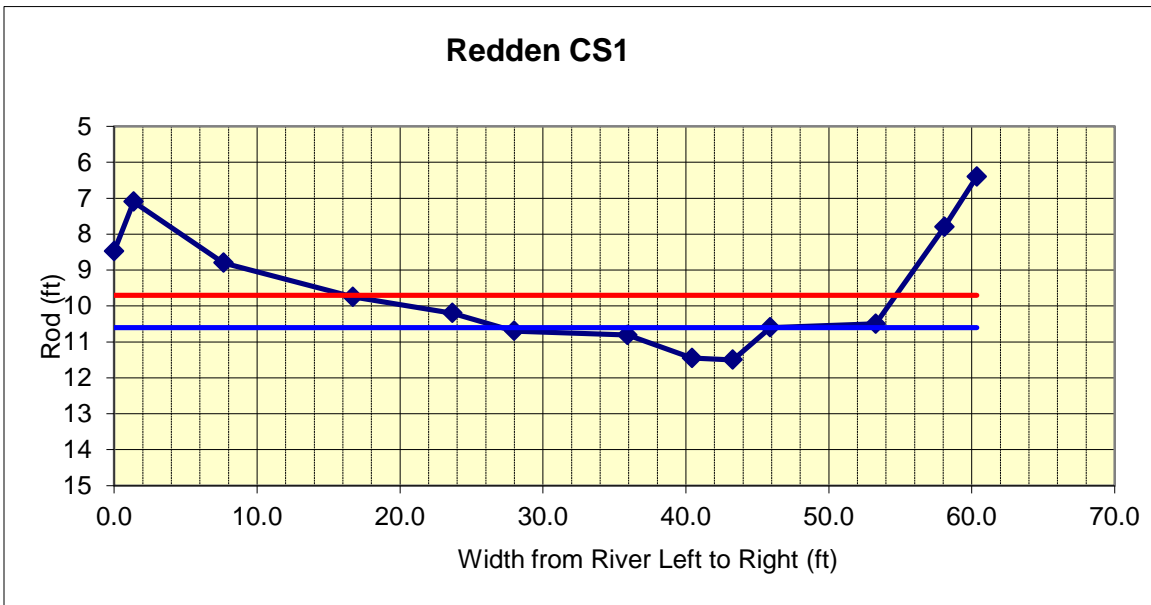
The upper portion of this profile has filled in and “smoothed”, as this sediment works downstream, it will fill in the area under the “deposition of sediment” line.

The two graphs shown above for the Redden Ranch show the effects of the restoration structures after one year of channel flooding and deposition. The cross section shows a channel that is un-gullied and has an active floodplain. The longitudinal profile shown has filled in with sediment and the structures are actually obscured under fresh sand and silt. This deposition will proceed from upstream (the sediment source) downstream through the longitudinal profile (the sediment sink).

Comparing this year's "as-built" data with surveys taken in the following years will show this deposition of sediment moving downstream through each treatment area. As the structures fill with sediment, additional layers of rock can be added onto the one rock dams to raise the grade even further and eliminate the channels. This will create slope wetlands out of formerly gullied channels.
