*Enhanced Resilience of Riparian and Wet Meadow Habitats in the Upper  
Gunnison Basin, Colorado: Phase II*

**Final Report  
Colorado Parks and Wildlife  
Colorado Wetlands for Wildlife Wetlands Program Project #634**

**By  
The Nature Conservancy in Collaboration with the  
Gunnison Climate Working Group  
June 8, 2017**

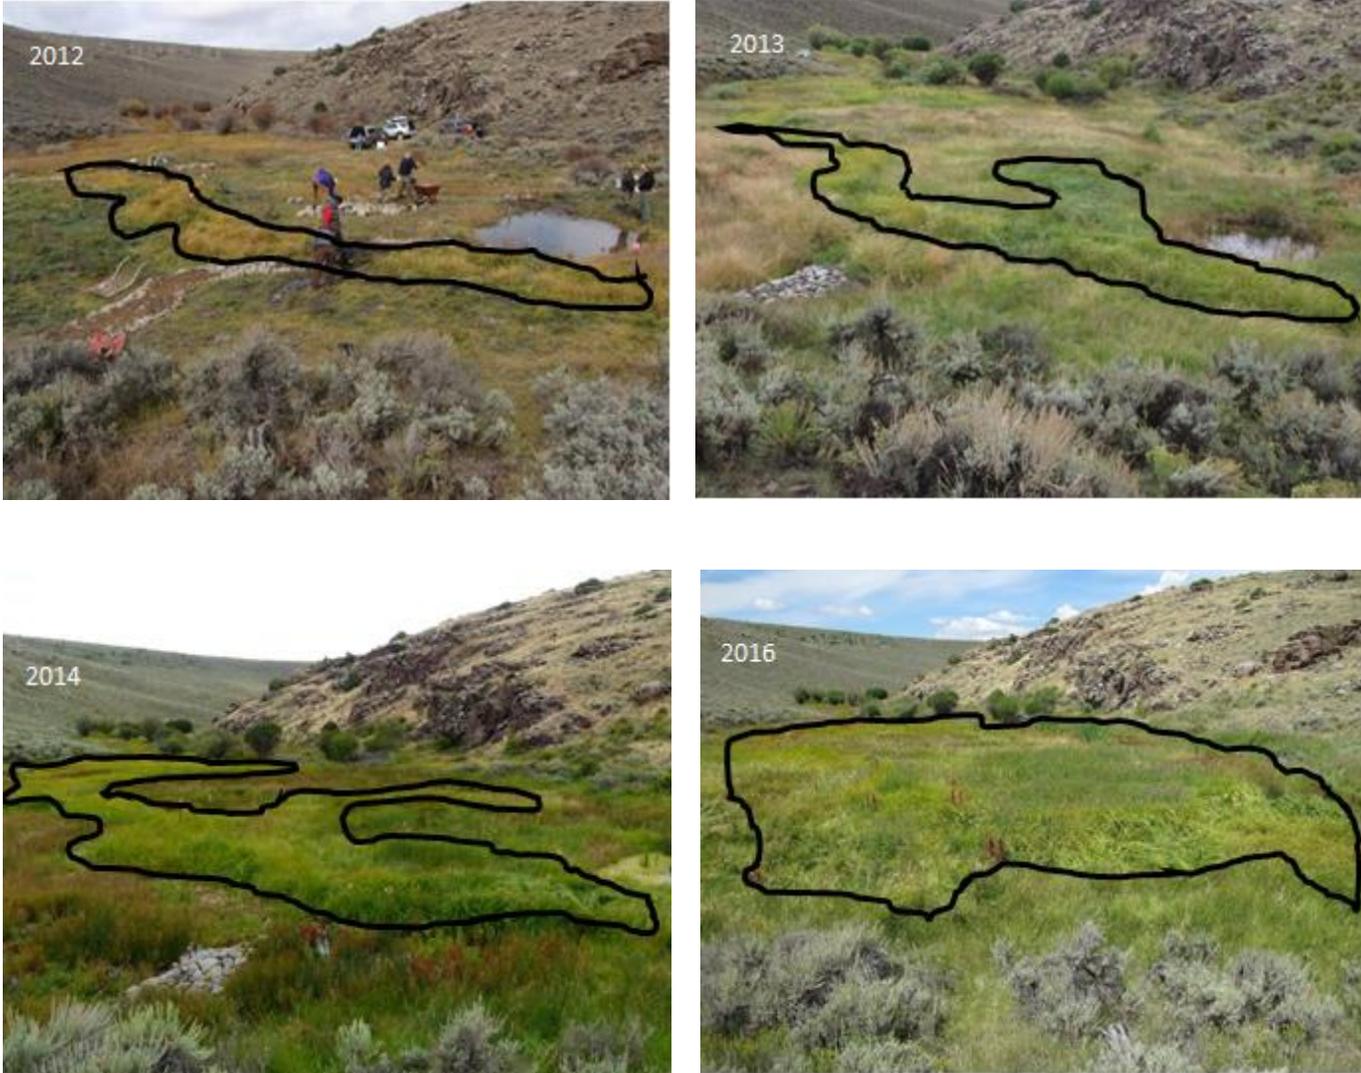
Figure 6. Wolf Creek Private: Fast response to Media Luna Structures

Wetland area increased from 25% to 80% of floodplain between 2012 & 2016 at CPW's Kaichen State Habitat Area.

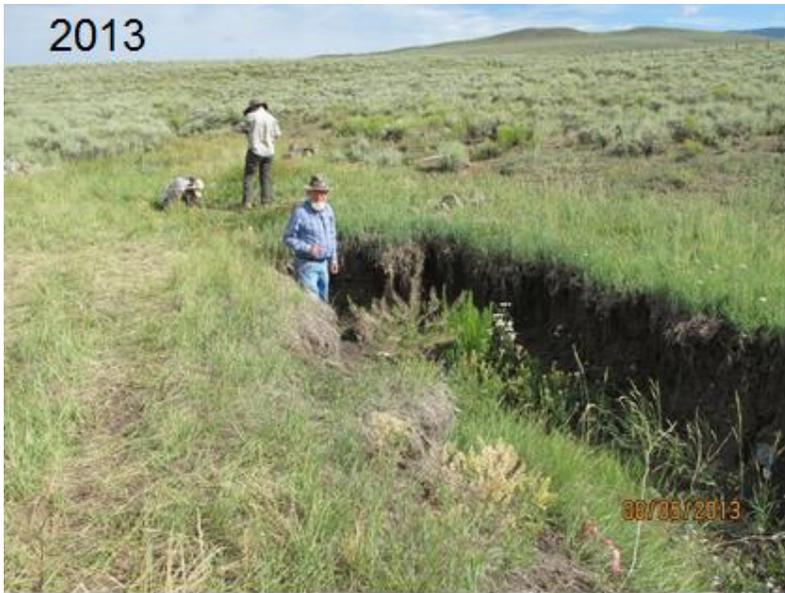
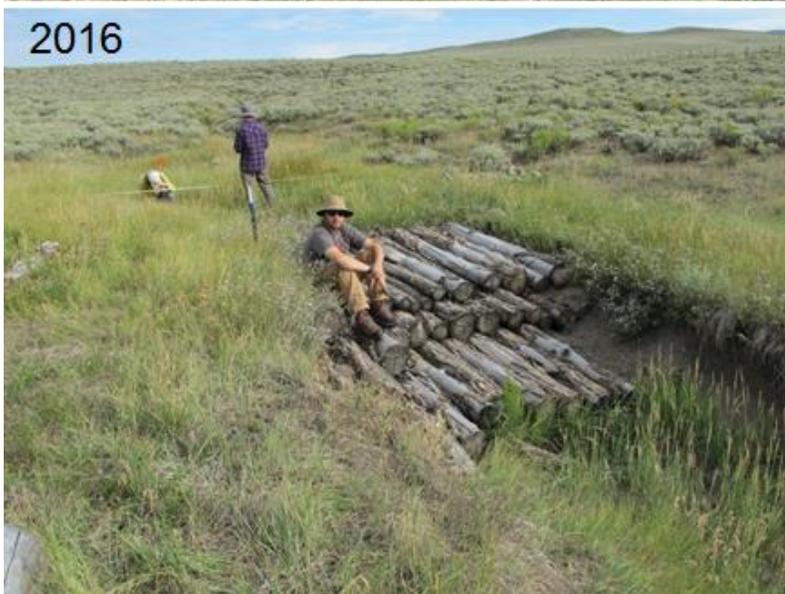
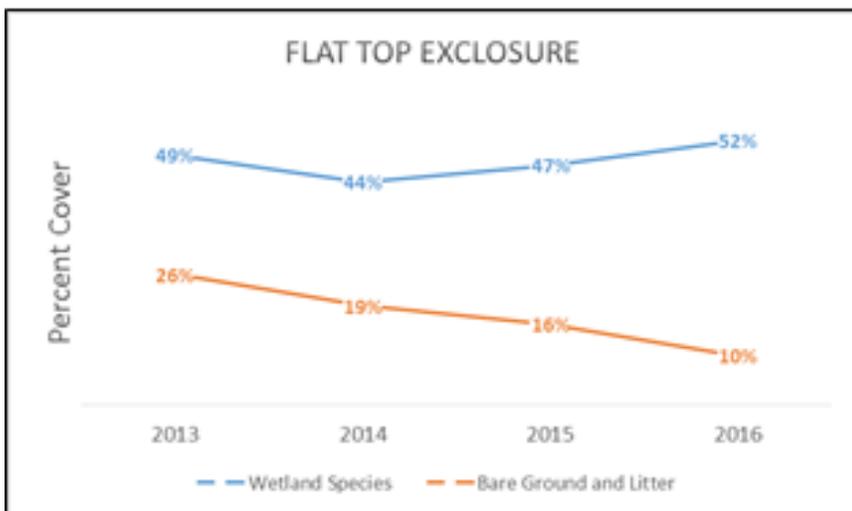
**Figure 7. West Flat Top Exclosure (USFS): Before and after installation of Log and Fabric Structure to control headcut.**

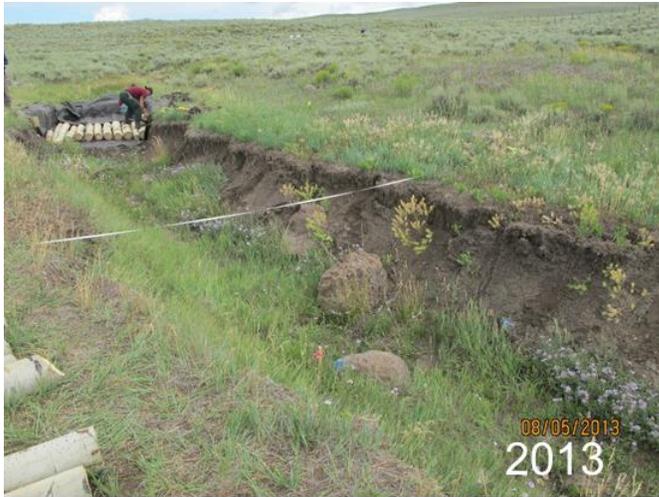
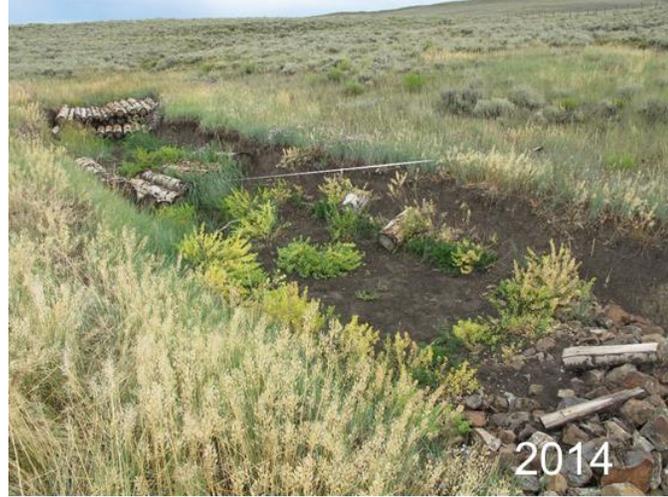
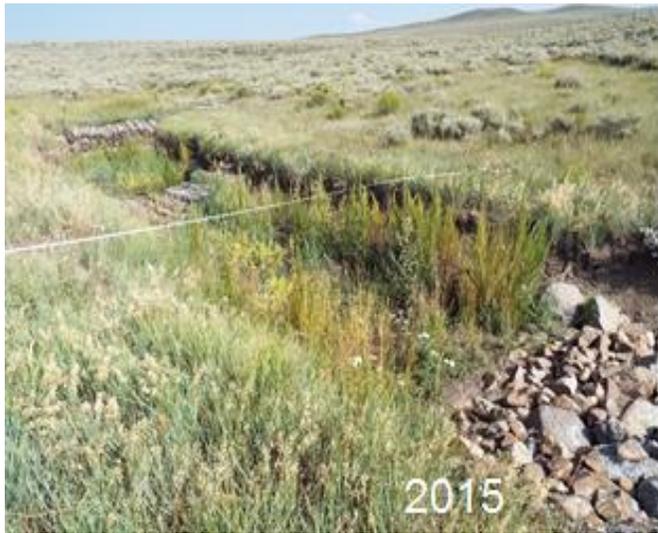
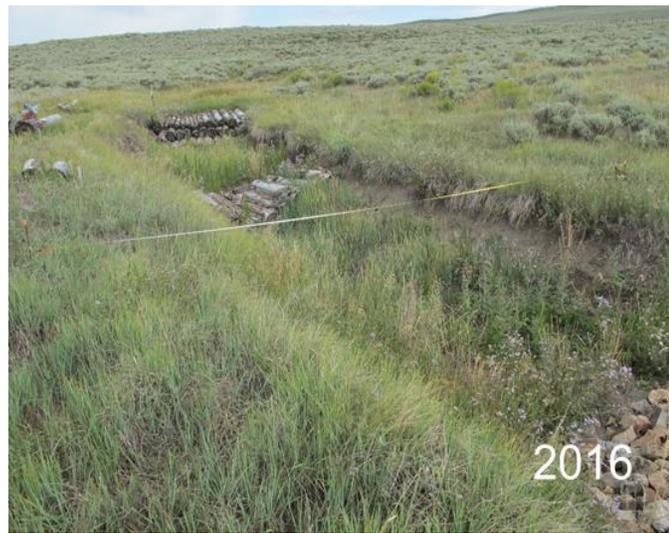
**Figure 8. West Flat Top (USFS): Slow response to Log & Fabric Structure to reduce head cut. The banks are stabilizing & there is less bare ground.**

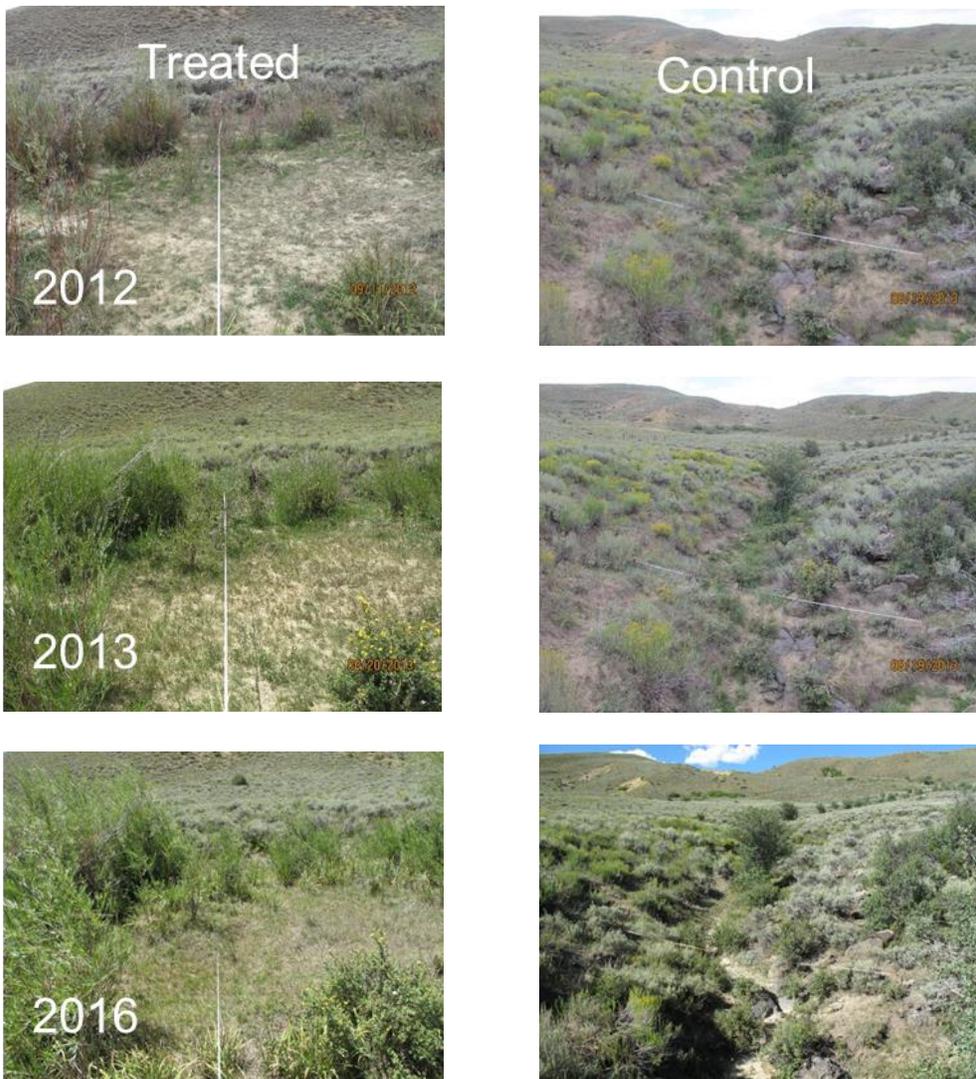
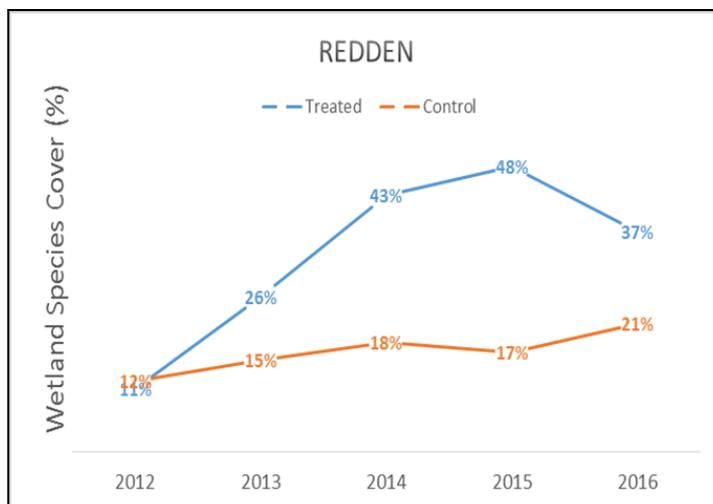
**Figure 9. West Flat Top Private Ranch: Response between 2012-2016. All 15 transects associated with the structures had an increase in wetland species cover. A second layer of rocks was added in 2016, post monitoring.**

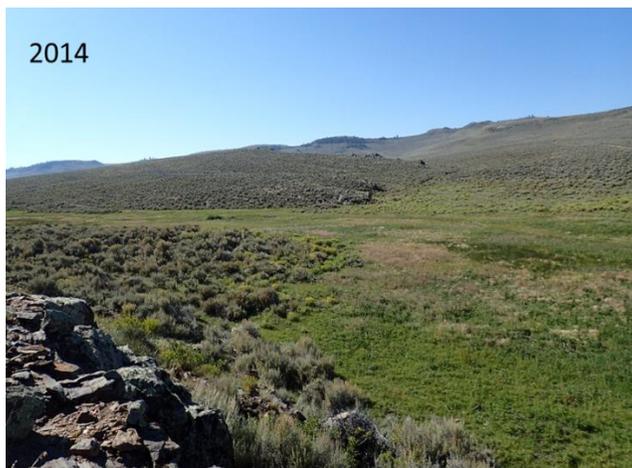
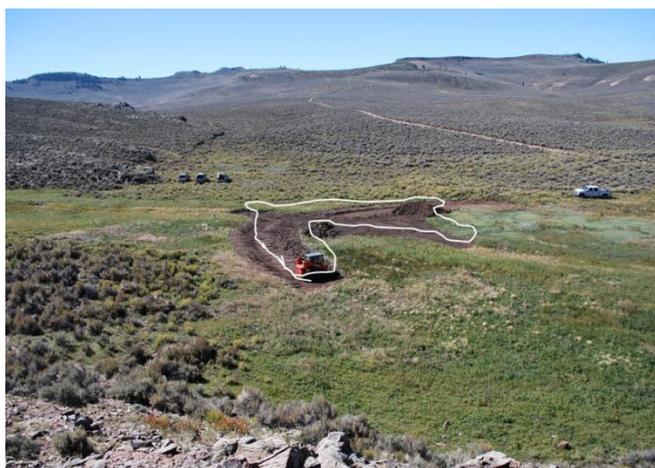
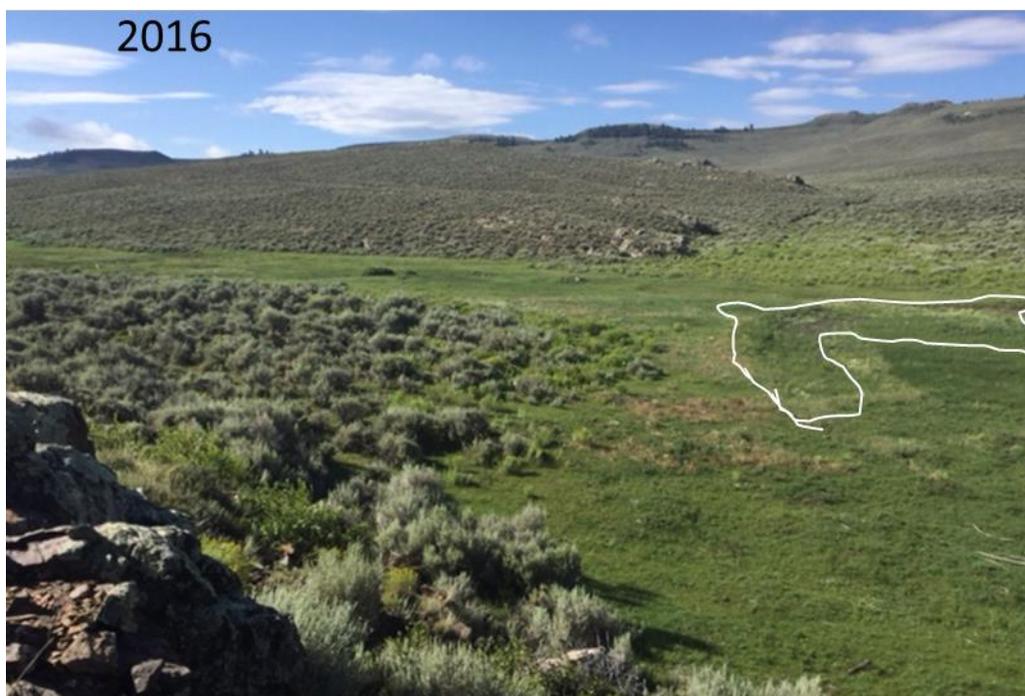
**Figure 10. Kezar Basin Private: Before, during and post construction of Double Bay Plug and Spread Structure**

Pre-structure, September 2014

Building plug and spread in September 2014  
(B. Neely)

The wetland species cover was 12% in 2014 and 30% in 2016, a 150% increase in wetland species cover.

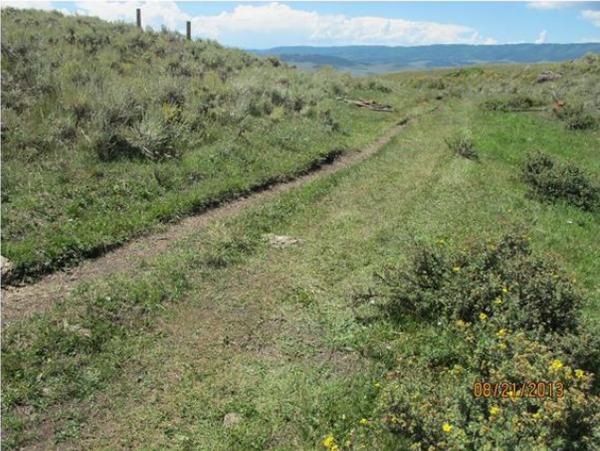
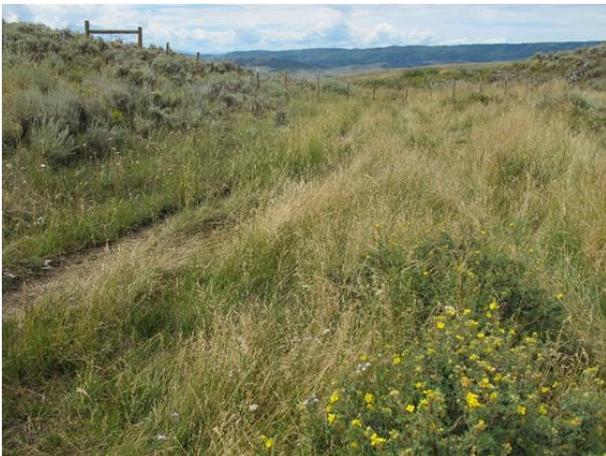
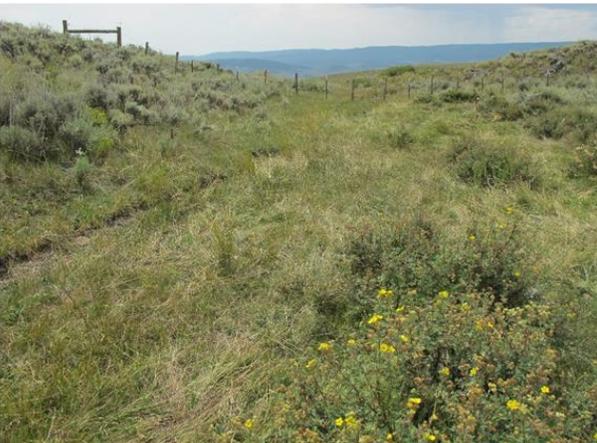
**Figure 11. West Flat Top at Henkel Road (USFS): The drift fence, a line of fence built across the stream channel, has reduced trailing and soil compaction by livestock and wildlife in this meadow.**

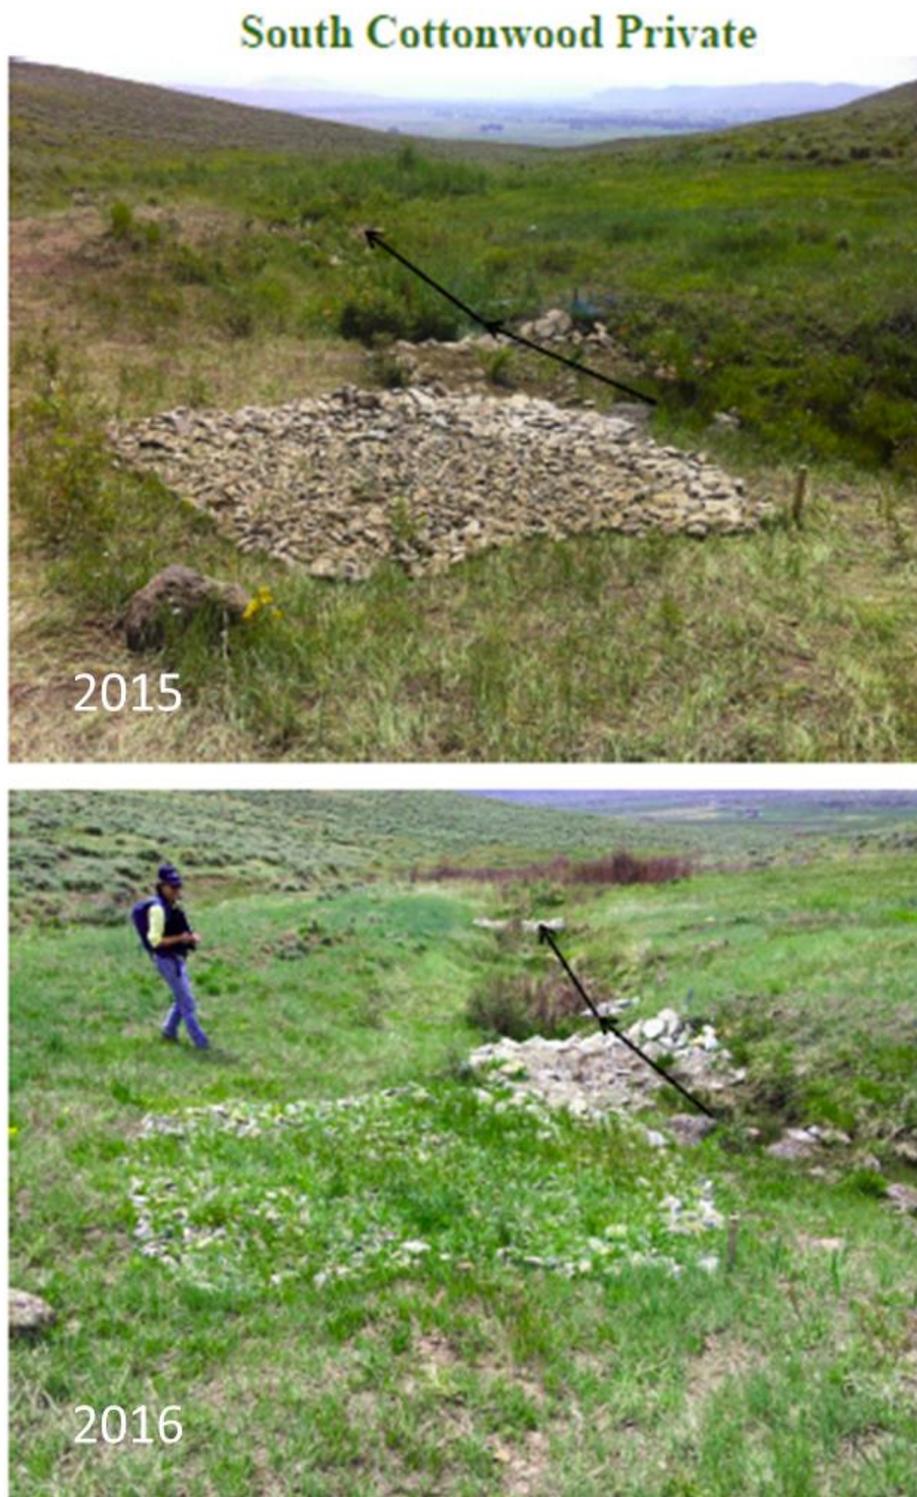
Figure 12. South Cottonwood Private: Vegetative response to a Rock Mulch Structure

Top Photo: August 20, 2015 (structure completion date); Bottom Photo: May 26, 2016, Page 5  
➤ Arrows indicates direction of water flow and matches 2015 and 2016 photo positions

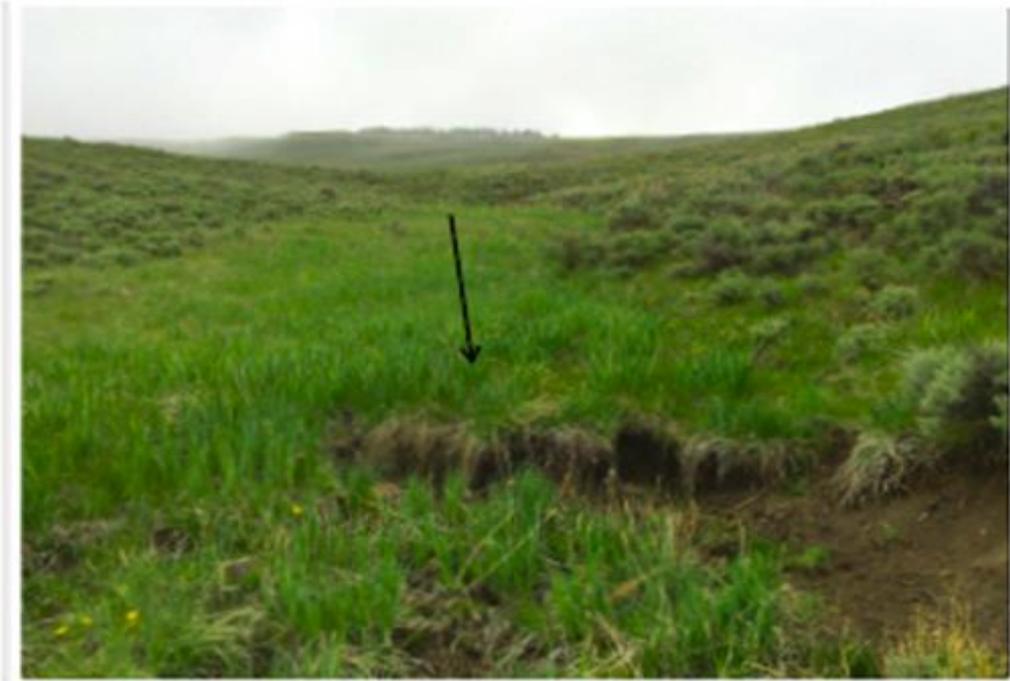
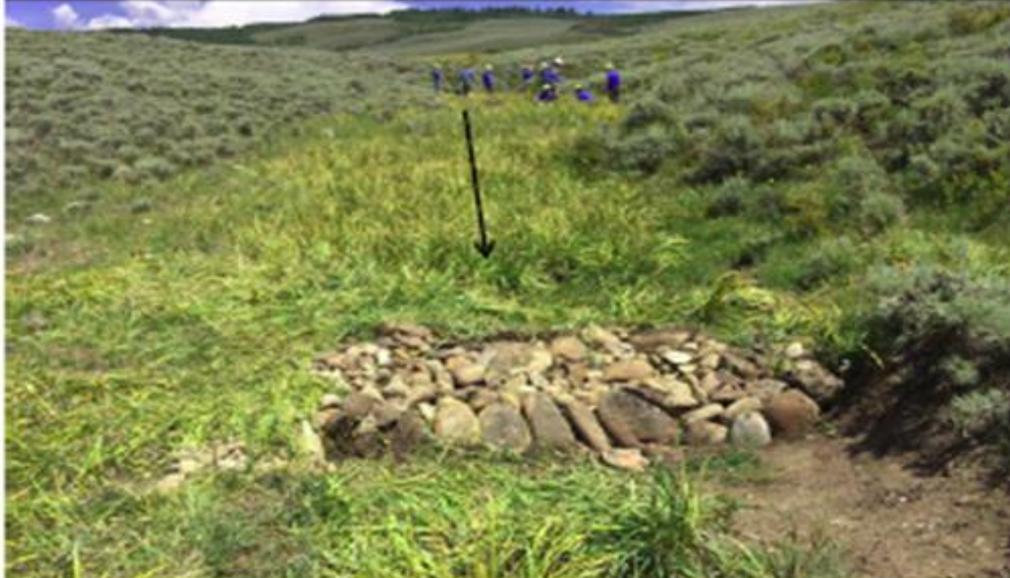
### USFS South Cottonwood Upper

Figure 13. Upper South Cottonwood (USFS): Pre-and post-construction of a Layback Structure to control the headcut. Photos were taken during the same year (2016).
