# Wet Meadow Restoration: Changes Over One Year

2012 vs 2013

Wolf Creek, Gunnison Basin

**Gunnison Basin Structures:  
Changes Over One Year  
Redden Ranch  
2012 compared to 2013**

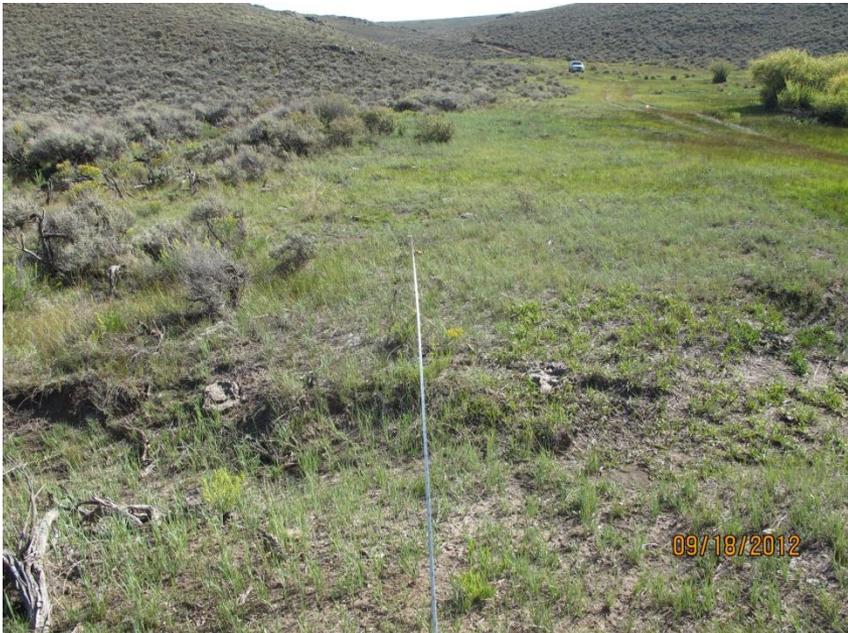
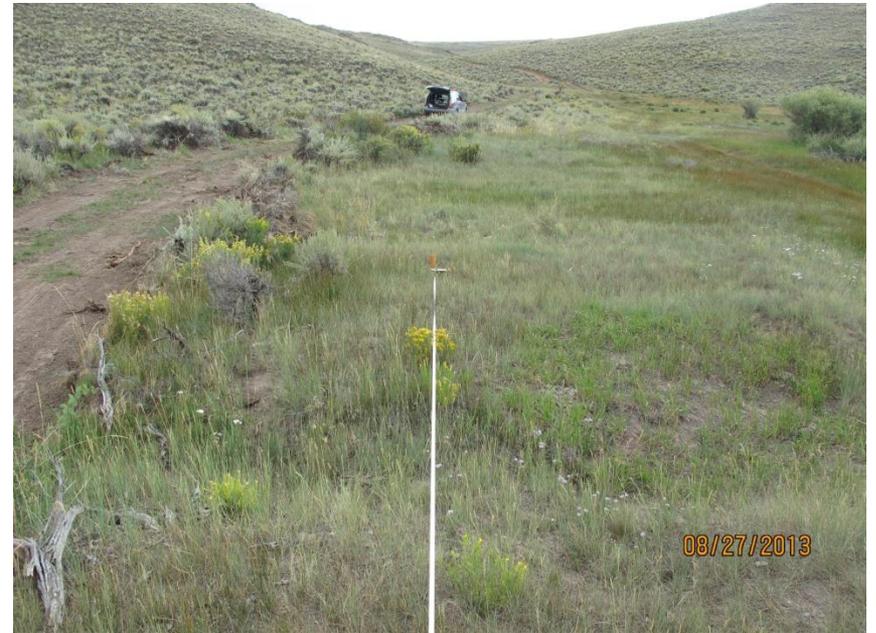
# Control: no structures built

Note: the new two track visible in the 2013 photo is part of the overall restoration plan. The original two-track bisected a wet meadow and the new two-track is now on the edge of the wet meadow. Transect photo: C01\_0m

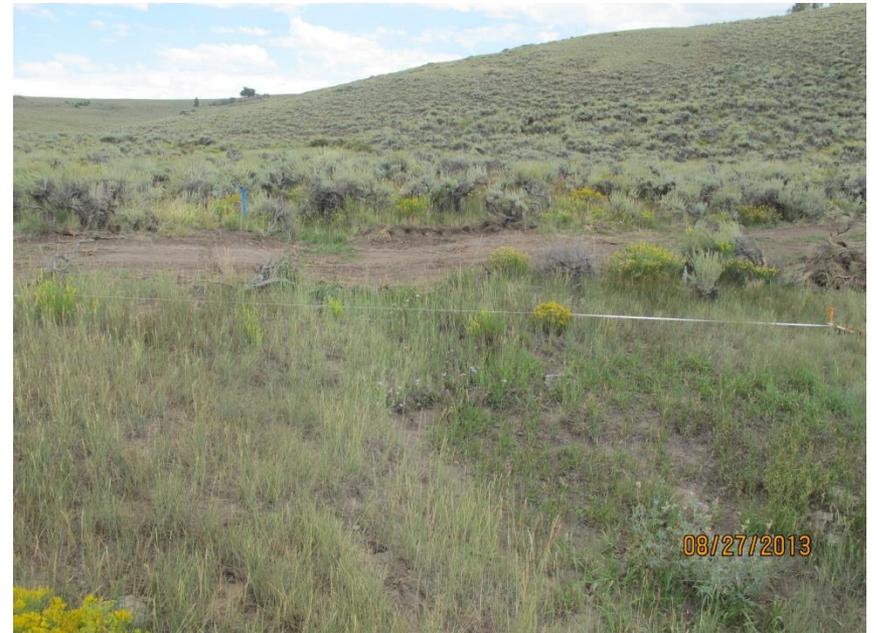
# Control

We can see an increase in cover and height of western wheat grass in the 2013 repeat photo, due to increased precipitation.

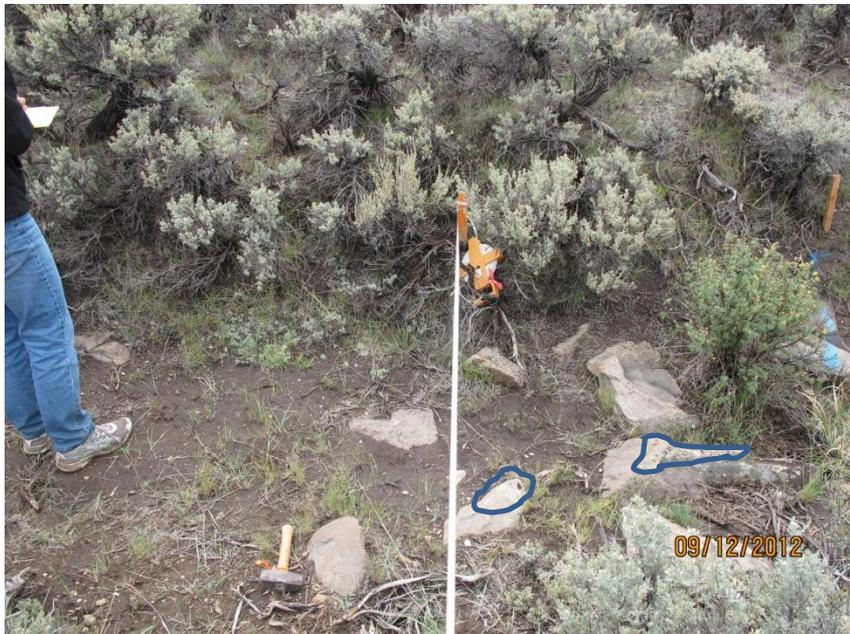
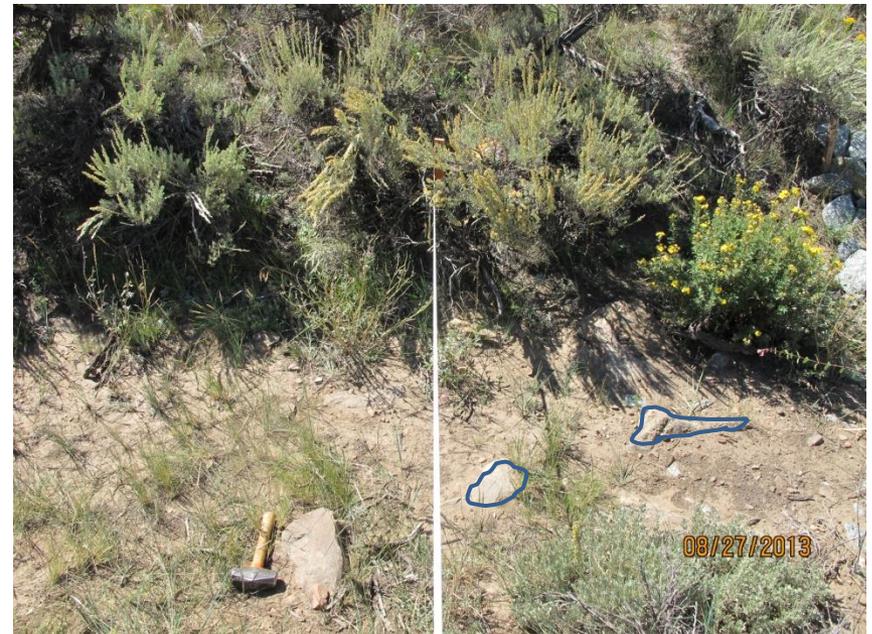
# One Rock Dam on Ephemeral Stream, GWT29\_0m

By 2013, sediments partially or completely covered many of the rocks. (Use the hammer to help locate the 2012 rocks and compare to the 2013 photo.)

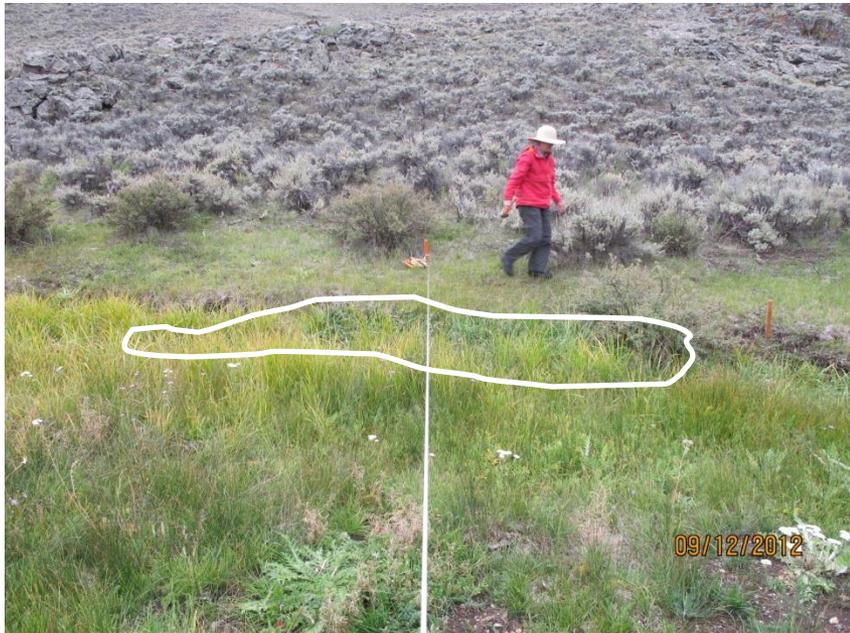
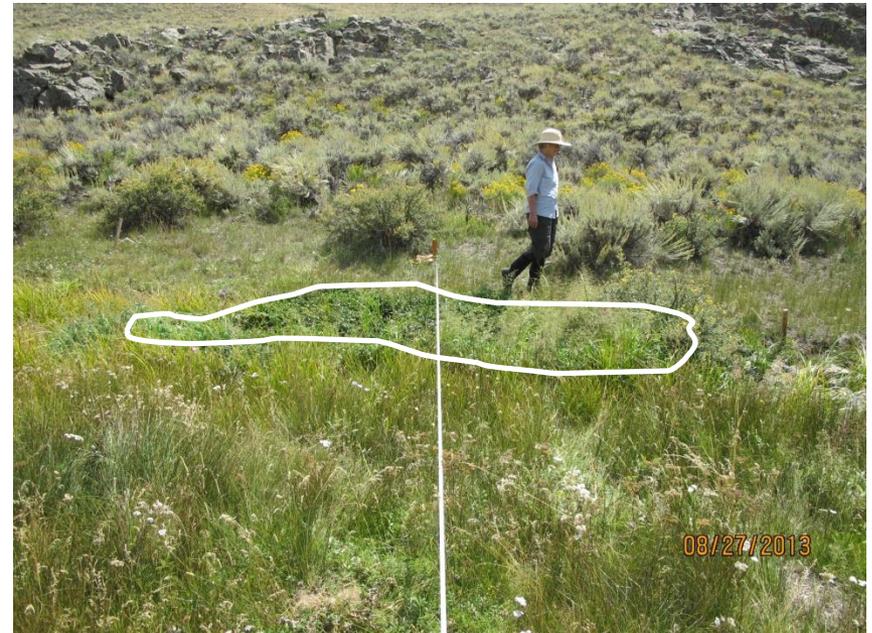
## GWT38\_0m

The white polygon was dominated by *Carex utriculata* in 2012 (left photo) and by *Veronica* in 2013 (right photo); *Veronica* only occurs in running water hence more water in 2013; **wetland obligates went from 35% in 2012 to 50% in 2013.**

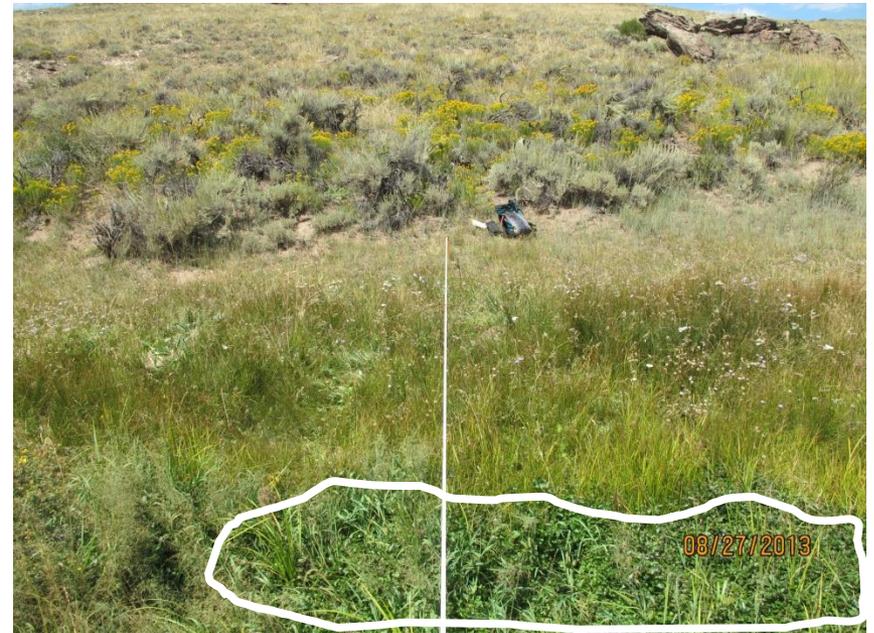
# Rock Run Down GWT38\_end

*The white polygon denotes the *Veronica wormskadii* area in 2012 (left) vs 2013 (right). At this site, **wetland obligates went from 35% in 2012 to 50% in 2013.***

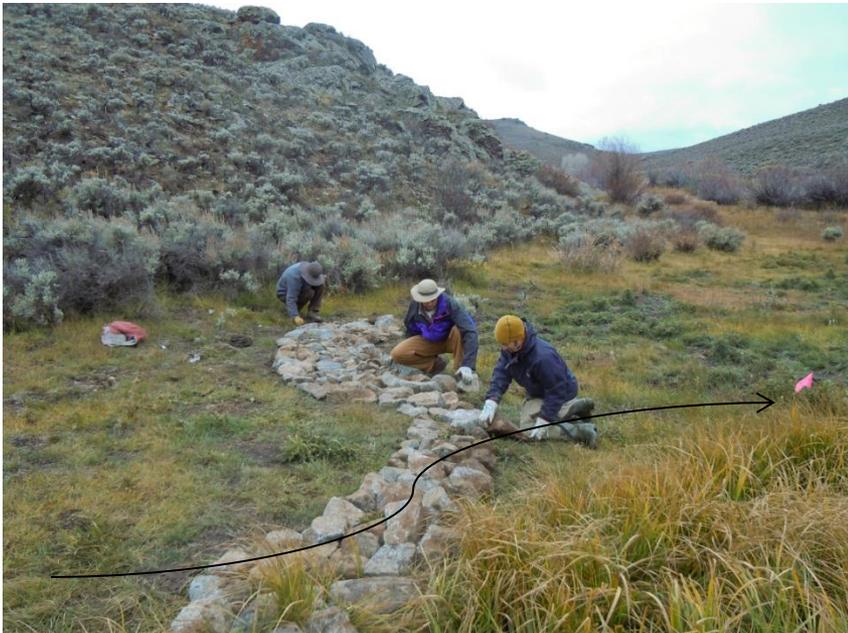
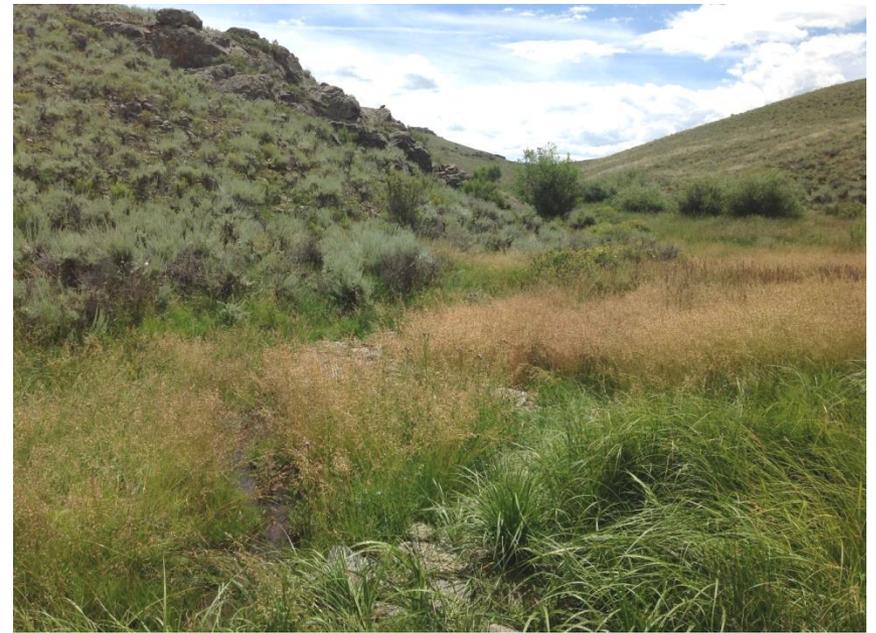
# Media Luna 43

The media luna was positioned to spread the water across the meadow. By 2013 the water had significantly spread across the meadow into areas that had once been saturated prior to the stream downcutting.

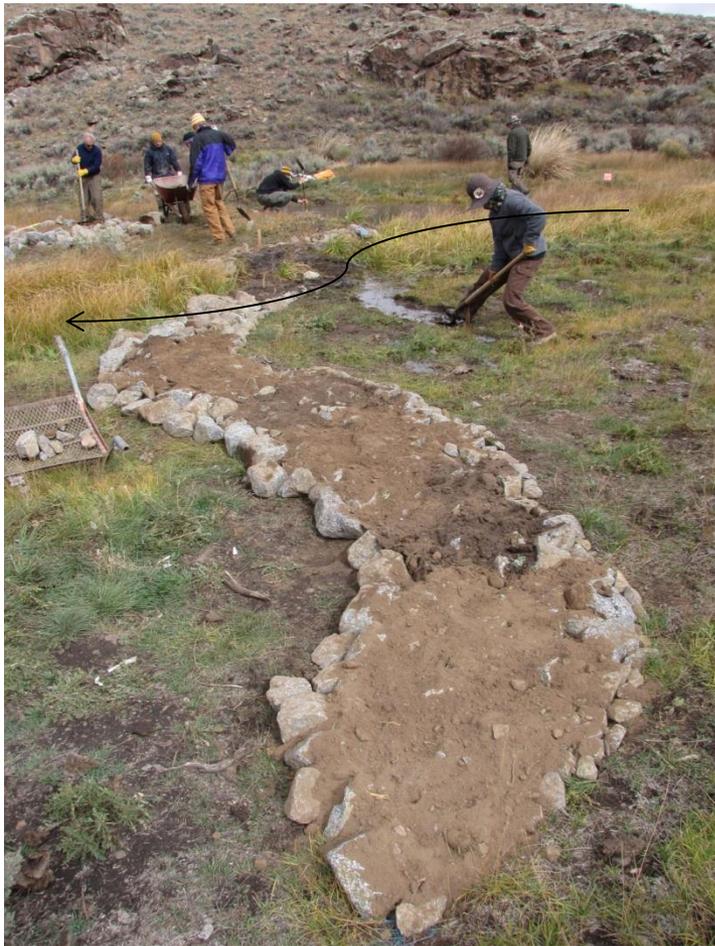
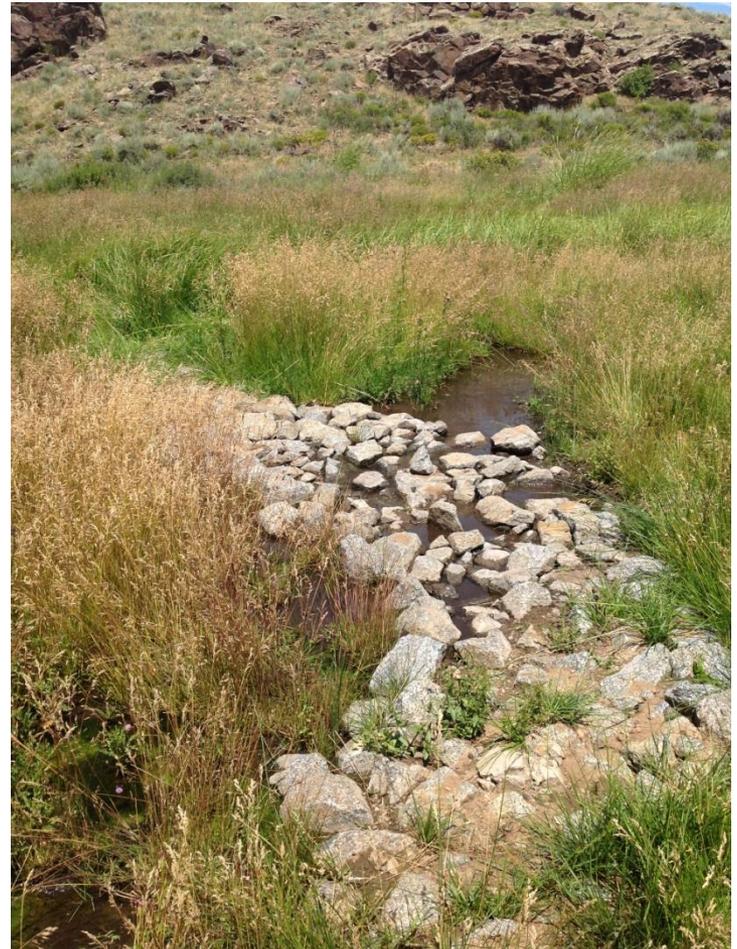
# Media Luna, 43

This media luna spread the water across the meadow within one year of its placement. Species composition will probably change within a year or two.

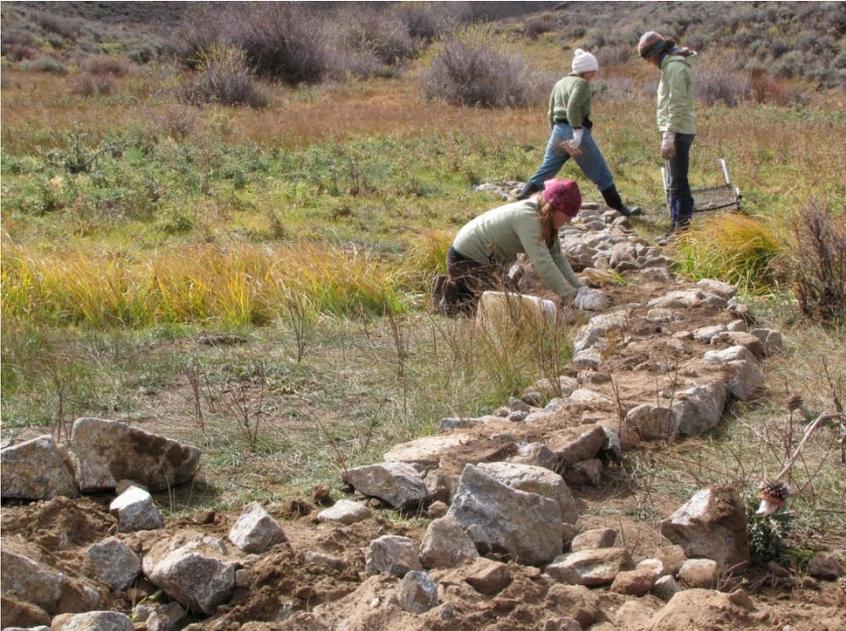
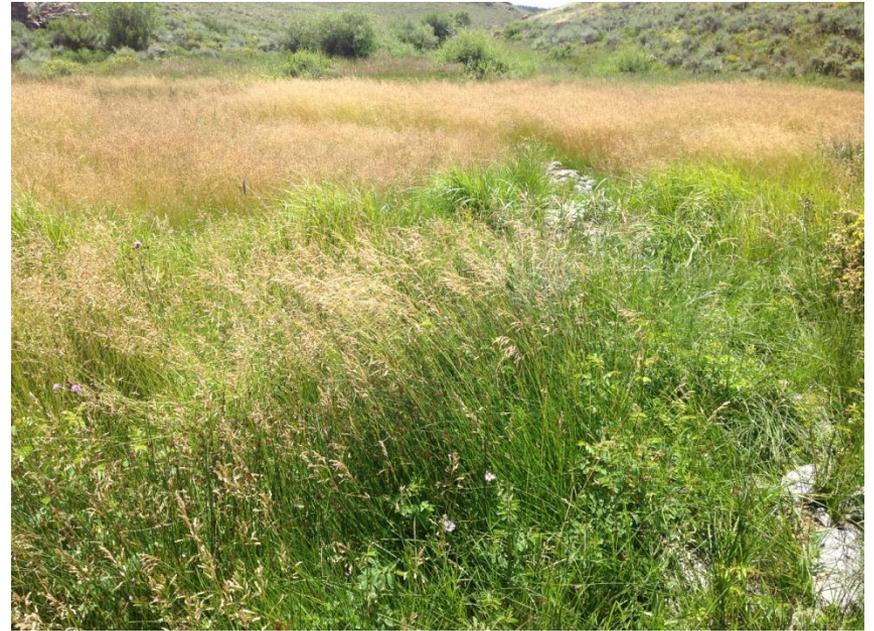
# Media Luna, 45

We documented remarkable changes in the cover and height of the vegetation after one year of building the media luna. Species composition will most likely change within the next year or two.

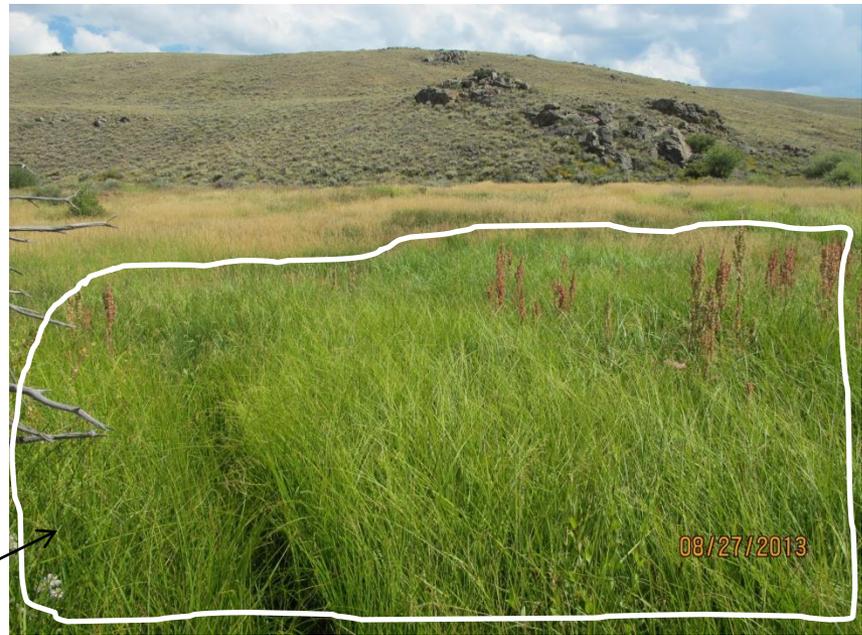
# Downstream of two media lunas, GWT46PP\_a

*Carex utriculata*, an obligate wetland species, expanded into new areas after the media luna was established.

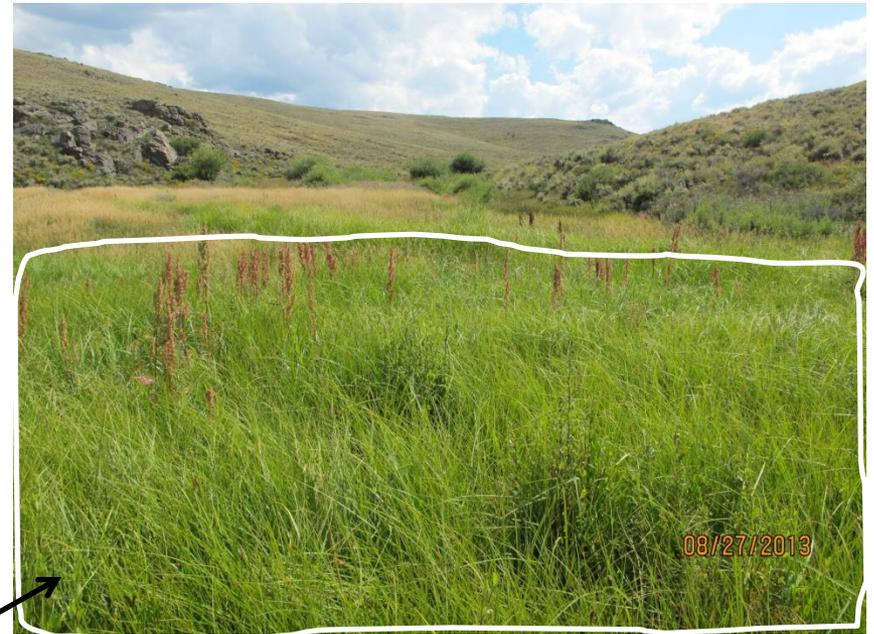
# Downstream of two media lunas, GWT46PP\_b

*Carex utriculata*, an obligate wetland species,  
expanded in area after the media luna was  
established.

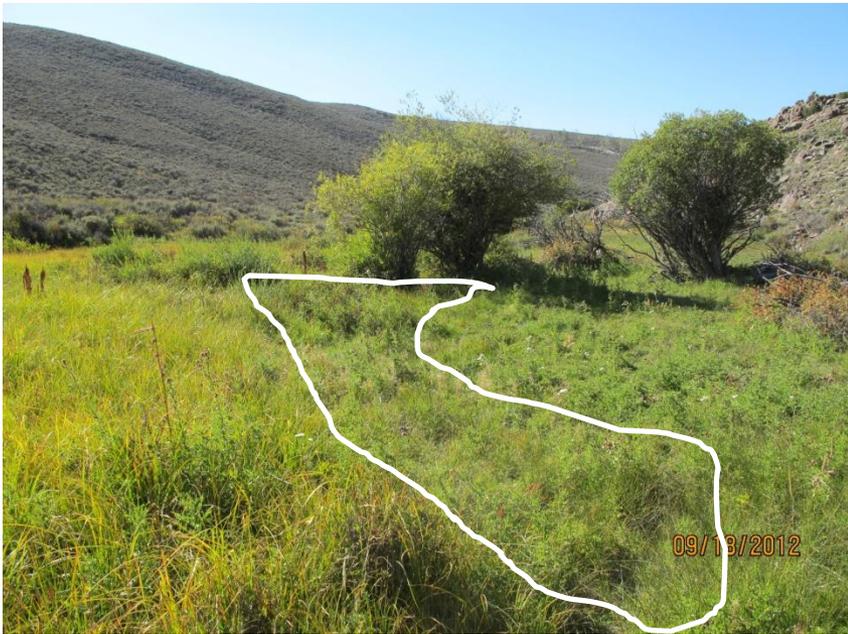
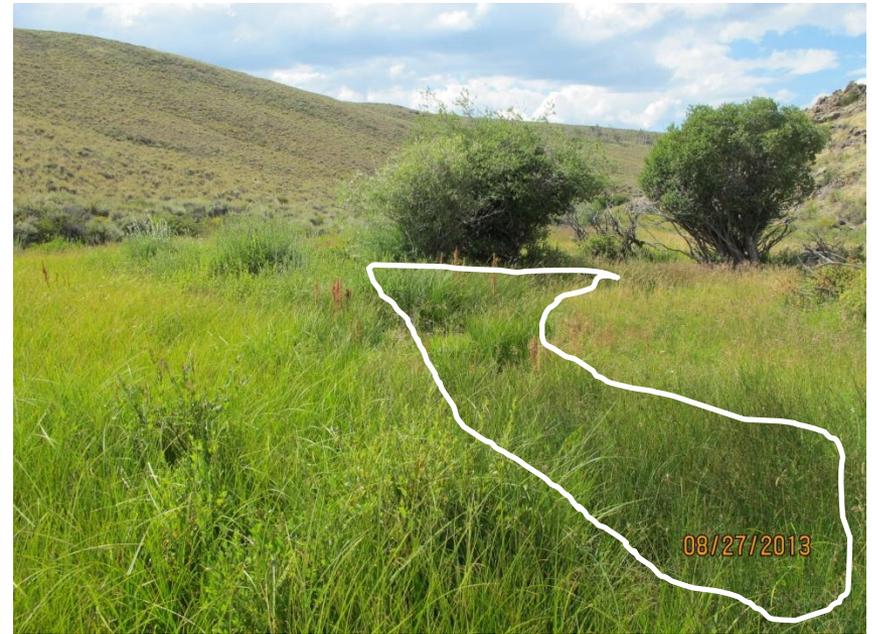
# Downstream of two media lunas, GWT46PP\_c

In 2012 (left photo) the white polygon was dominated by more xeric species and by 2013, one year after media lunas were established, the area was dominated by *Carex uticulata*, an obligate wetland plant

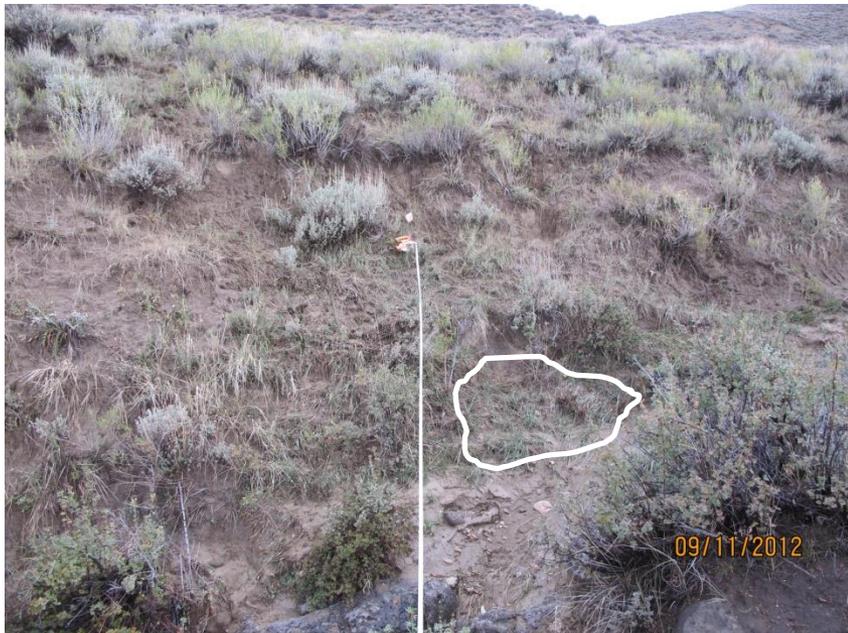
## GTC02\_0m

*54% bare ground, liter or rock in 2012*

The area within the white polygon is sparsely vegetated in 2012

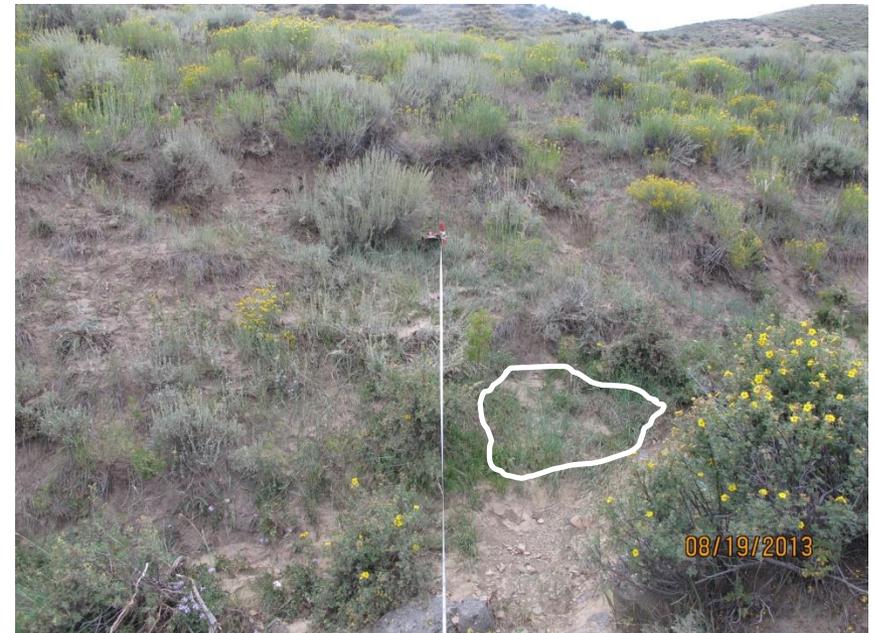
*33% bare ground, liter or rock in 2013*

The area within the white polygon has more cover in 2013, due to higher rainfall

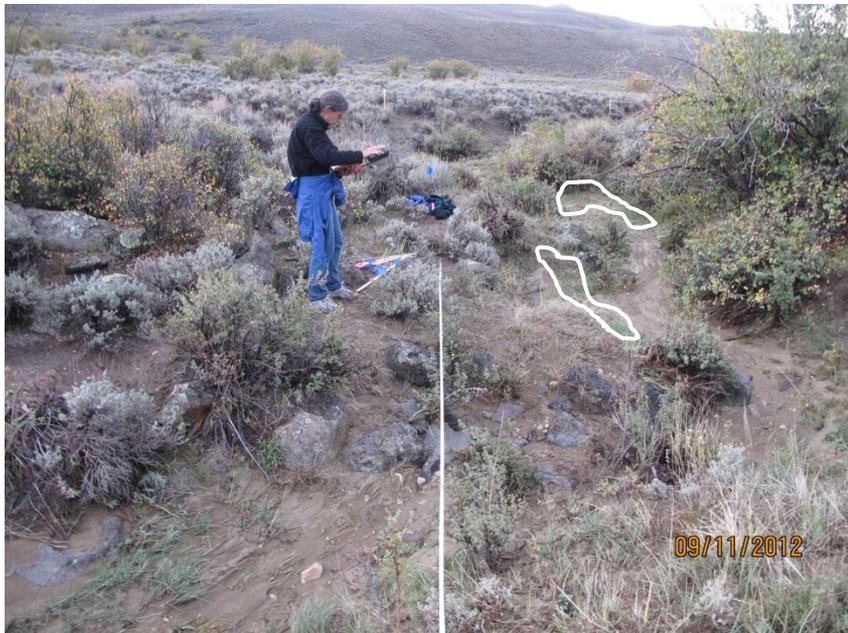
## GTC02\_end

*54% bare ground, liter or rock in 2012*

The area within the white polygon was sparsely vegetated in 2012

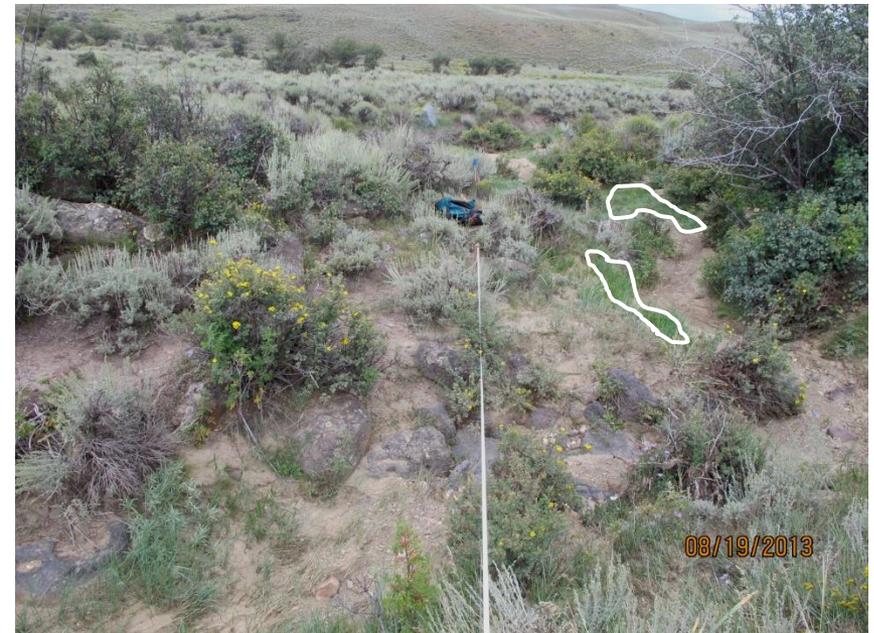
*33% bare ground, liter or rock in 2013*

The area within the white polygon is more densely vegetated in 2013, due to more rain

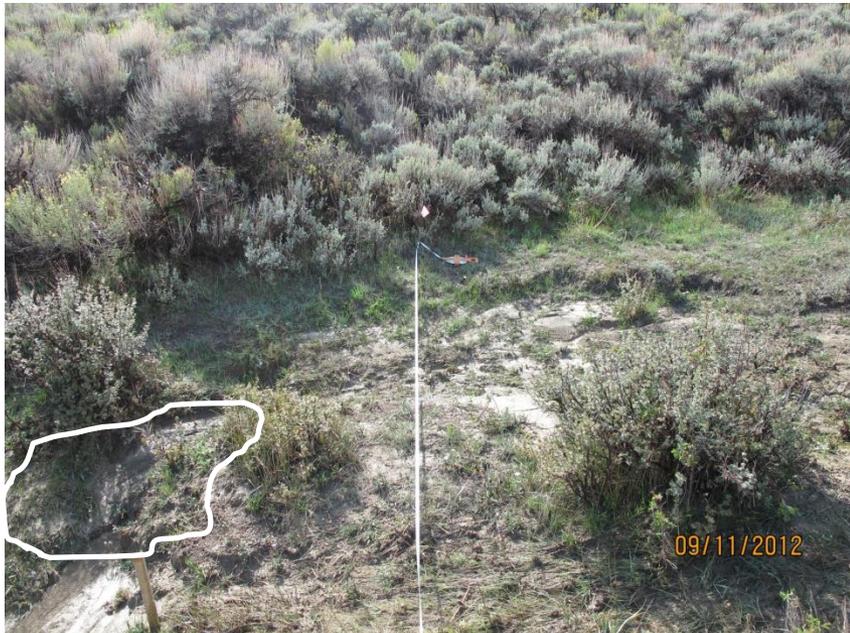
## GRT07\_0m

The white polygon denotes the area where the one rock dam will be built

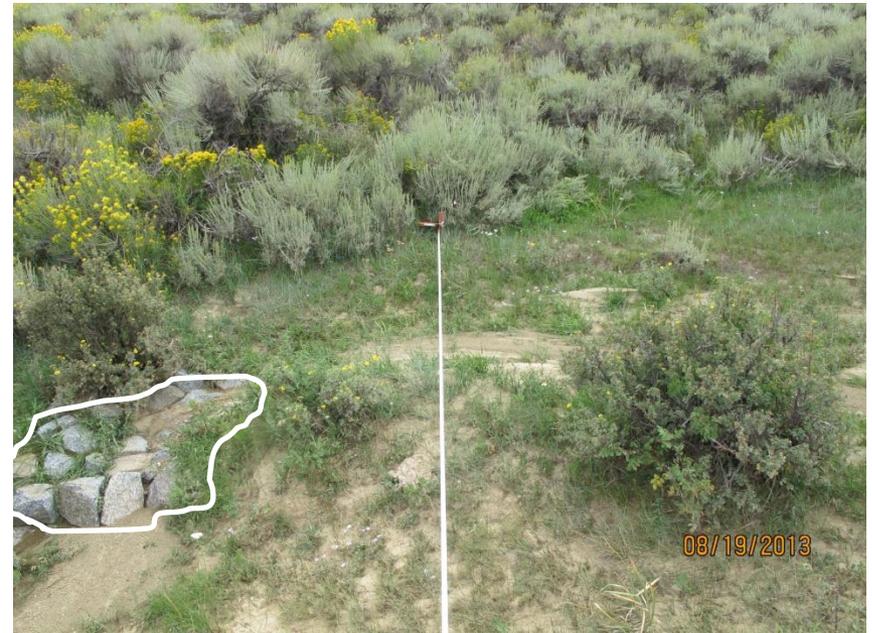
The white polygon represents the area where the one rock dam was built

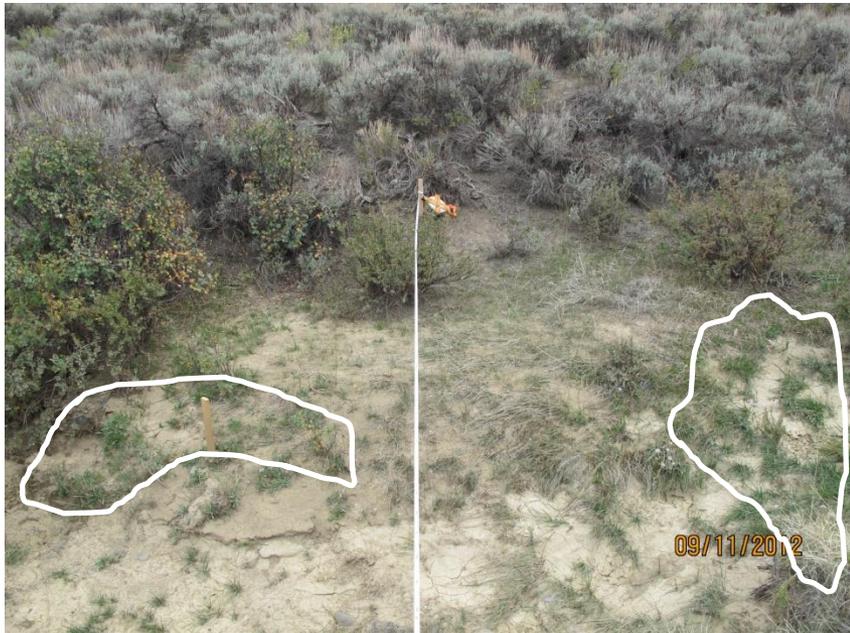
# GRT28\_0m

The are within the white polygon will be impacted by the one rock dam that was built shortly after this photo was taken

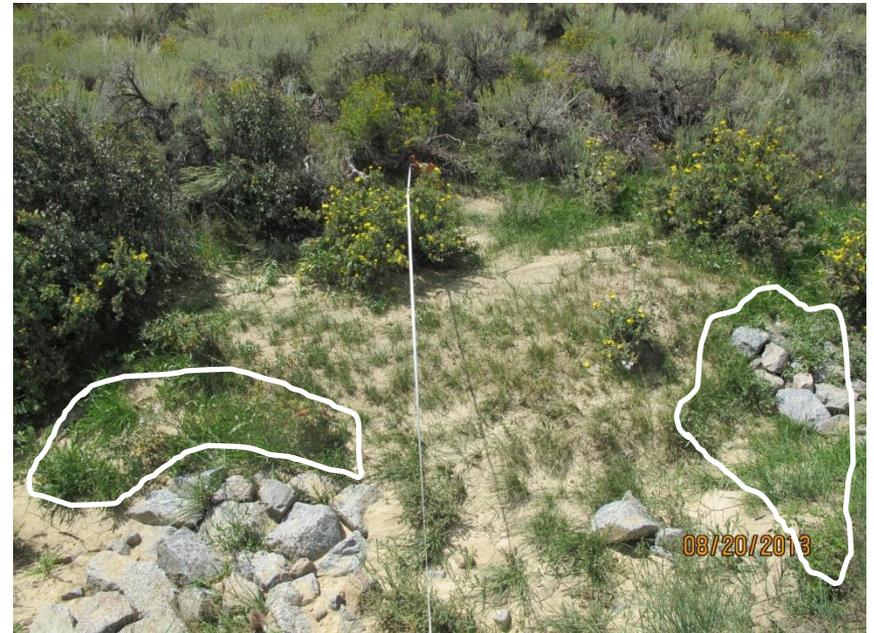
The area within the white polygon was impacted by the one rock dam

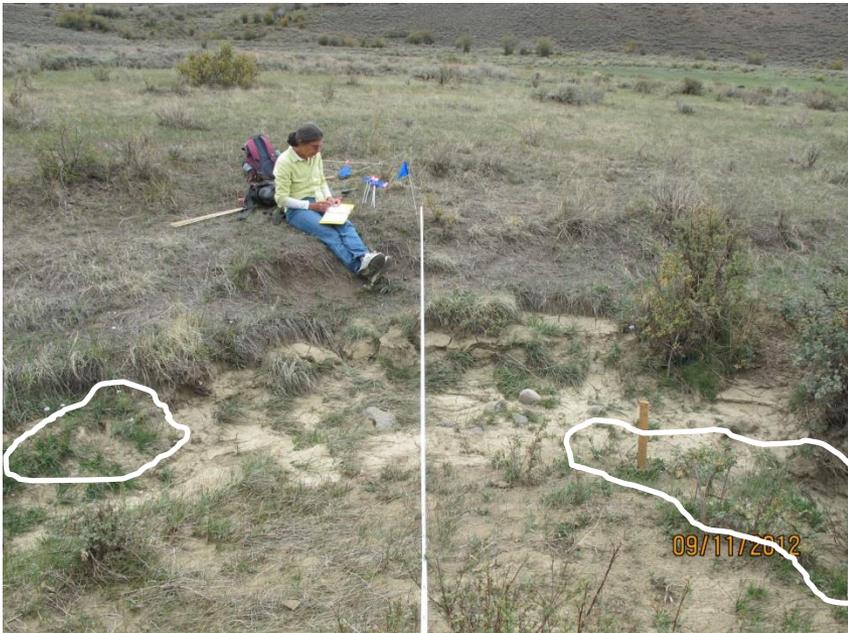
# GRT28\_end

White polygons denote the area that will be impacted by the one rock dam

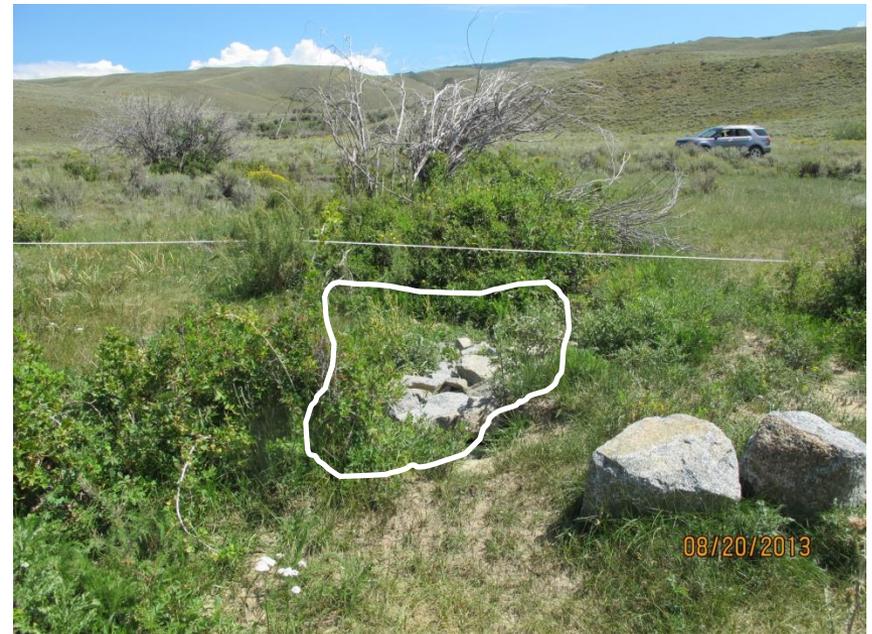
The white polygon denotes the area that was influenced by the one rock dam after one year

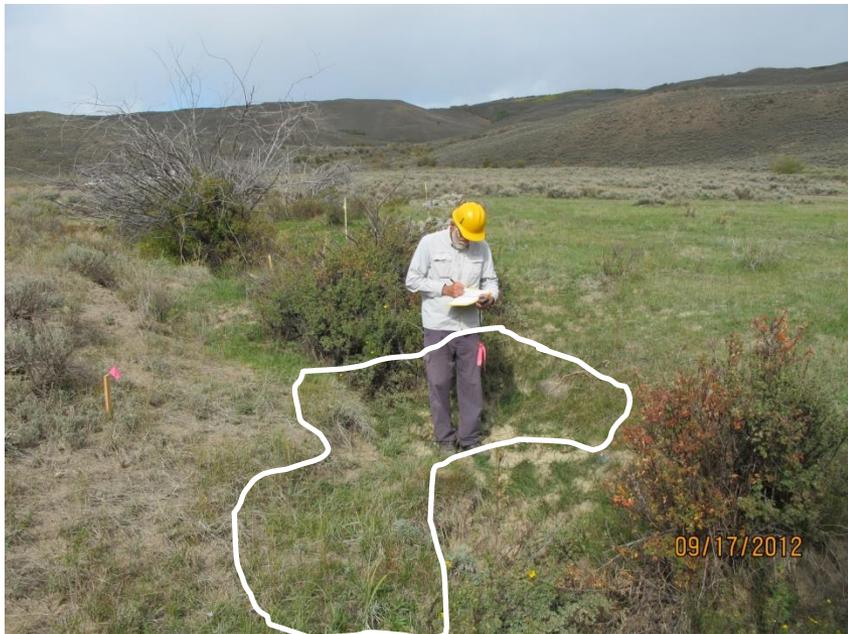
# One Rock Dam on Ephemeral Stream GRT49PP

*Bare ground and litter occupied 41% in 2012*

The white polygon represents the area that will be impacted by the one rock dam

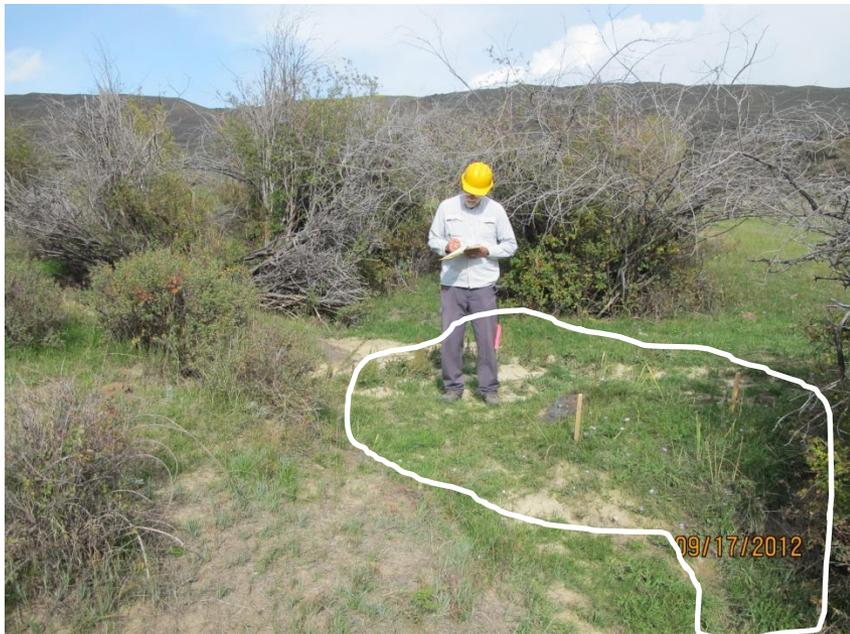
# One Rock Dam on Ephemeral Stream GRT53PP

The white polygon outlines the floodplain that the one rock dam will influence.

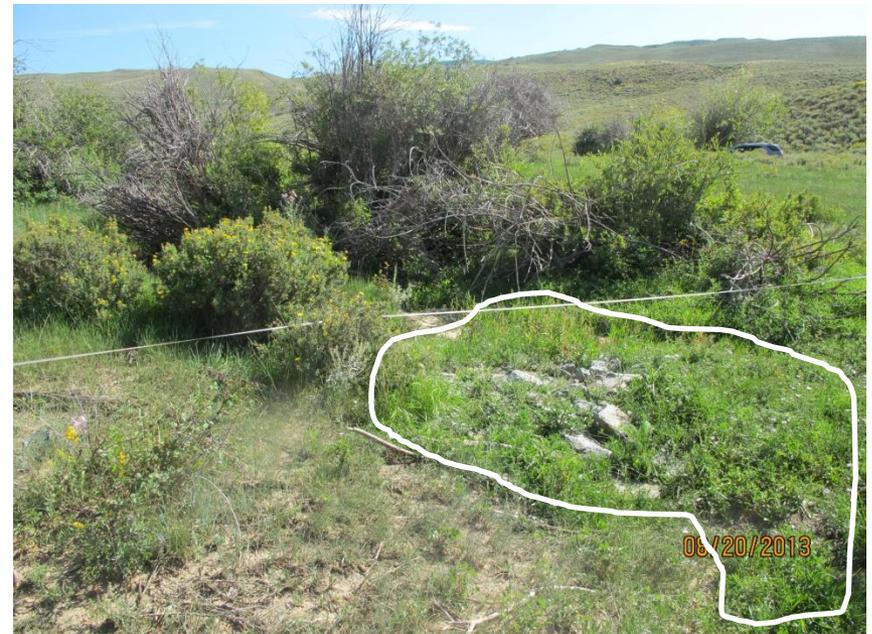
The white polygon outlines the floodplain that the one rock dam influenced after one year.
