Final Report to the Terra Foundation

RESTORATION/RESILIENCE-BUILDING OF RIPARIAN AND WET MEADOW HABITATS:
UPPER GUNNISON RIVER BASIN, COLORADO

By The Nature Conservancy
in Collaboration with the Gunnison Climate Working Group
January 6, 2017

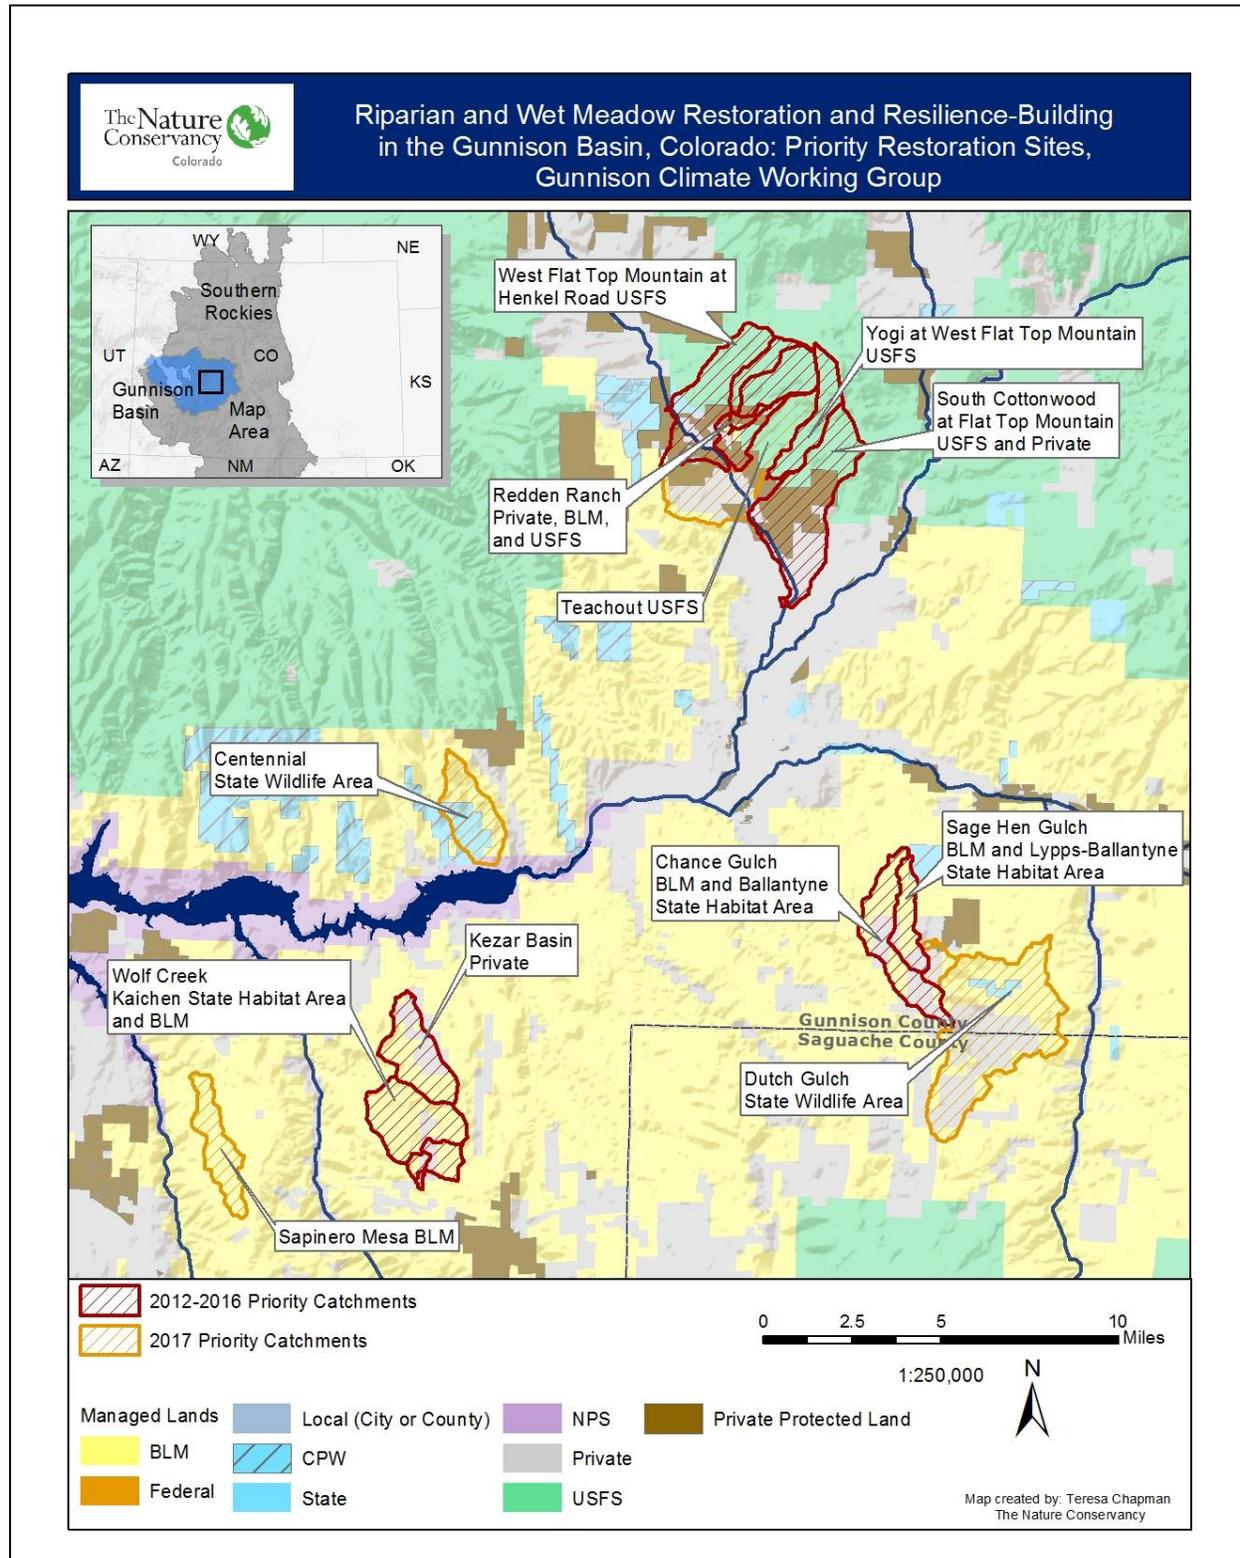
Figure 1. Overview Map of Priority Restoration Sites in the Gunnison Basin.

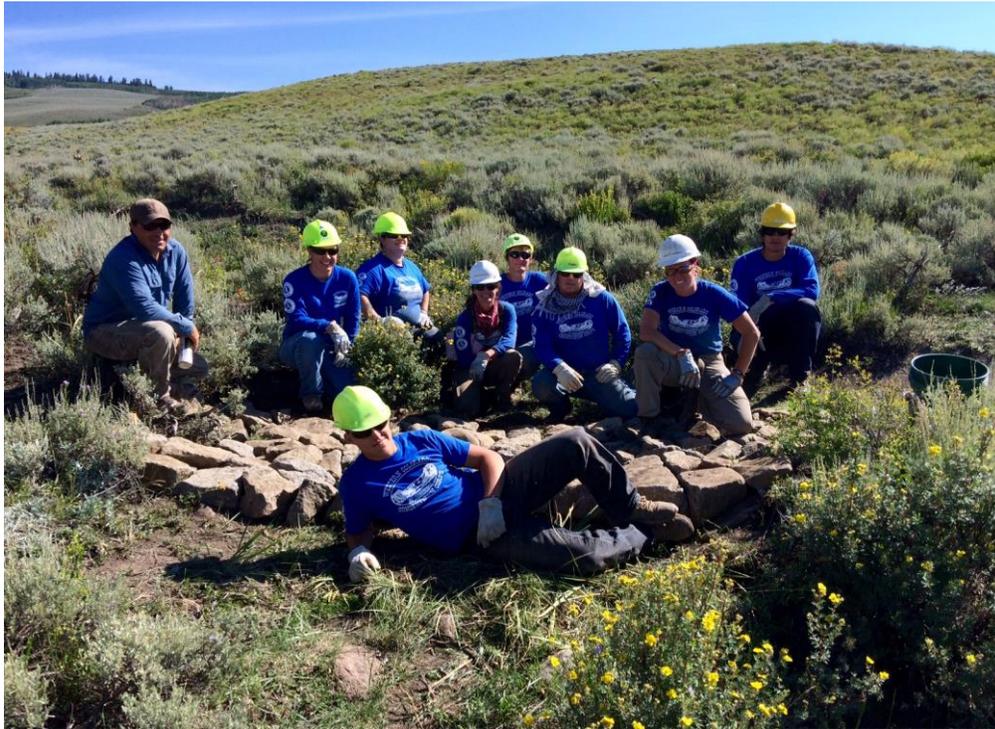
Figure 2. Western Colorado Conservation Corps celebrate completion of a one rock dam at West Flat Top with Shawn Conner, restoration expert with BIO-Logic, Inc. Photo by Matt Vasquez, USFS.

Following the training, restoration experts and team members provided technical oversight to youth field crews in building rock structures for approximately 4-6 weeks from late July to early September. See Figure 2 for a photograph of the WCCC field crew members showing off their completed rock structure.

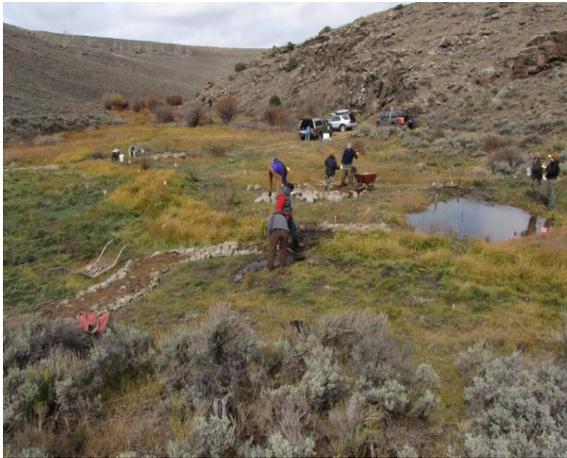
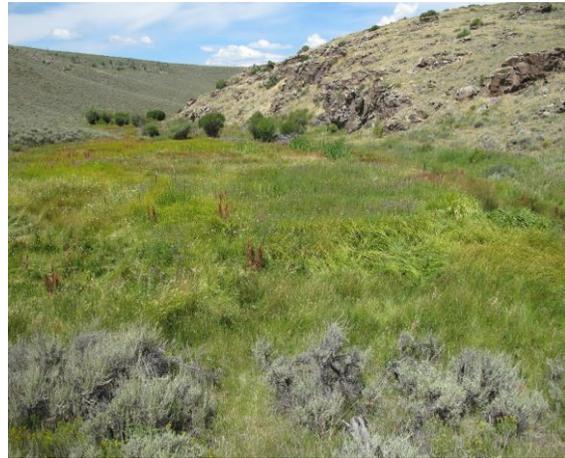
Figure 2. The Wolf Creek East Fork site showed fast response to media lunas. Wetland area increased from approximately 25% of the floodplain in 2012 and 80% in 2016. Wetland species cover increase by 220% over 4 years.

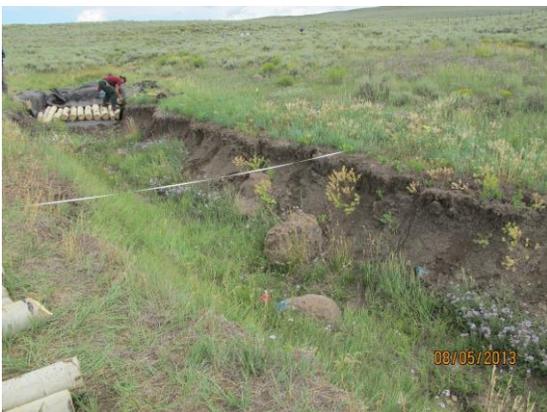
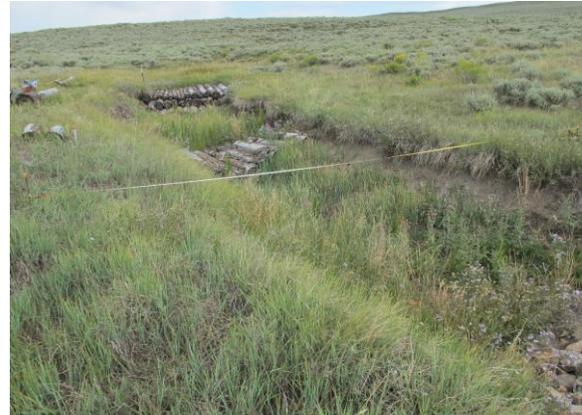
Figure 4. Percent change in wetland species cover for reaches with four years (top) and three years (bottom) after structures were built. Blue bars represent treated areas and orange bars represent controls (untreated areas).

See Figures 2-3 for photos and Figure 4 for graphic showing percent change in wetland species cover for reaches over three and four years after structures were built. See Table 5 for a summary of wetland species cover response rates at priority sites by stream reach grouped into fast, slow and no response categories for priority sites and stream reaches. See Appendix D and E for the vegetation monitoring report and photo documentation of vegetation response to treatments.

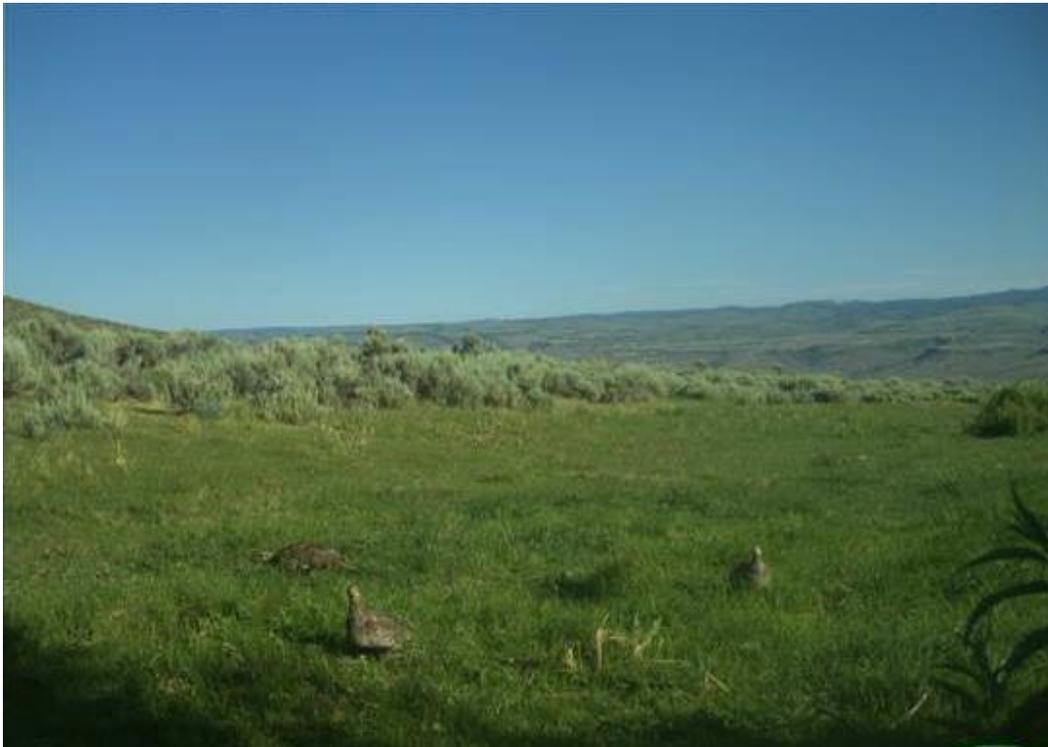
Figure 5. Three Gunnison sage-grouse hens captured on camera on July 16, 2016 in a wet meadow treated with plug and spread structures in Kezar Basin (Photo by Nathan Seward, CPW).

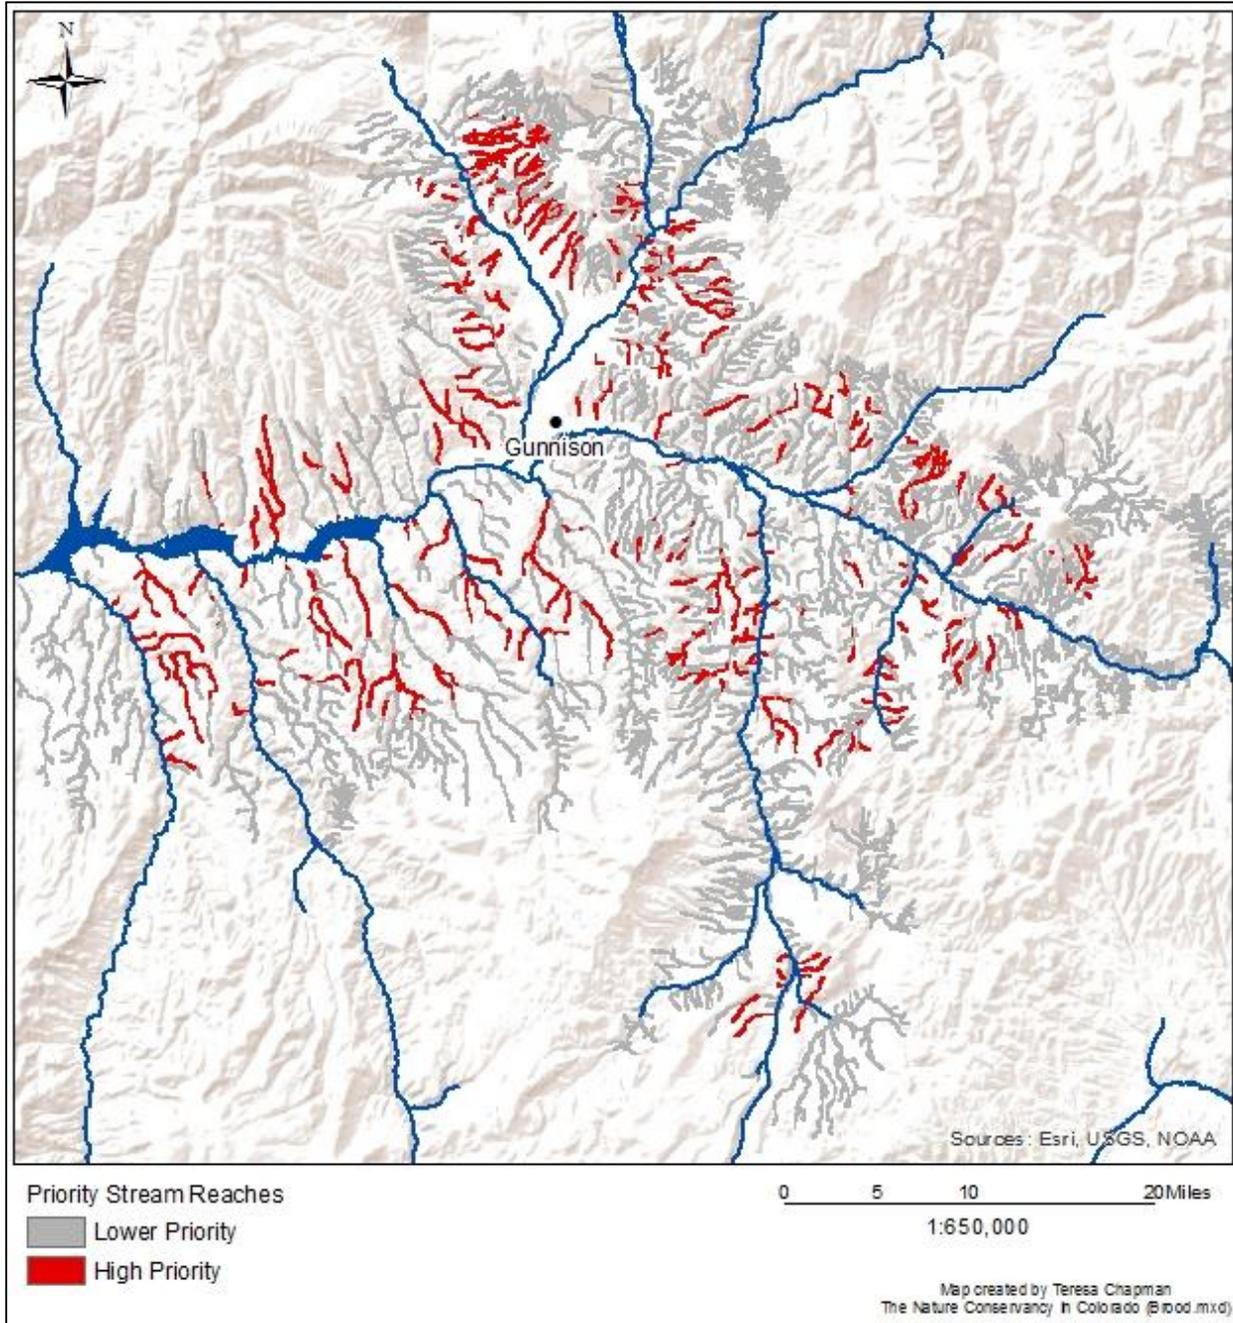
Figure 6. Map of high priority stream reaches in the Gunnison Basin based on four criteria: 1) brood rearing habitat, 2) within two miles of a lek, 3) *Restoration Potential Index* between 60 and 100 (indicating riparian areas that significantly dried during the drought but maintain greenness during wet years), and 4) *Riparian Condition Index* between 1 and 25 (indicating that current riparian vegetation occupies a small percentage of the floodplain). These stream reaches have high potential to improve using restoration techniques and to increase resilience to the impacts of climate change; field verification is needed to confirm specific needs and restoration treatments.

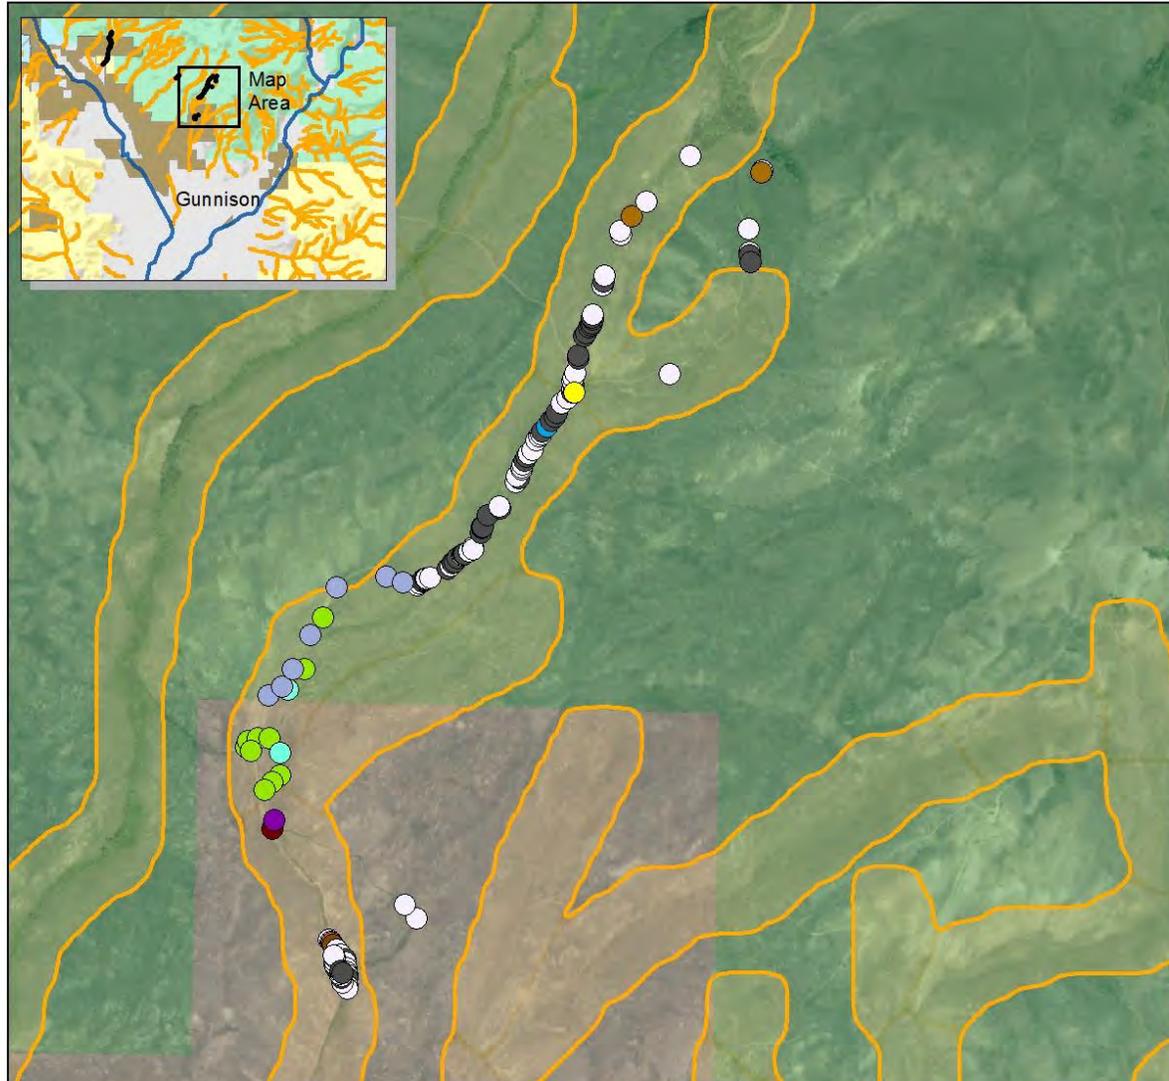
5. South Cottonwood at Flat Top Mountain USFS and Private

The Nature Conservancy Colorado
 South Cottonwood at Flat Top Mountain USFS and Private
 (Upper and East Fork of South Cottonwood)
 Restoration Structures

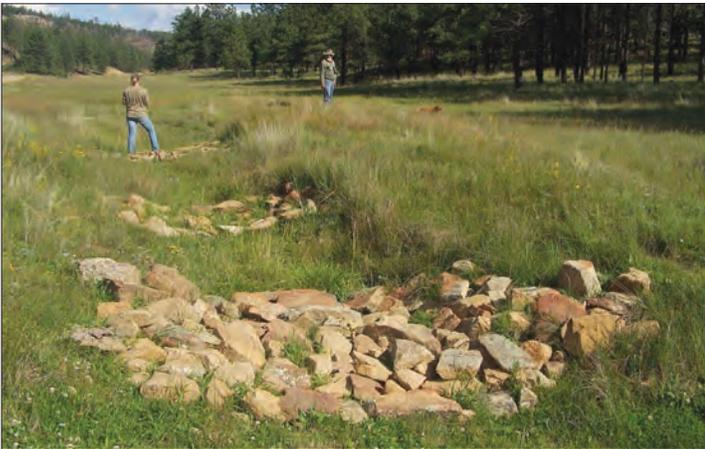
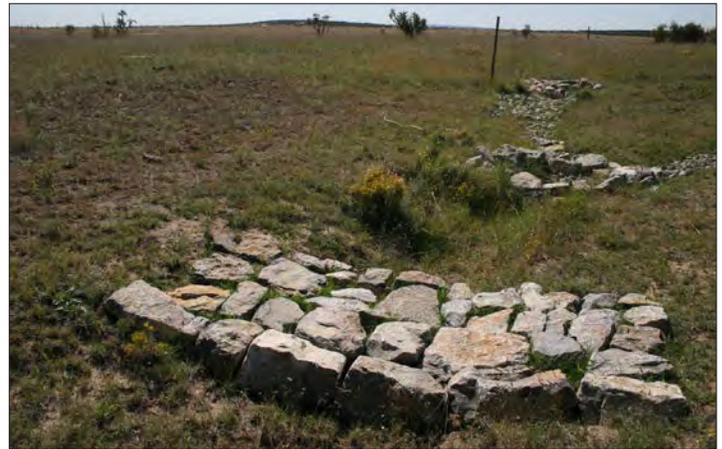
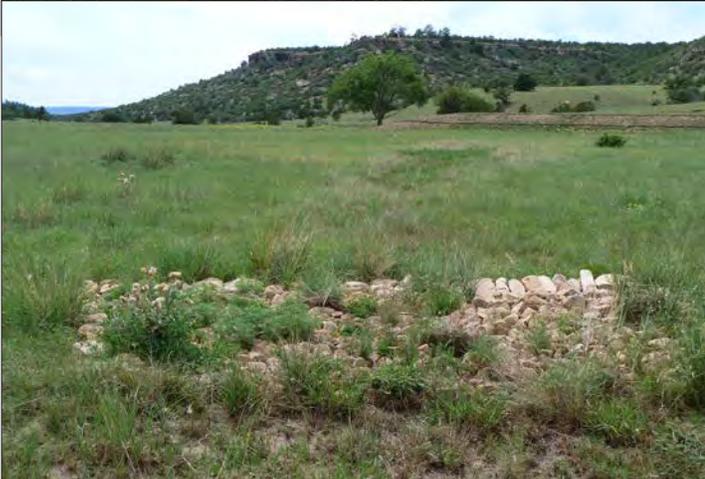
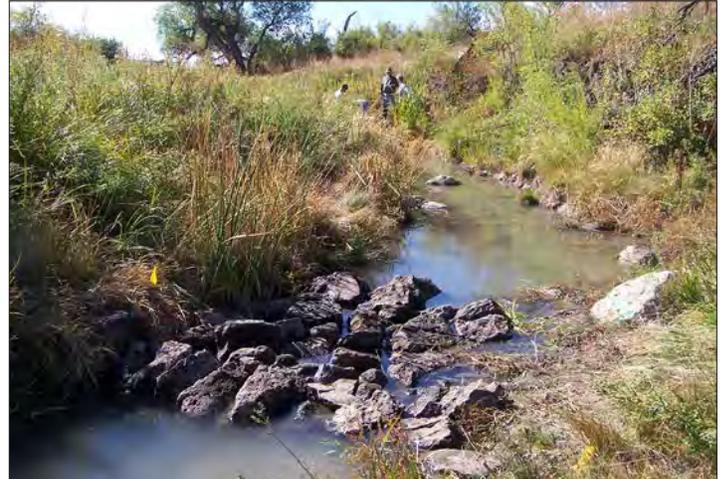
Filter Weir

Plan View

Longitudinal Profile

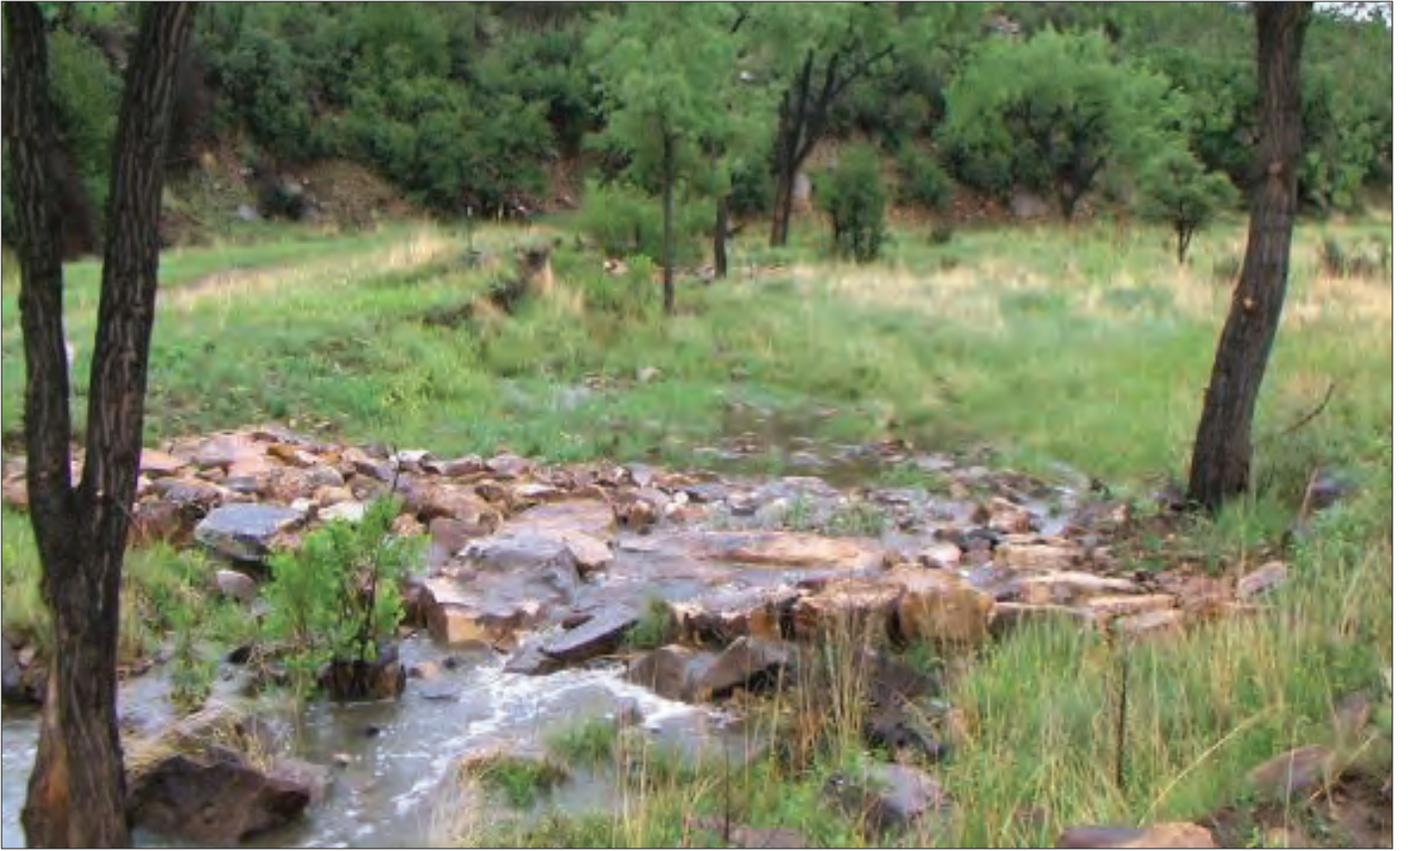
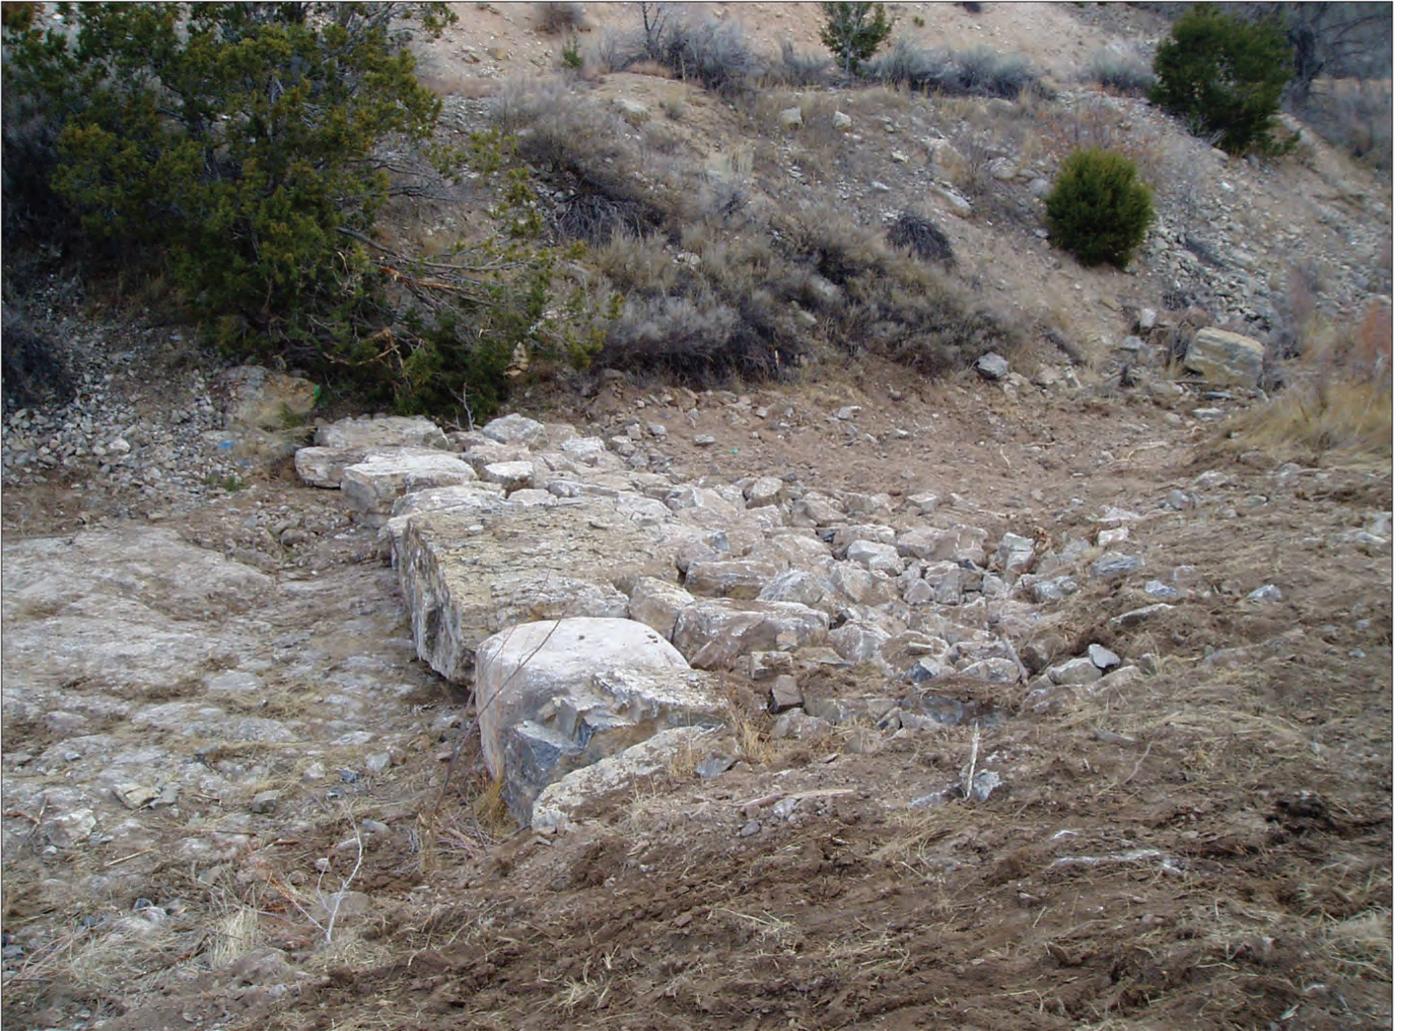
MEDIA LUNA

Sheet Flow Spreader (tips UP)
Spreads runoff from channels and initiates sheet flow.

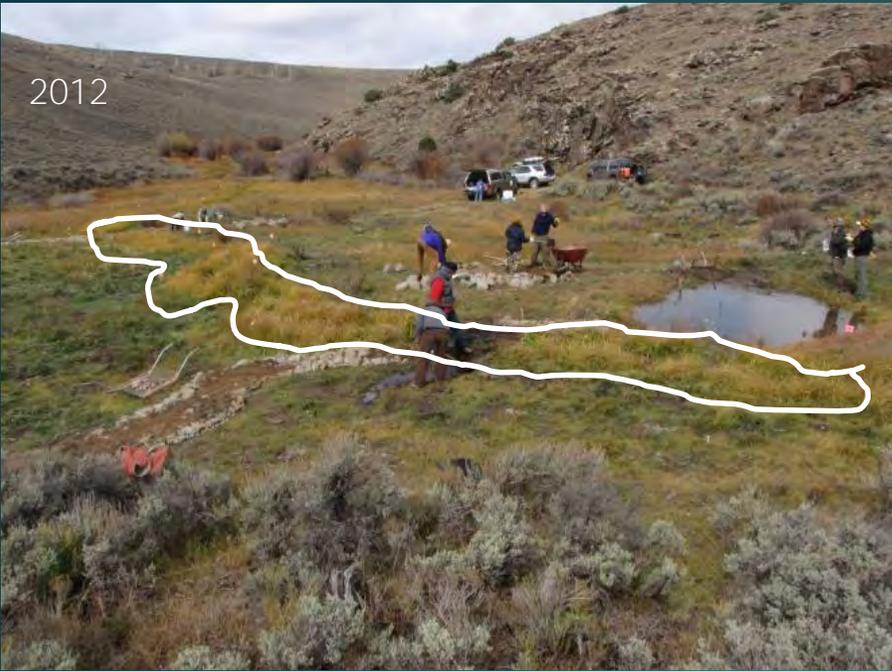
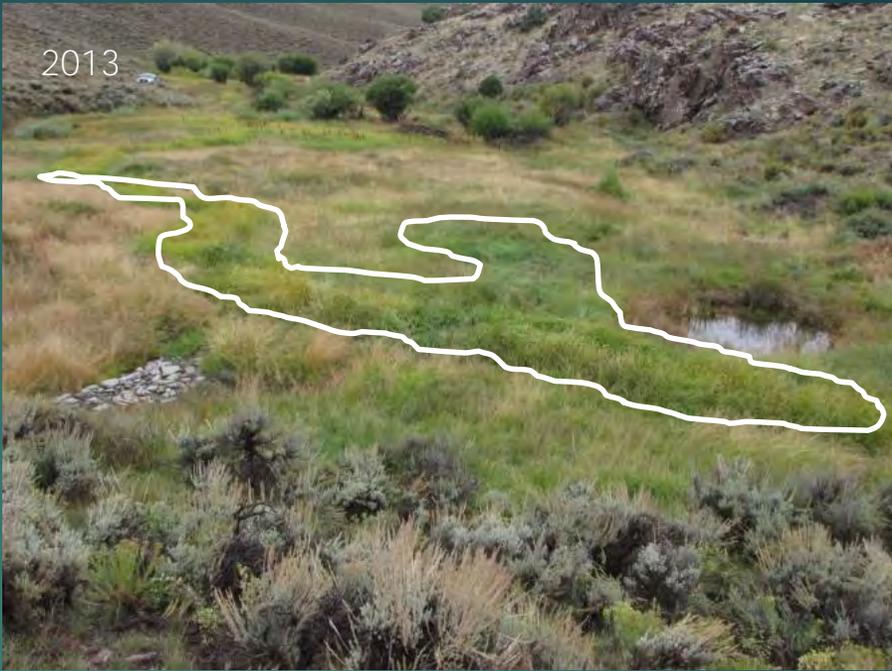
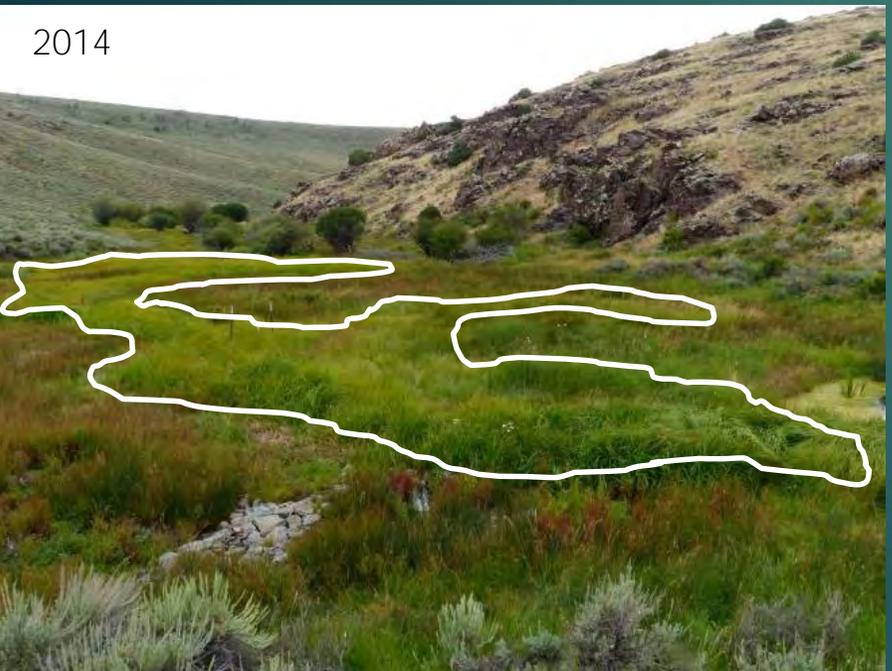
All 15 transects associated with the structures had an increase in wetland species cover. A second layer of rocks was added in 2016, post monitoring

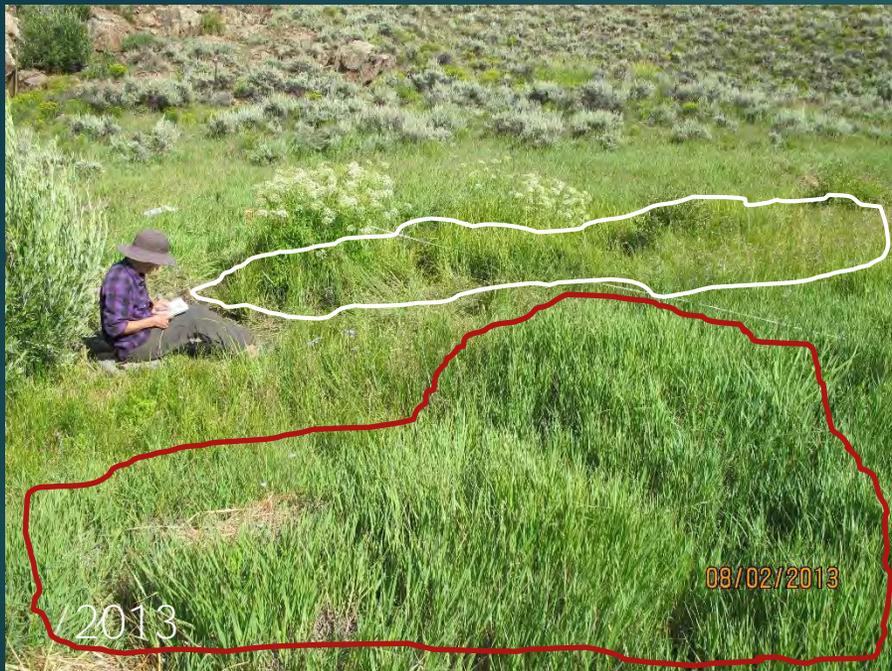
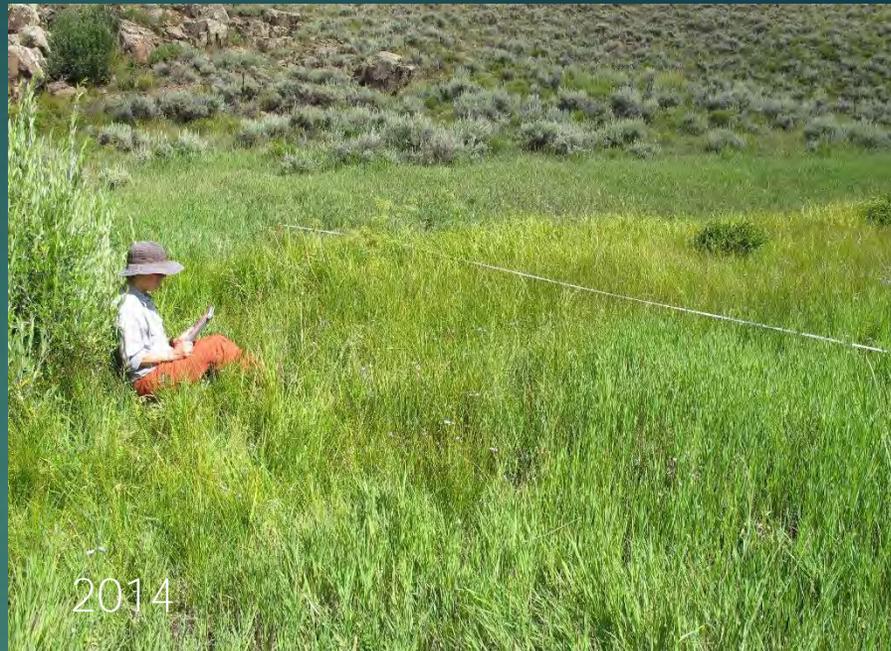
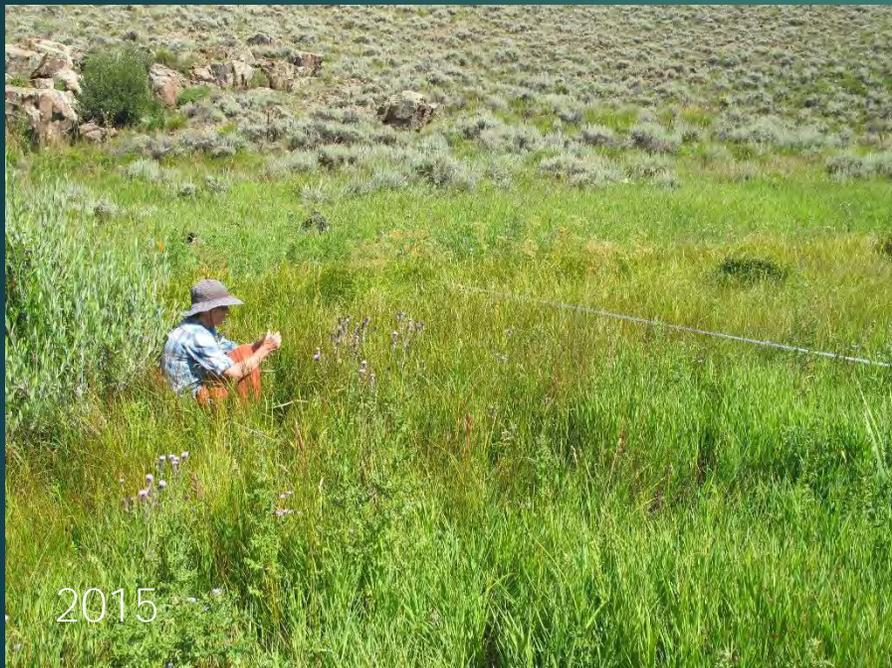
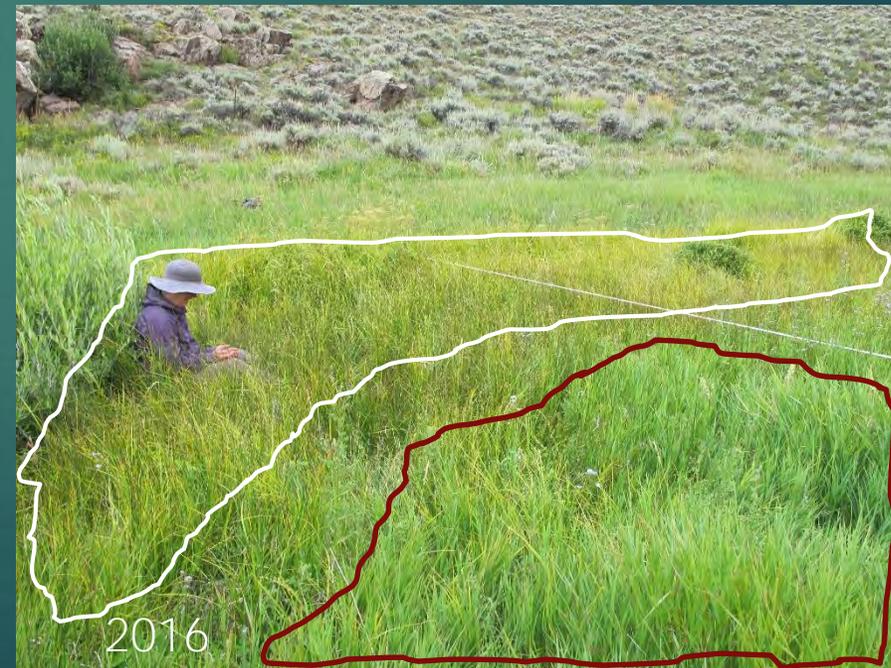
Wetland species cover increased by 56% along this transect.

The white polygon indicates the wetland area; the red polygon represent smooth brome

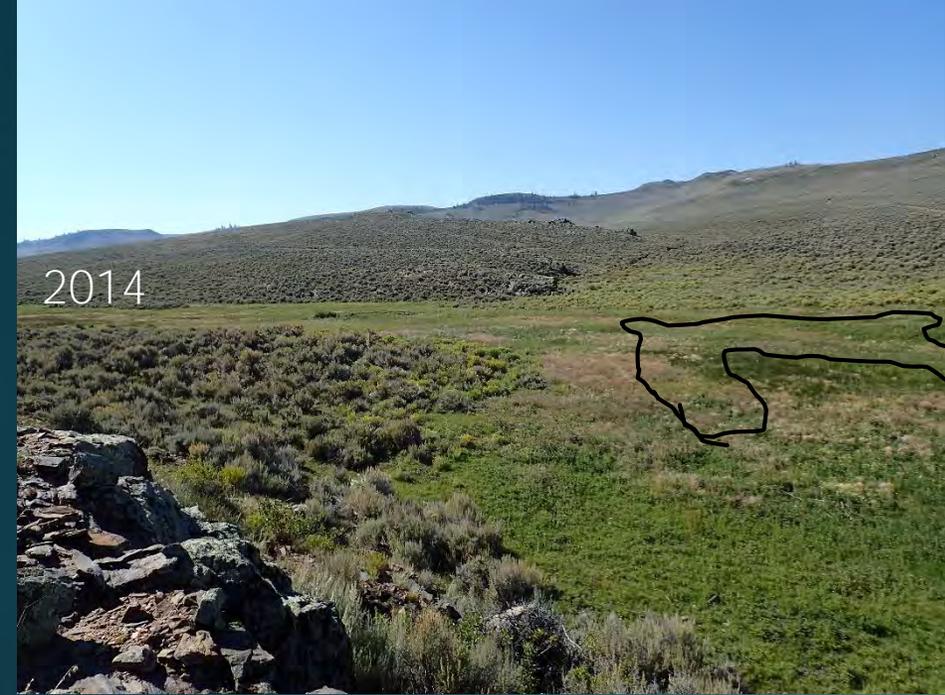
Building plug and spread in September 2014 (photo by B. Neely)

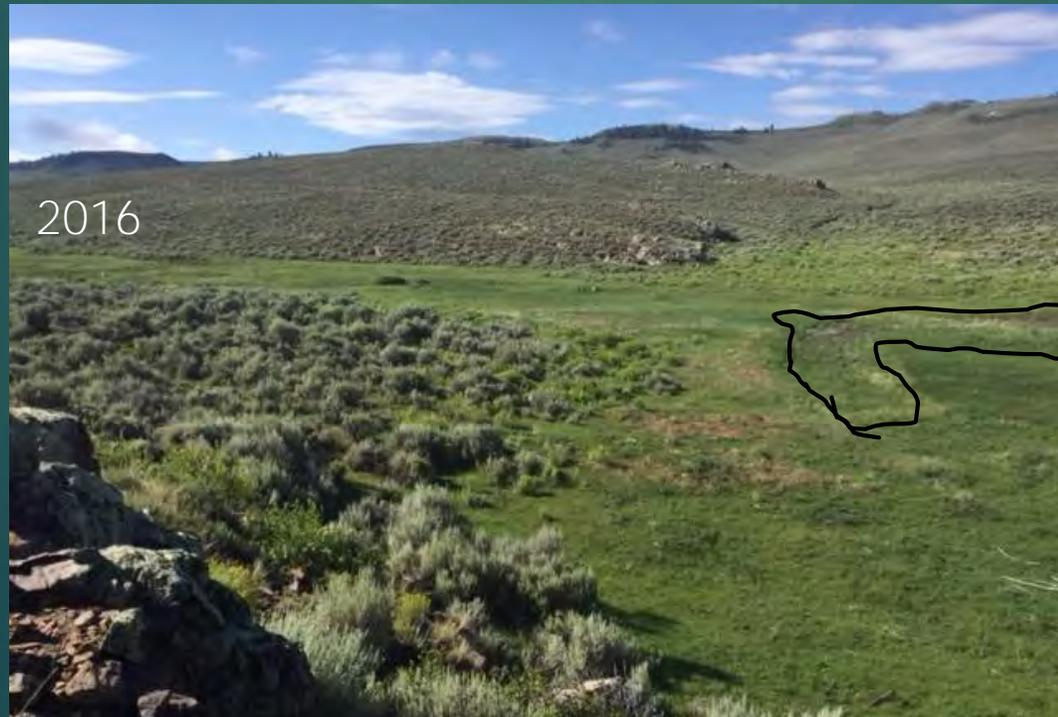
2016
The wetland species cover was 12% in 2014 and 30% in 2016, a 150% increase in wetland species cover

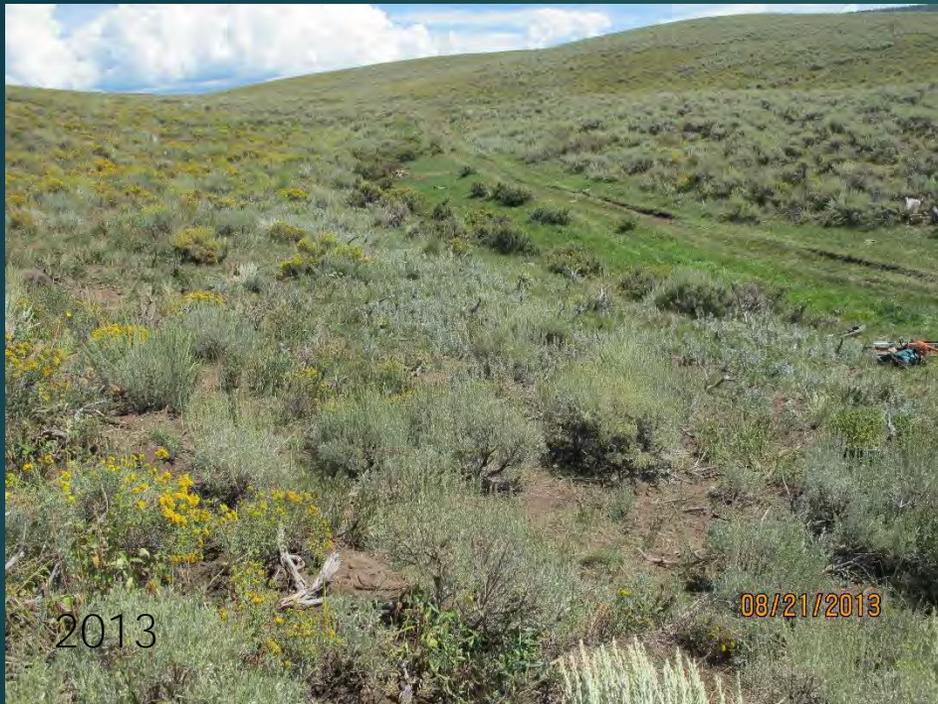
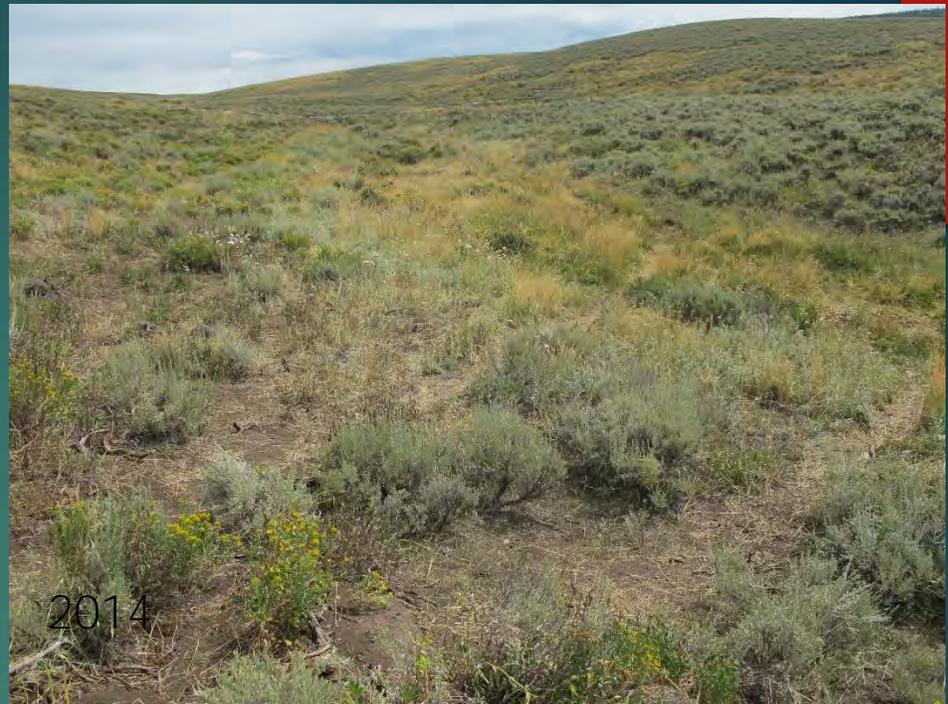
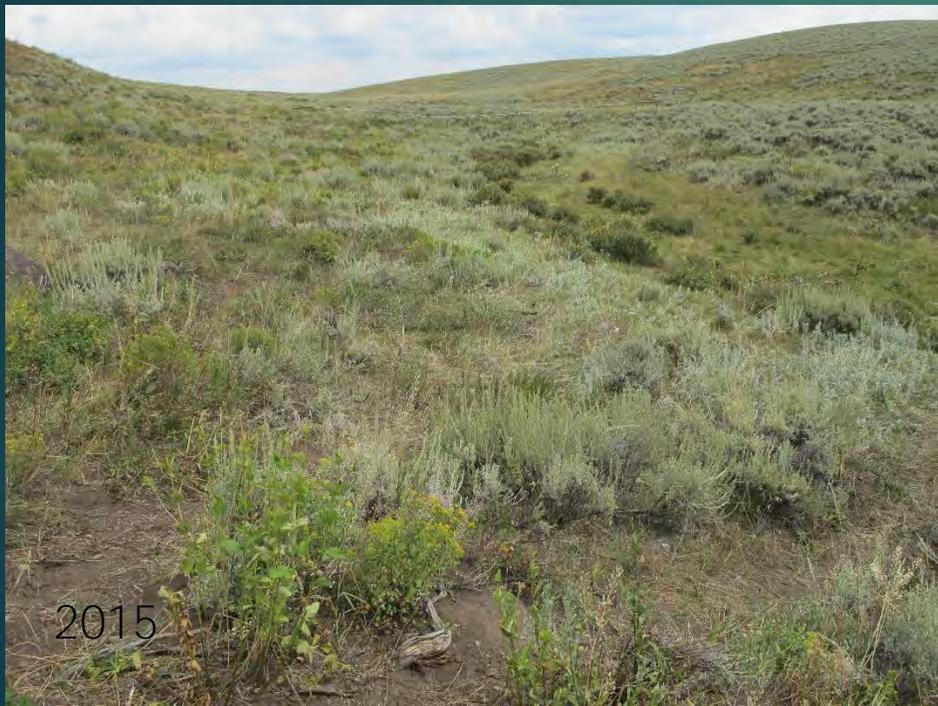
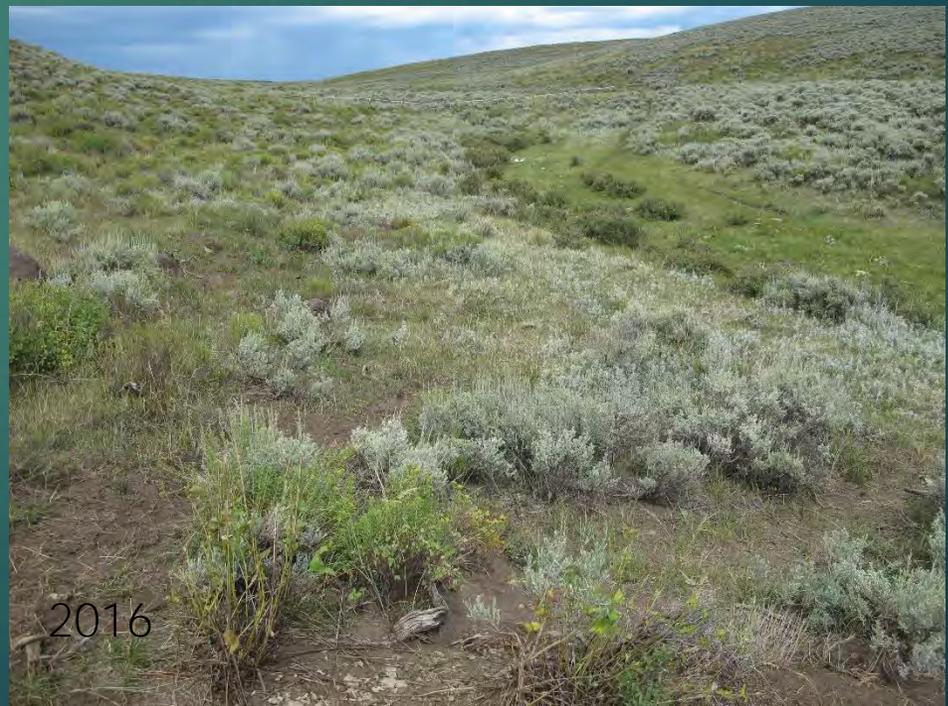
Two drift fences stopped the cattle trailing. Up until 2016, the cattle were avoiding the valley bottom, but as of 2016 they started to graze the area.

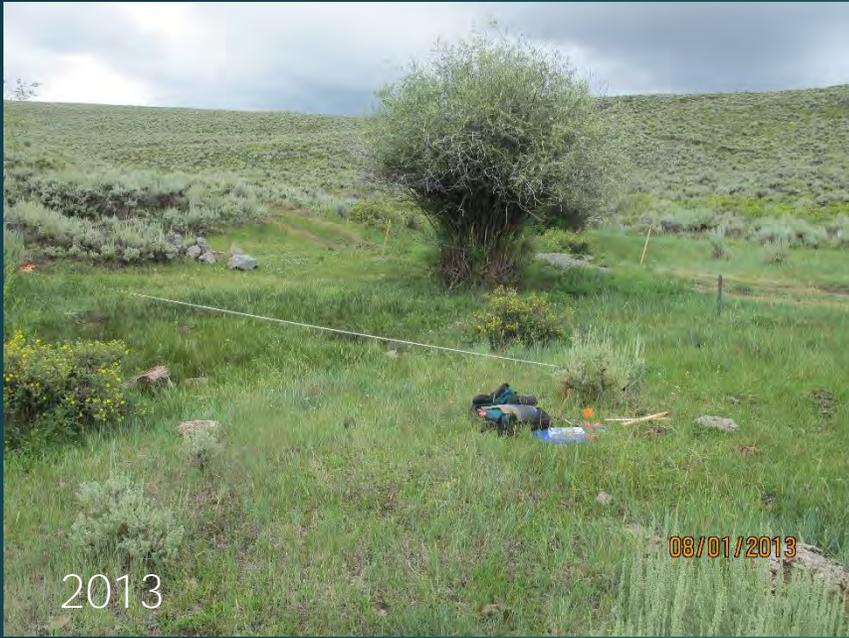
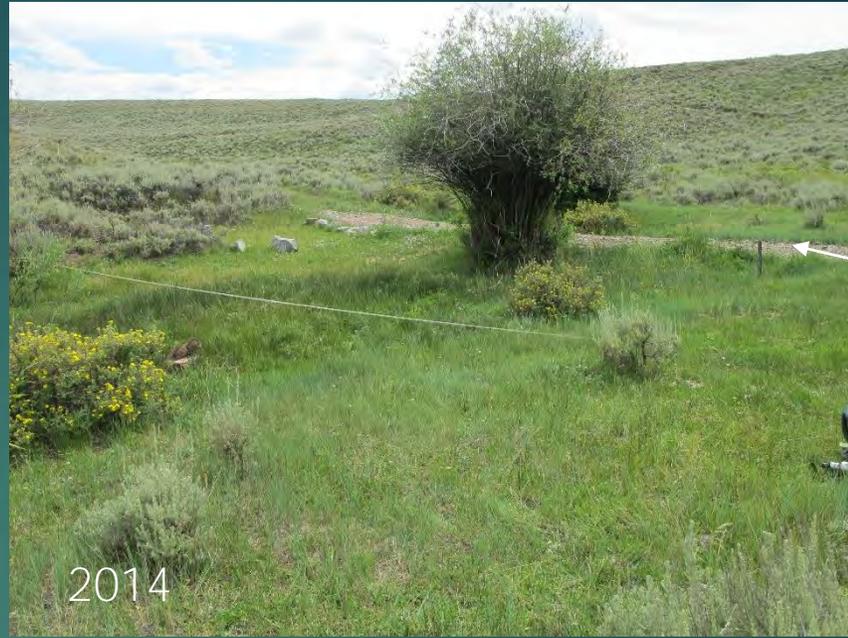
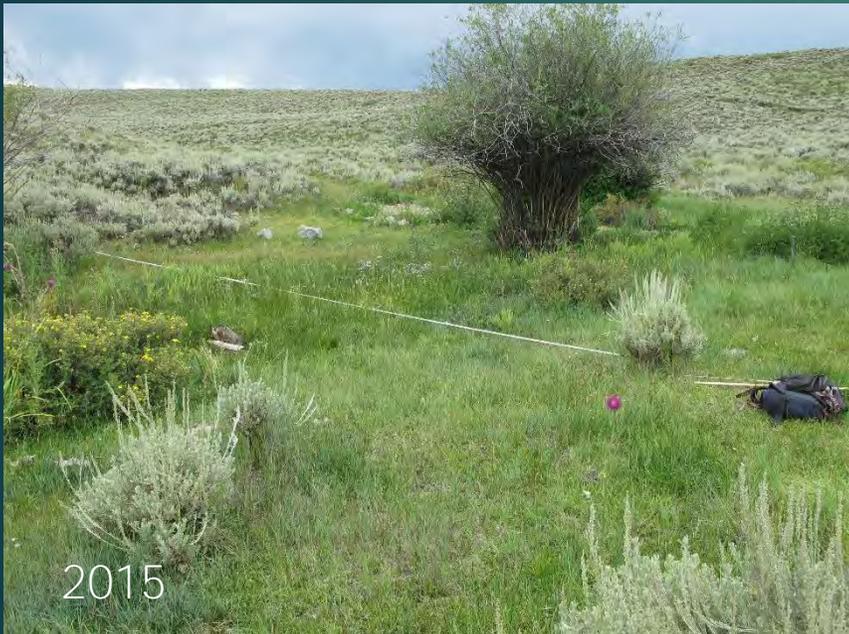
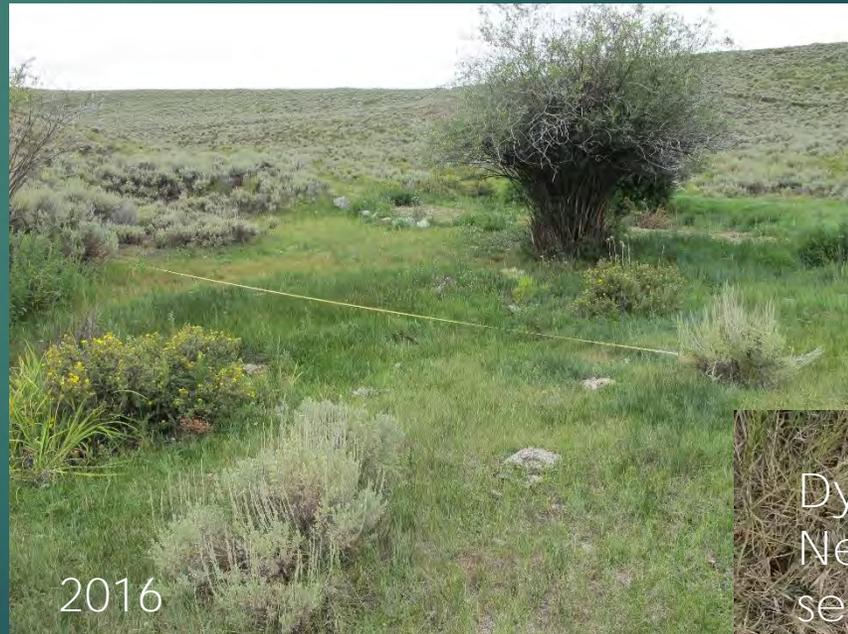
The low water crossing impeded the downstream flow and the wetland species are being negatively impacted. Note the willow vigor
