Final Report to the Terra Foundation

RESTORATION/RESILIENCE-BUILDING OF RIPARIAN AND WET MEADOW HABITATS:
UPPER GUNNISON RIVER BASIN, COLORADO

By The Nature Conservancy
in Collaboration with the Gunnison Climate Working Group
January 6, 2017

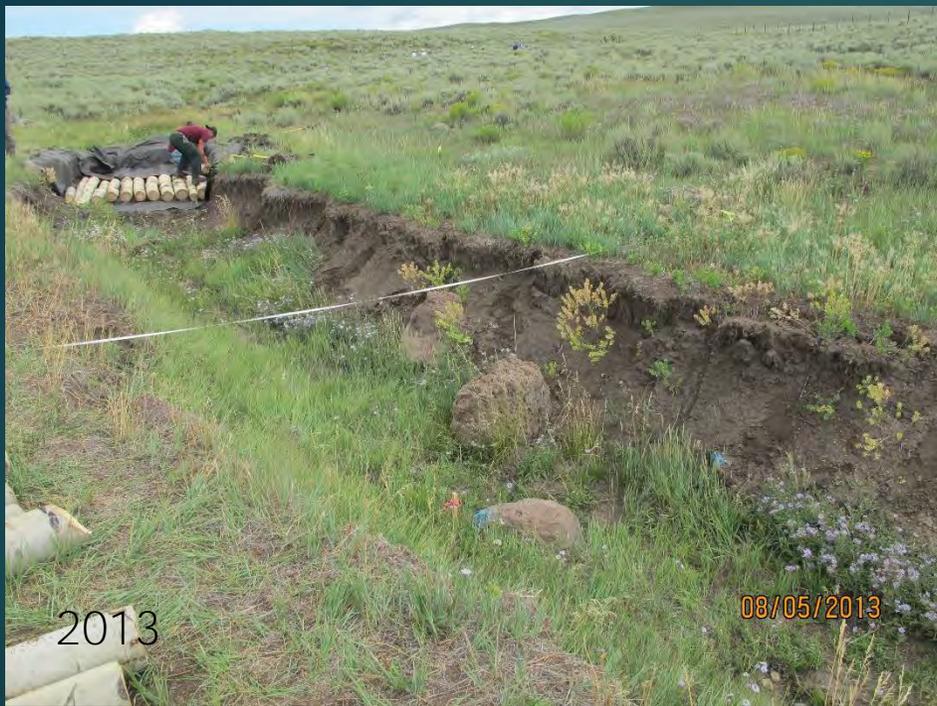
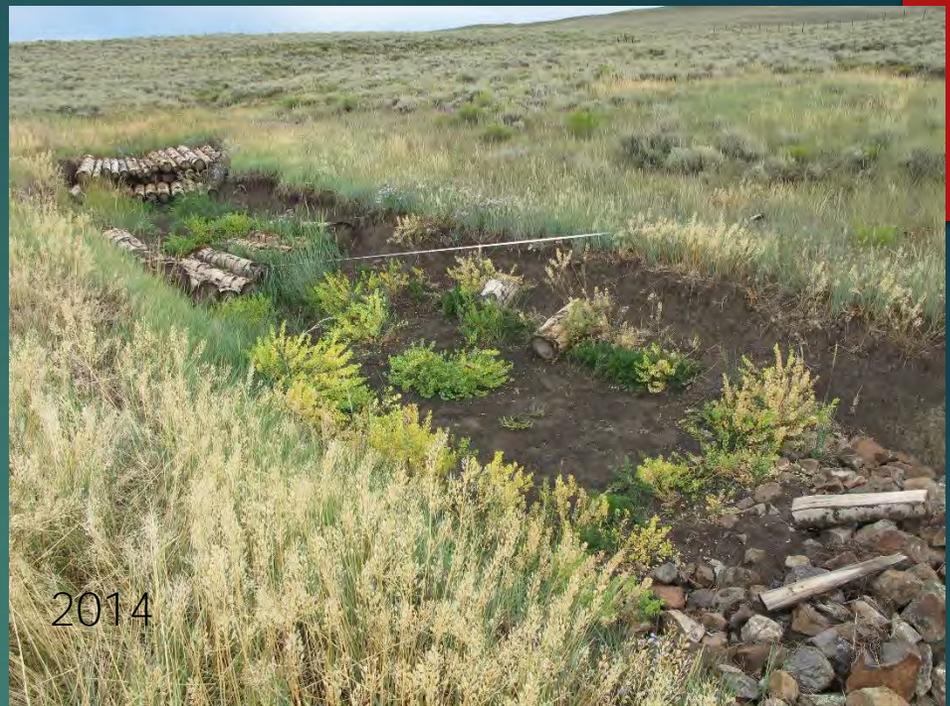
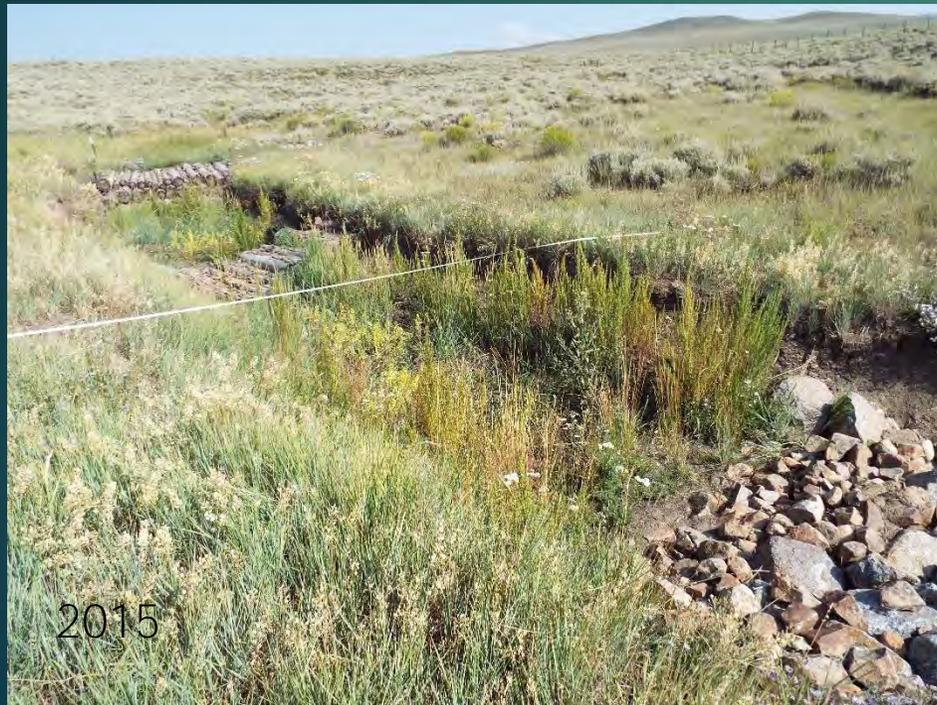
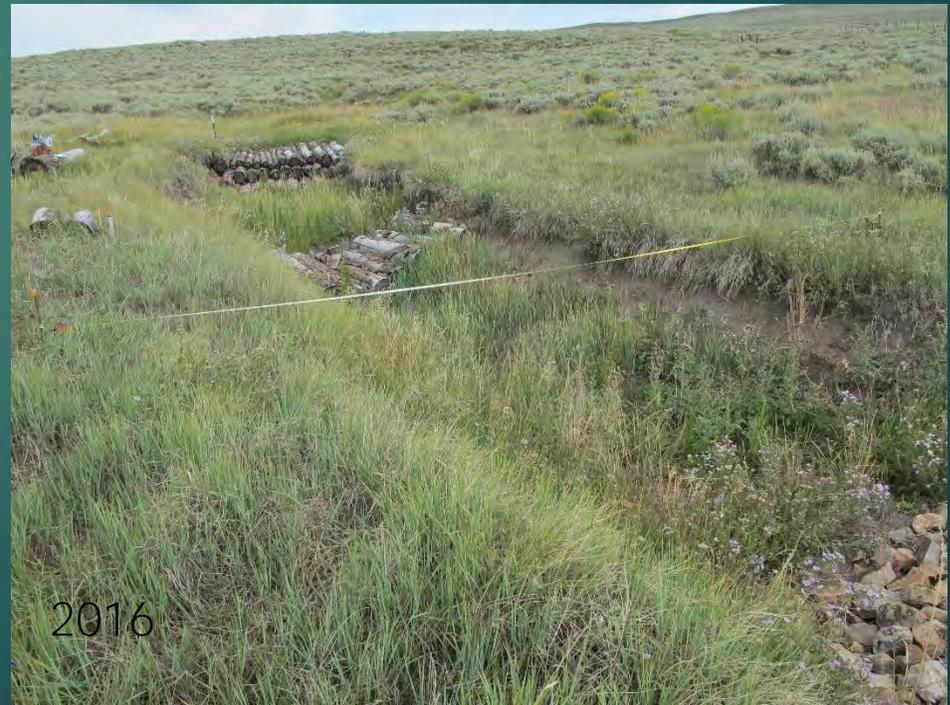
Note that the banks are stabilizing and there is less bare ground.

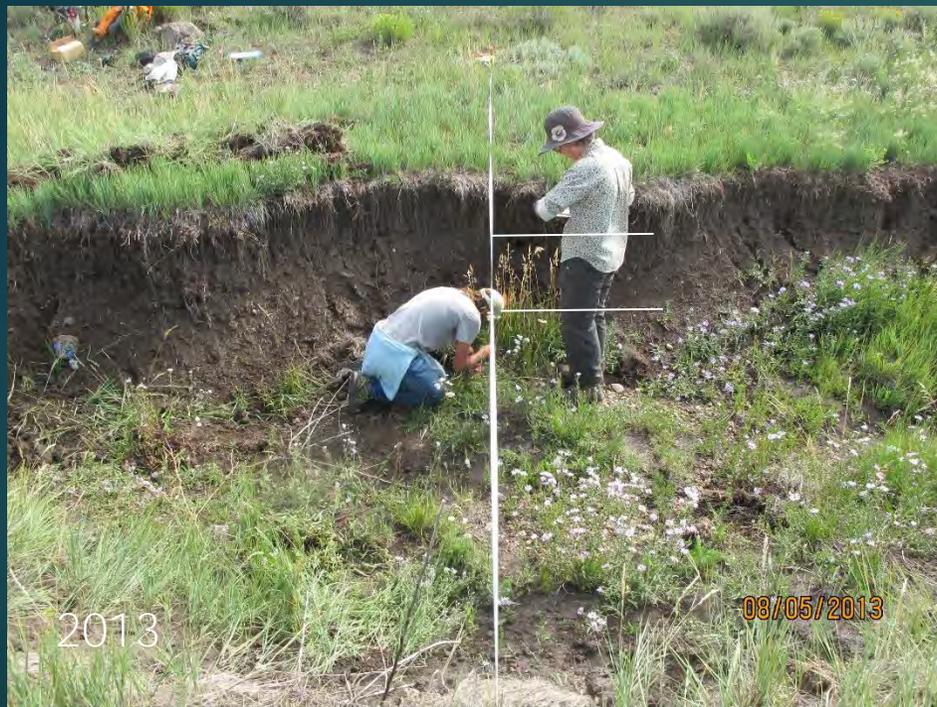
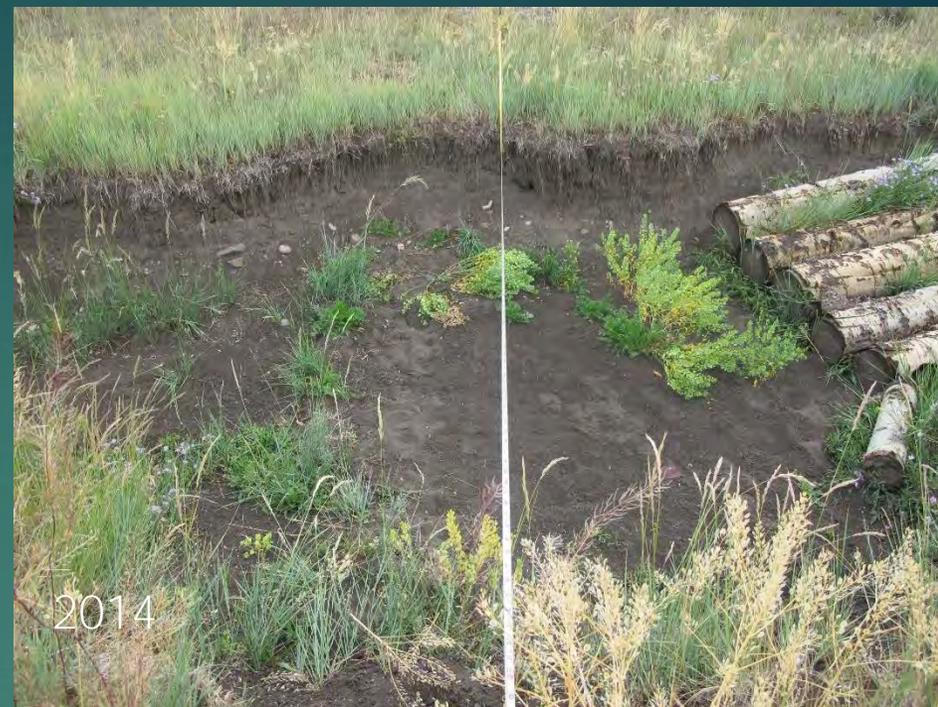
Abundant sediment was deposited in 2014

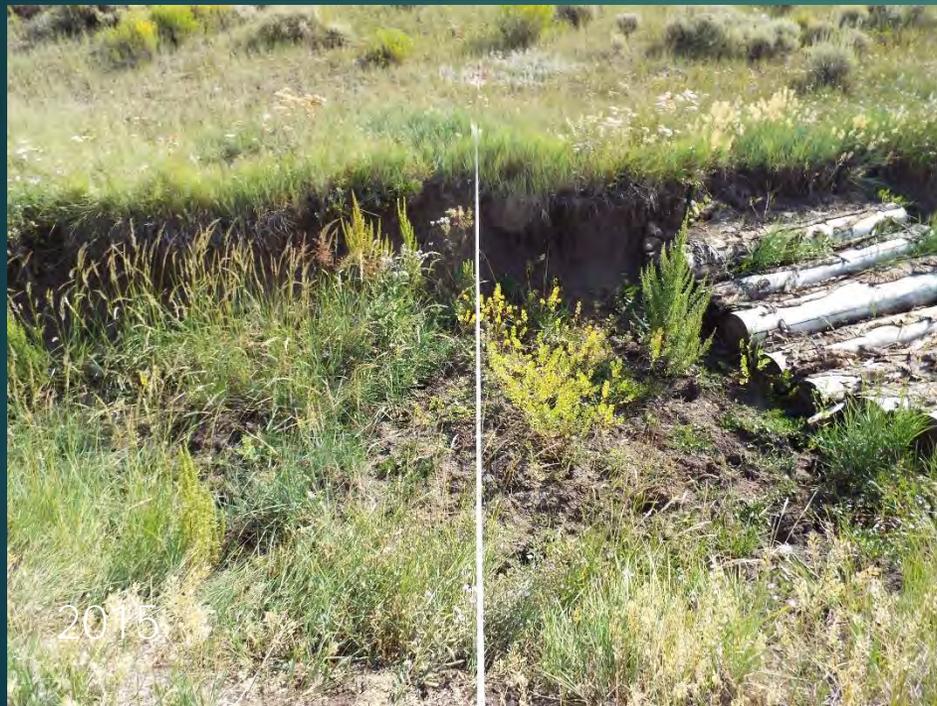
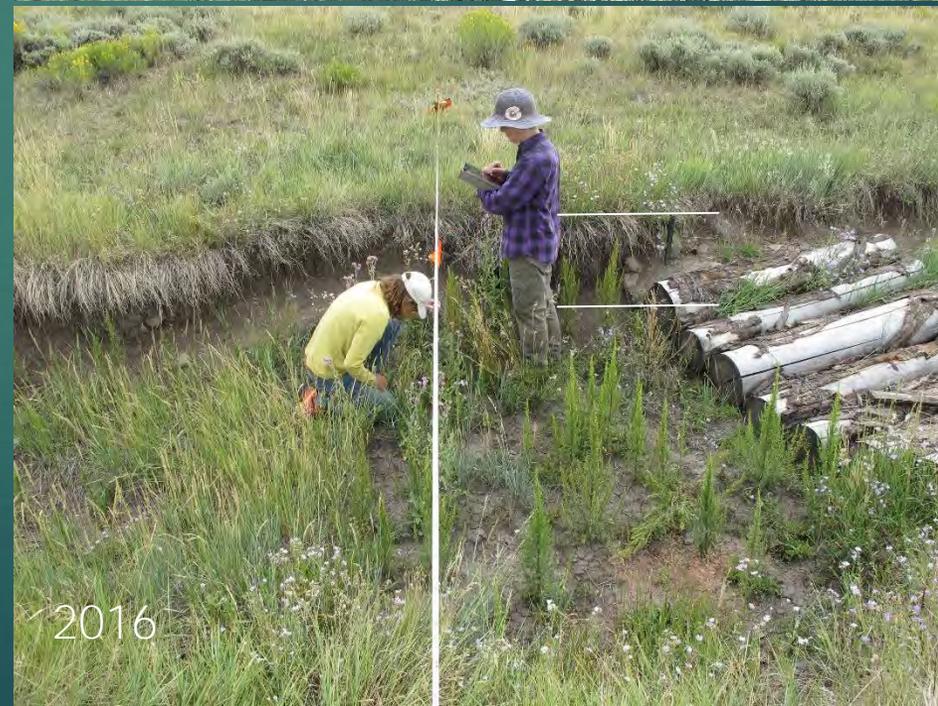
Notice the location of Gay's waist compared to the bank; approximately 1' of sediment was deposited, due to the log structure

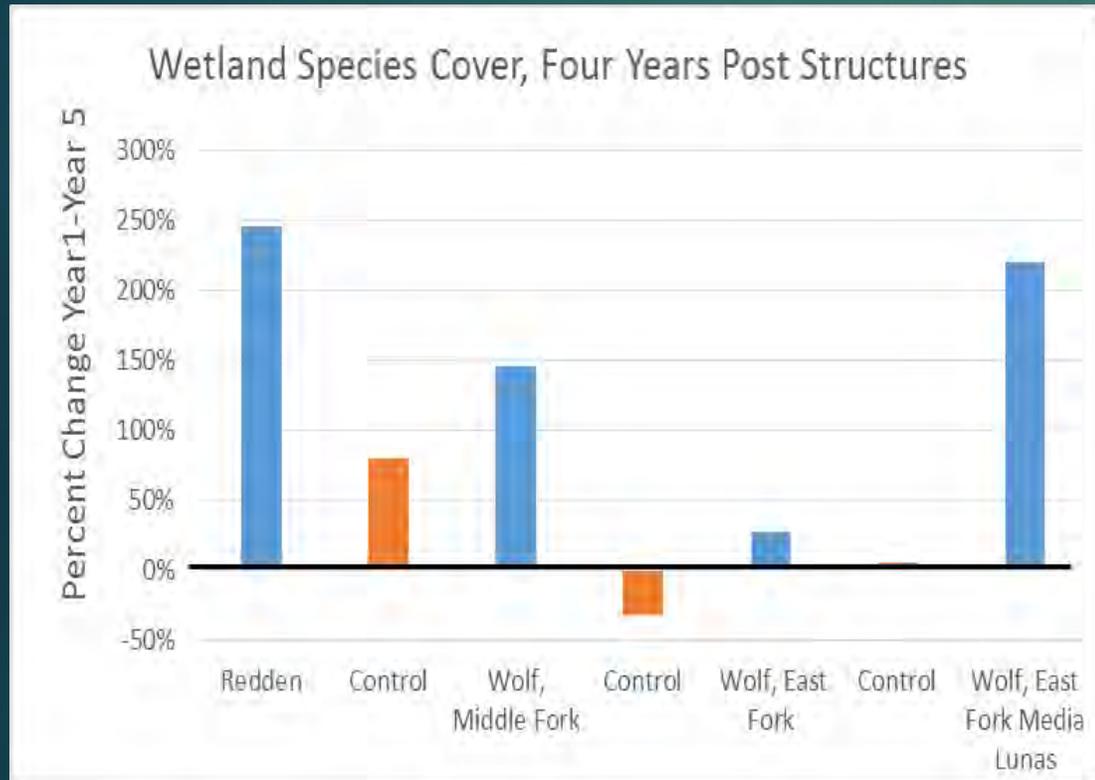
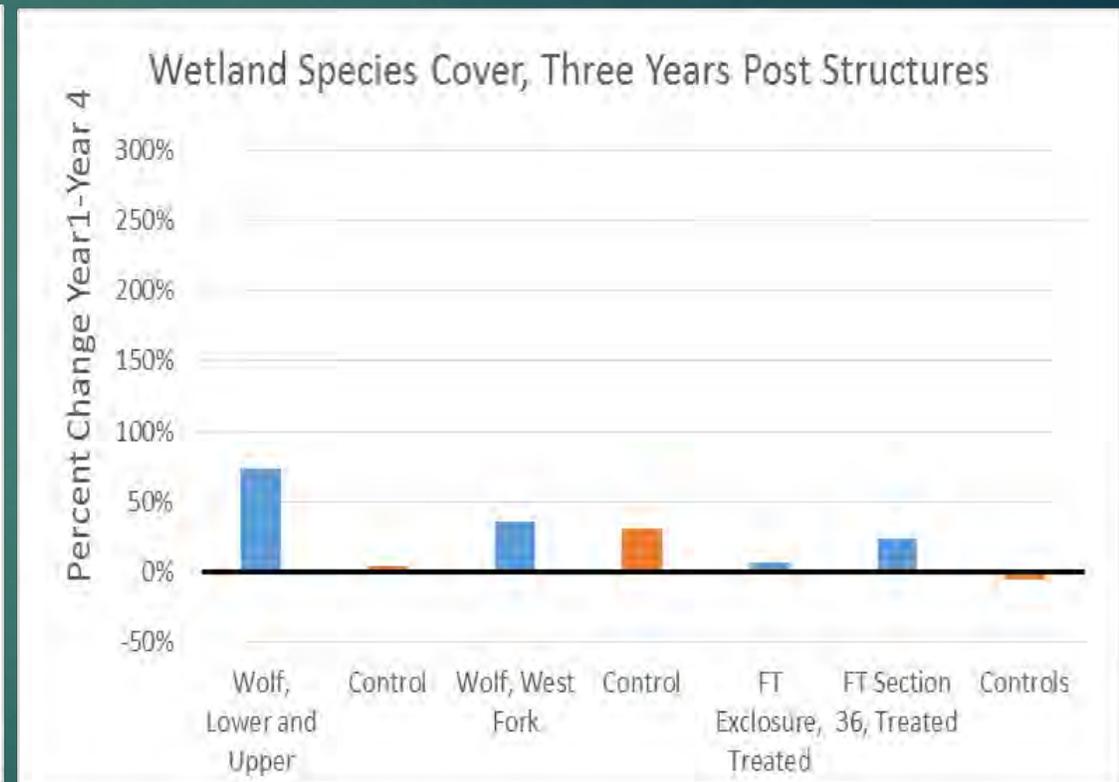
Wetland Species Cover Change: a comparison across sites

There is a varied rate of response between sites, from almost 0 to 250%

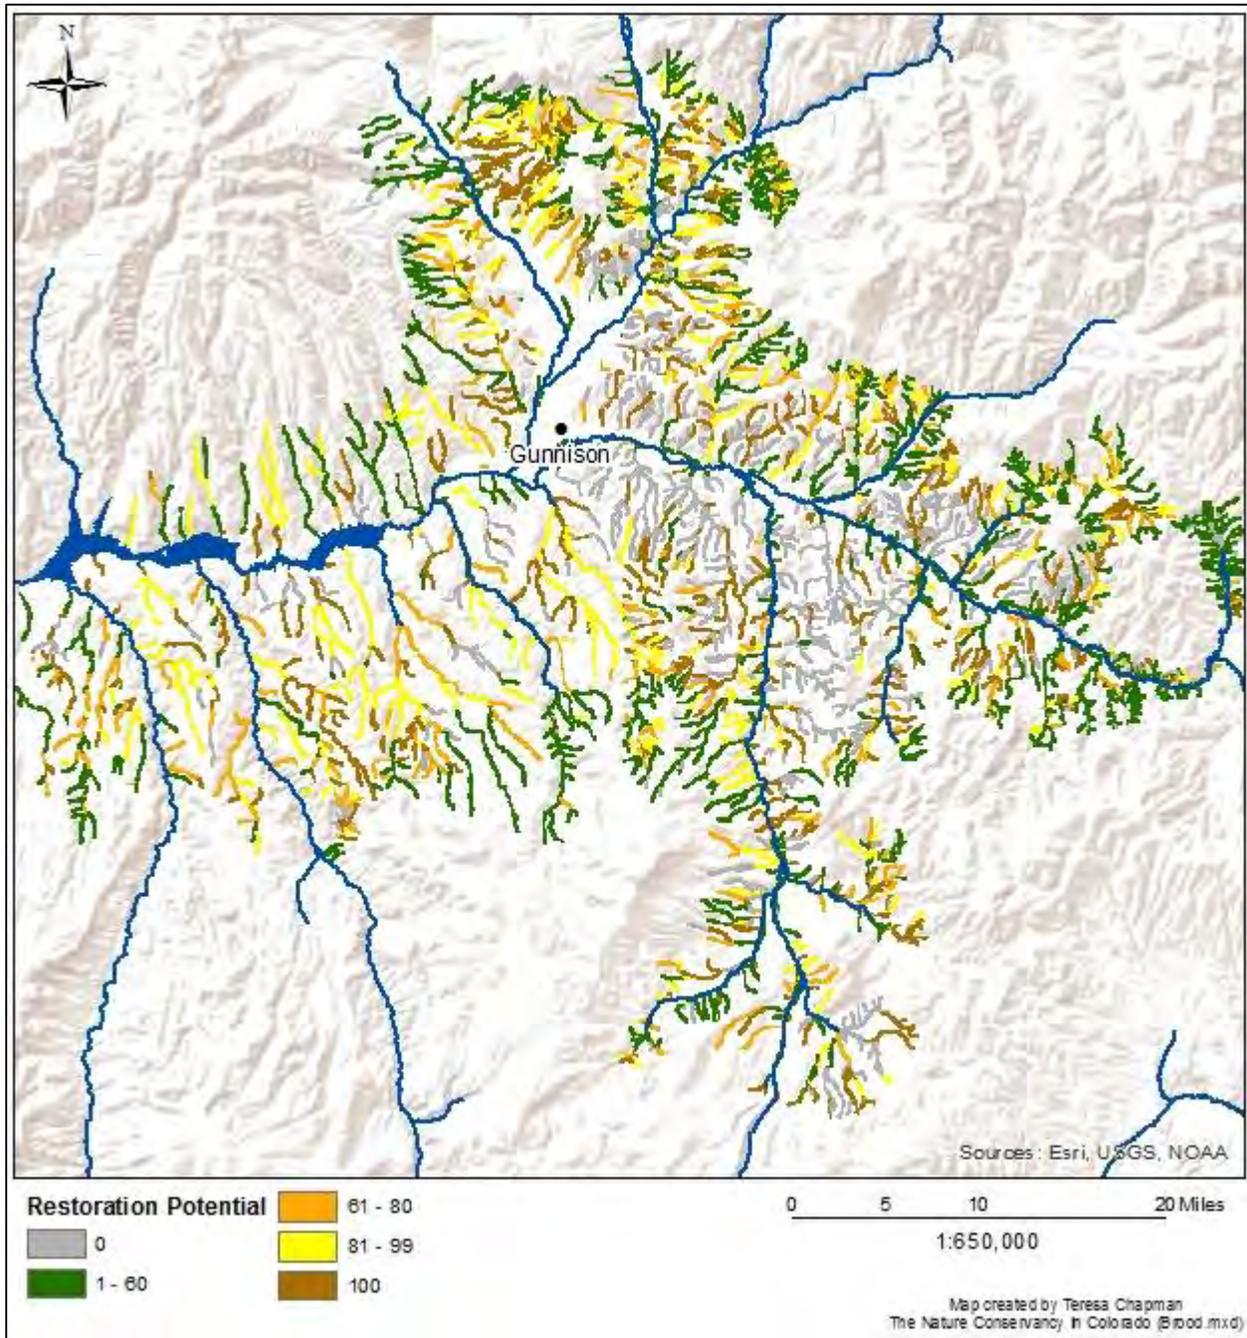
Figure 8. Restoration Potential Index across the Gunnison Basin stream reaches. The West Flat Top at Henkel Road restoration site scored 100 on the Restoration Potential Index since the stream reach did not have riparian area that greened up above NDVI 4000 in year 2002. Of the total stream reaches near leks, 847 streams measured with Restoration Potential Index above 60, meaning they lost 60-100% of very green riparian area during the drought and indicating they could benefit from current restoration treatments. These streams total 421 miles and approximately 1732 acres of current riparian vegetation.

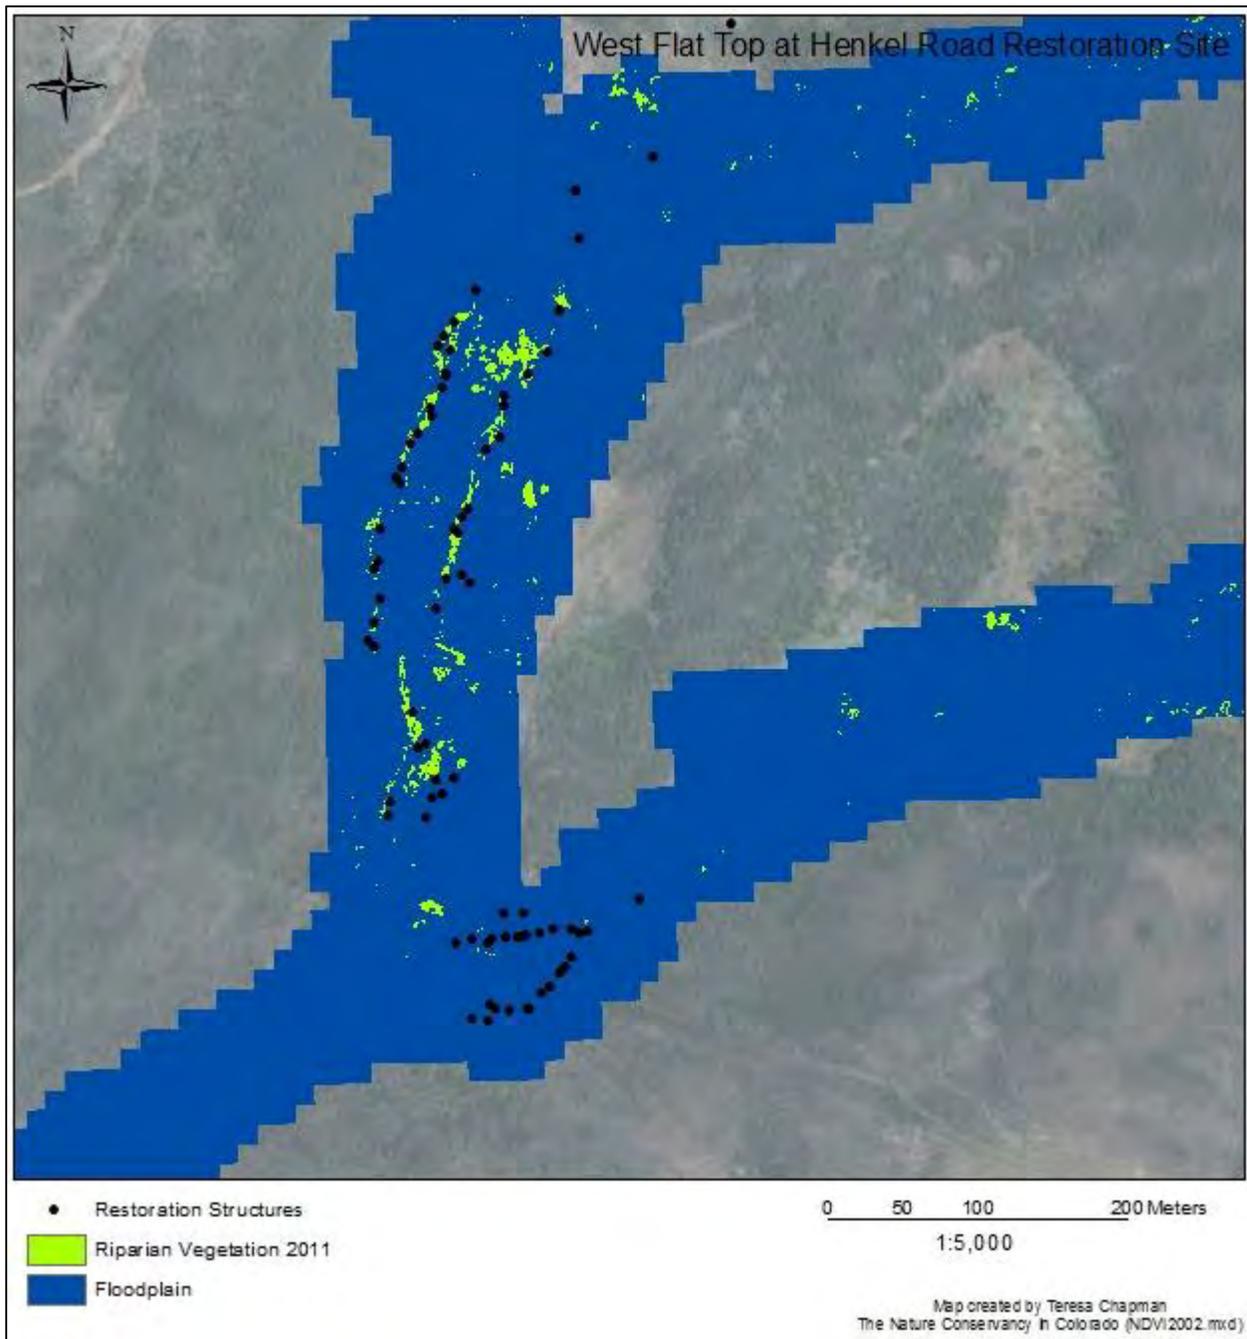
Figure 10. Extent of riparian vegetation in 2011 prior to restoration overlaid with topography based modeled floodplain at West Flat Top at Henkel Road restoration site. The ratio of 2011 riparian vegetation to the area of the floodplain creates the Riparian Condition Index and estimates the potential for expansion of the wetland.

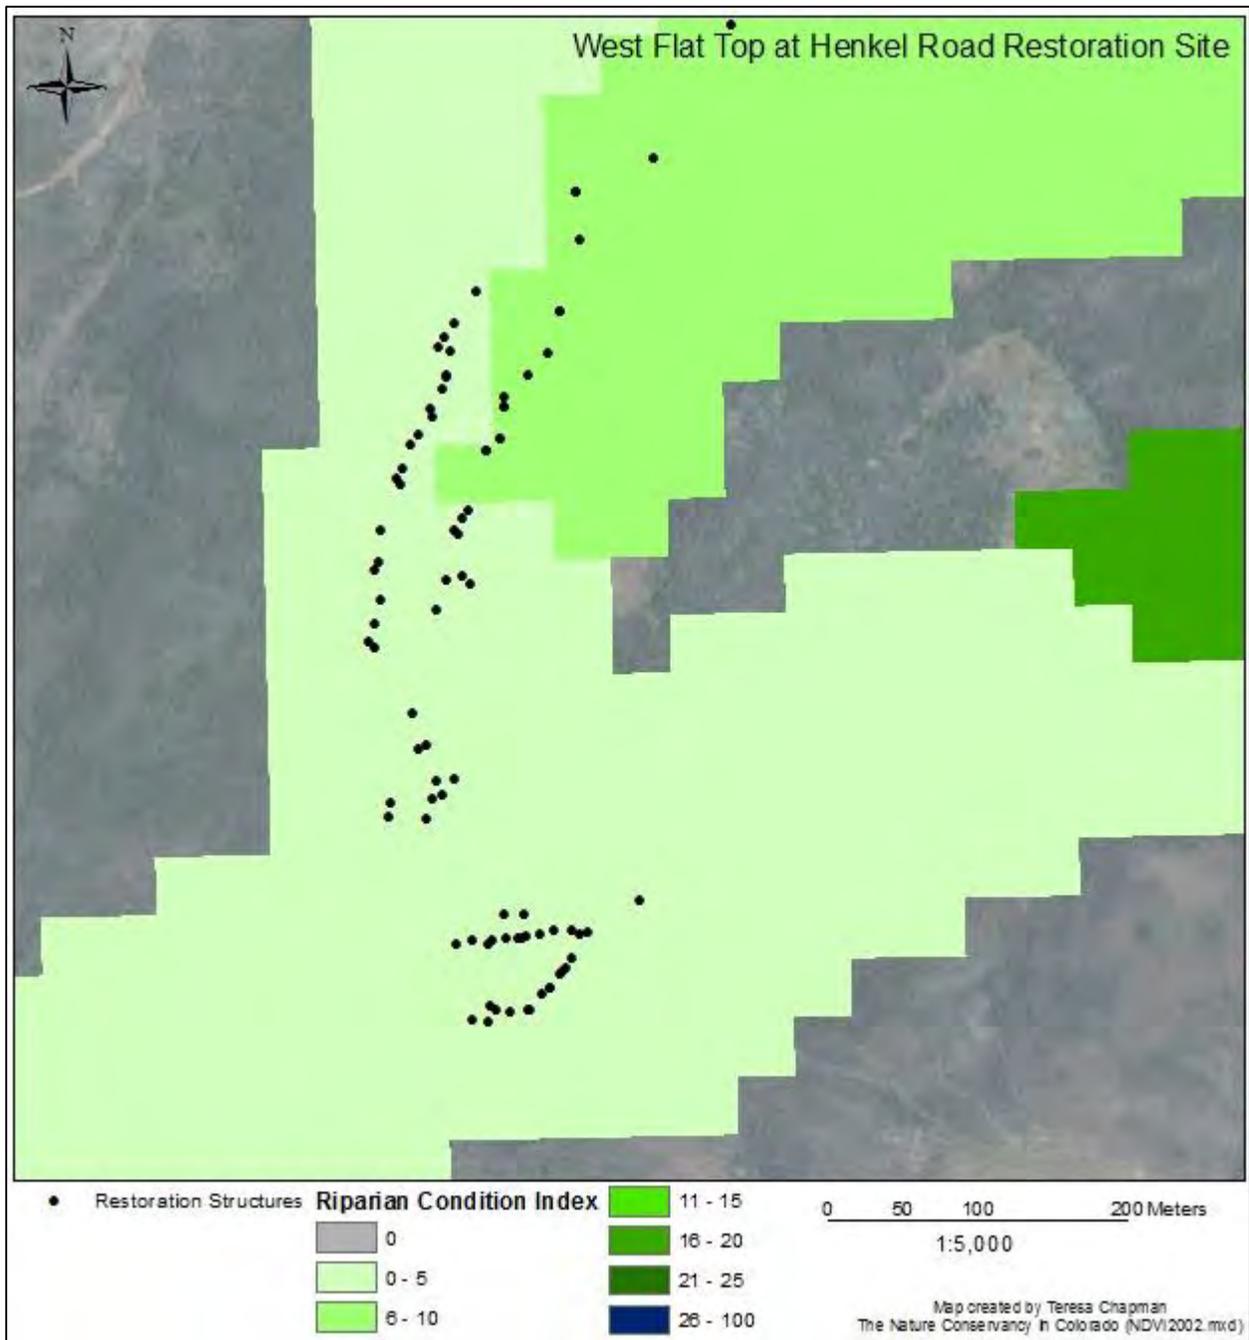
Figure 11. Riparian Condition Index at West Flat Top at Henkel Road restoration site. The site scored a 3 for this index, indicating that riparian vegetation in 2011 only occupied a small fraction of the potential floodplain and there is opportunity to expand the riparian vegetation here.

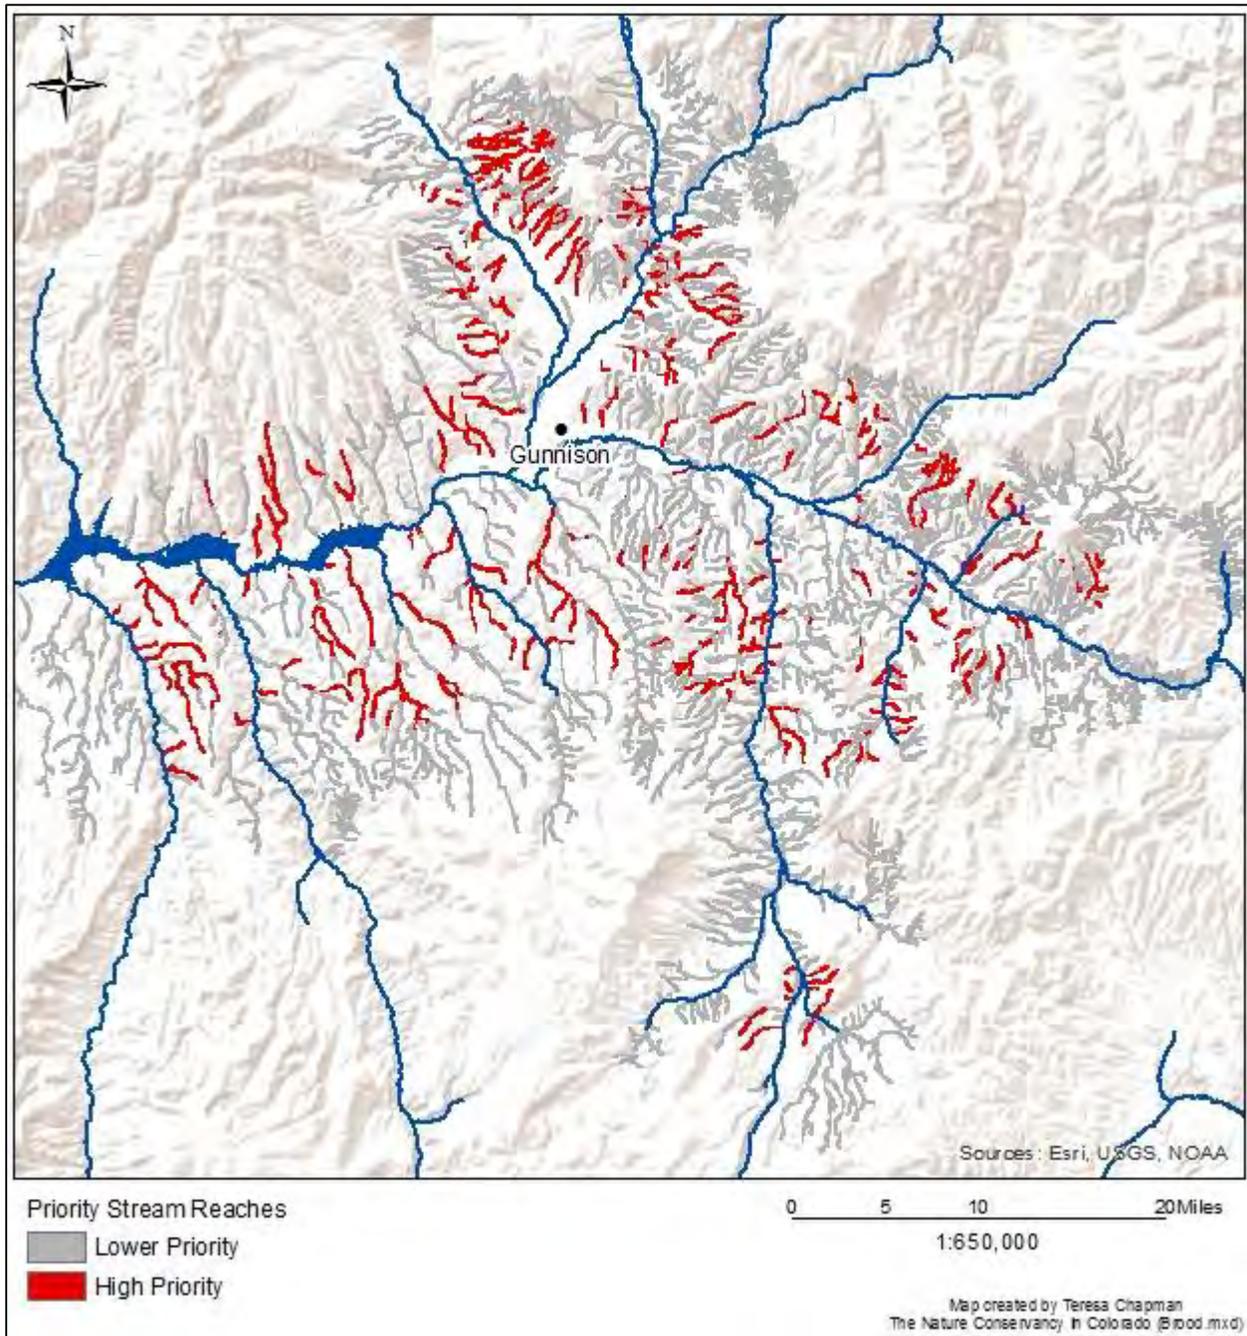
Figure 13. Map of priority stream reaches identified by the GIS analysis within the Gunnison Basin. High Priority stream reaches are defined as: 1) intersecting brood rearing habitat, 2) within two miles of a lek, 3) with a Restoration Potential Index between 60 and 100 (indicating riparian areas that significantly dried during the drought but maintain greenness during wet years), and 4) with a Riparian Condition Index between 1 and 25 (indicating that the current riparian vegetation occupies a small percentage of the floodplain). Combining these metrics results in stream reaches with high potential to improve by our restoration techniques and to increase resilience to the impacts of climate change, including drought and monsoons.

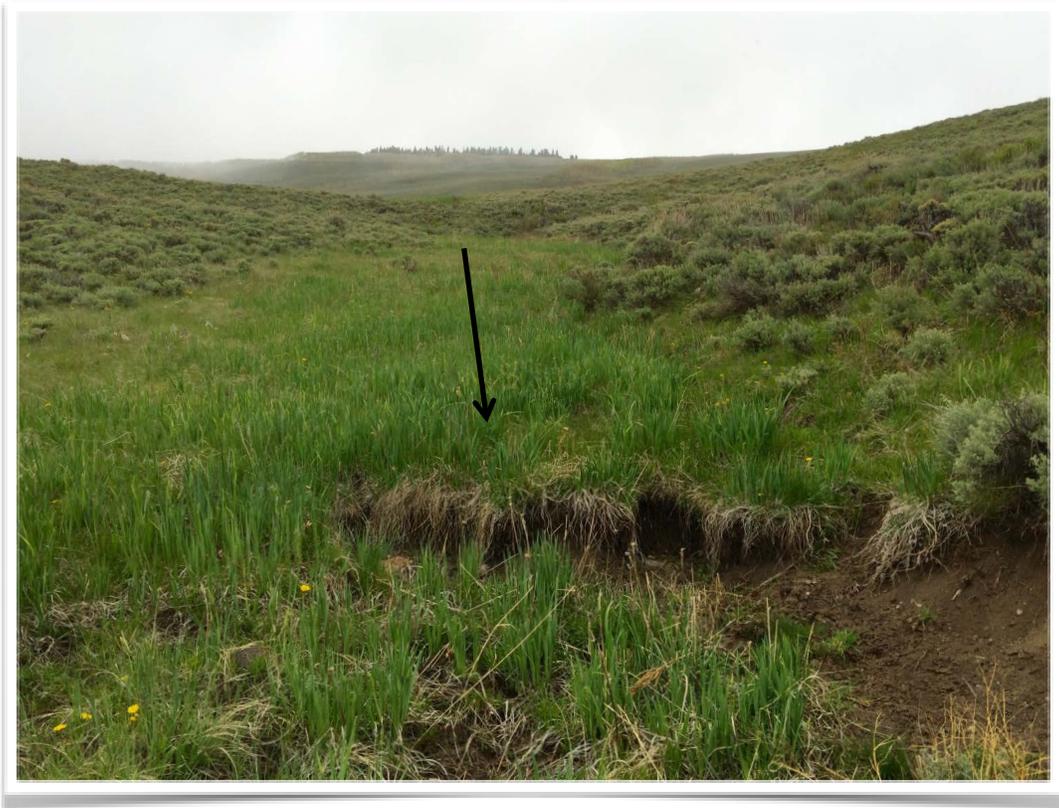
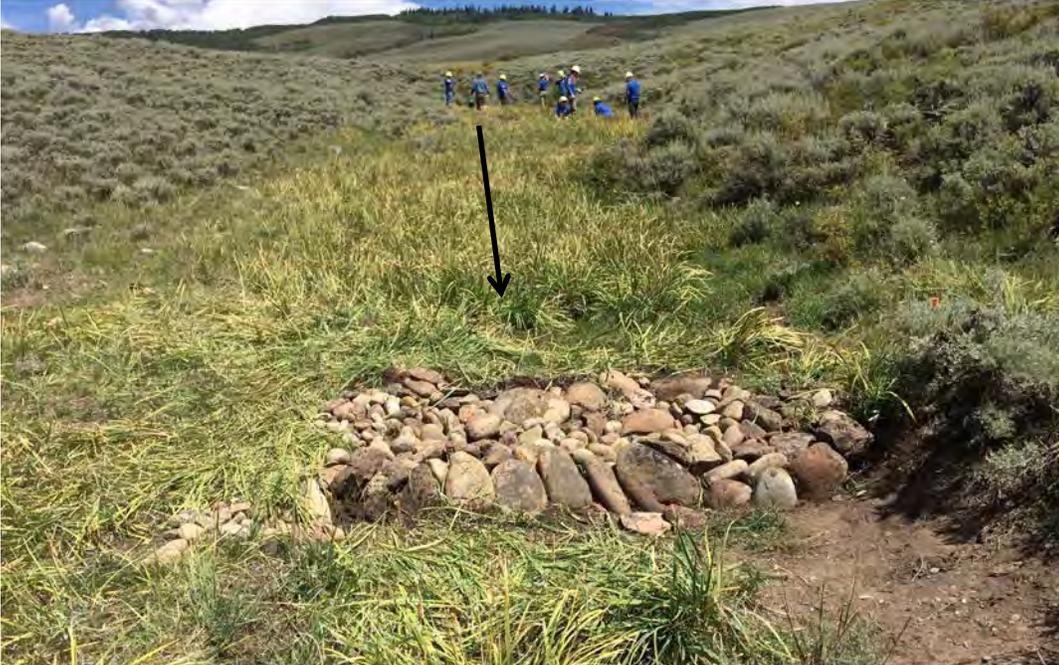
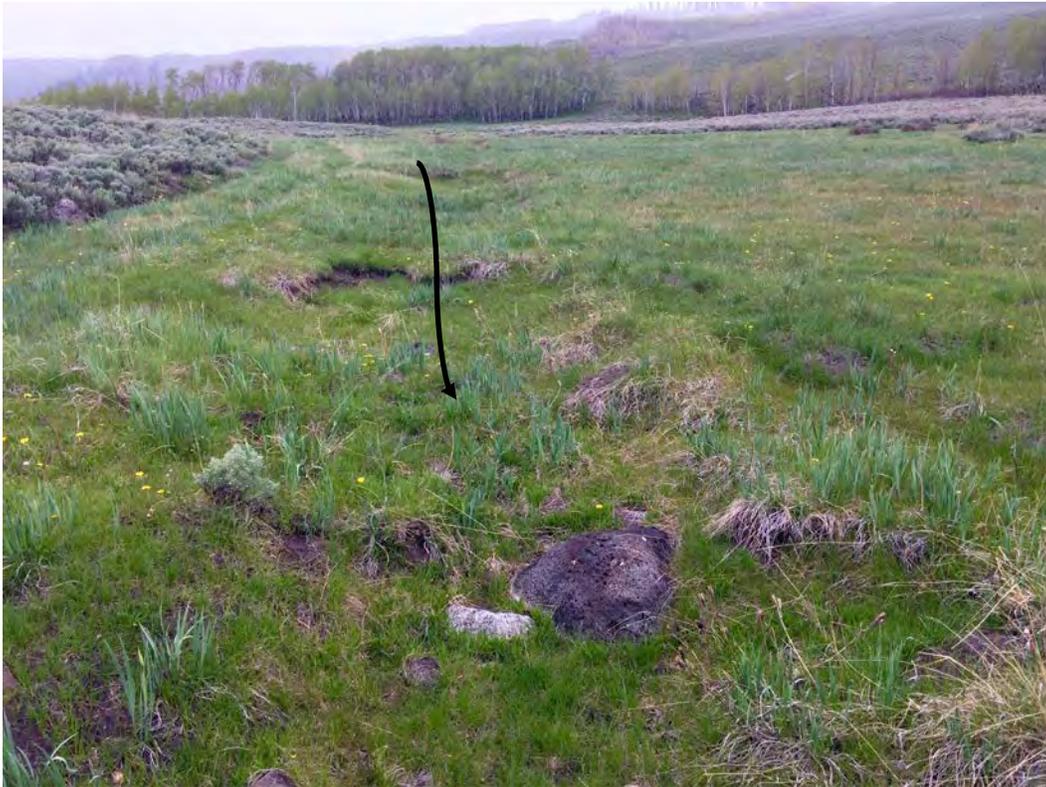
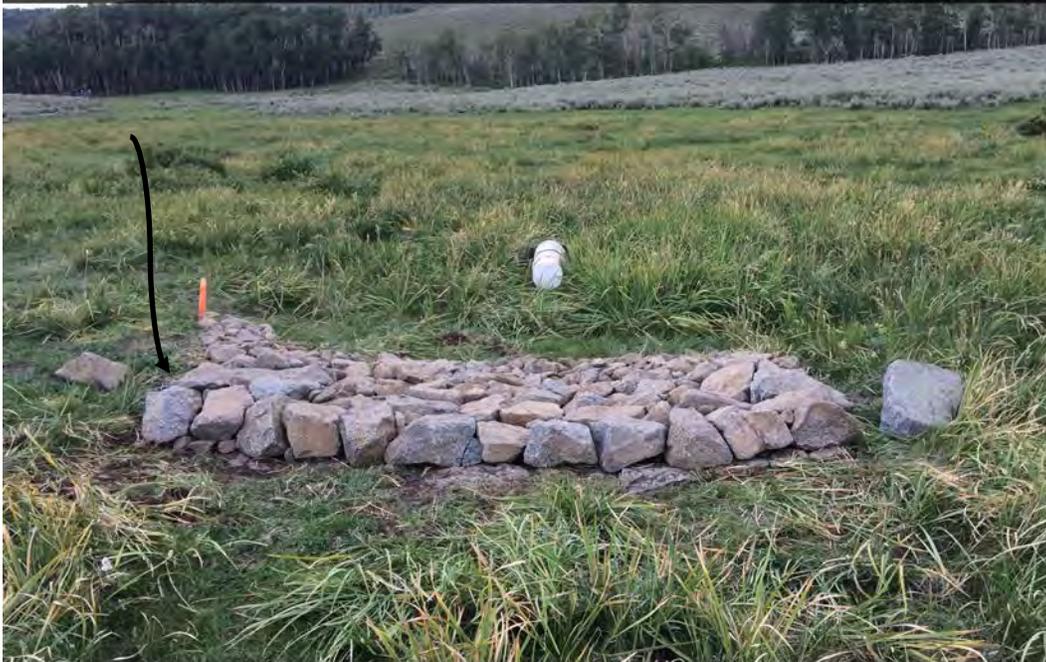
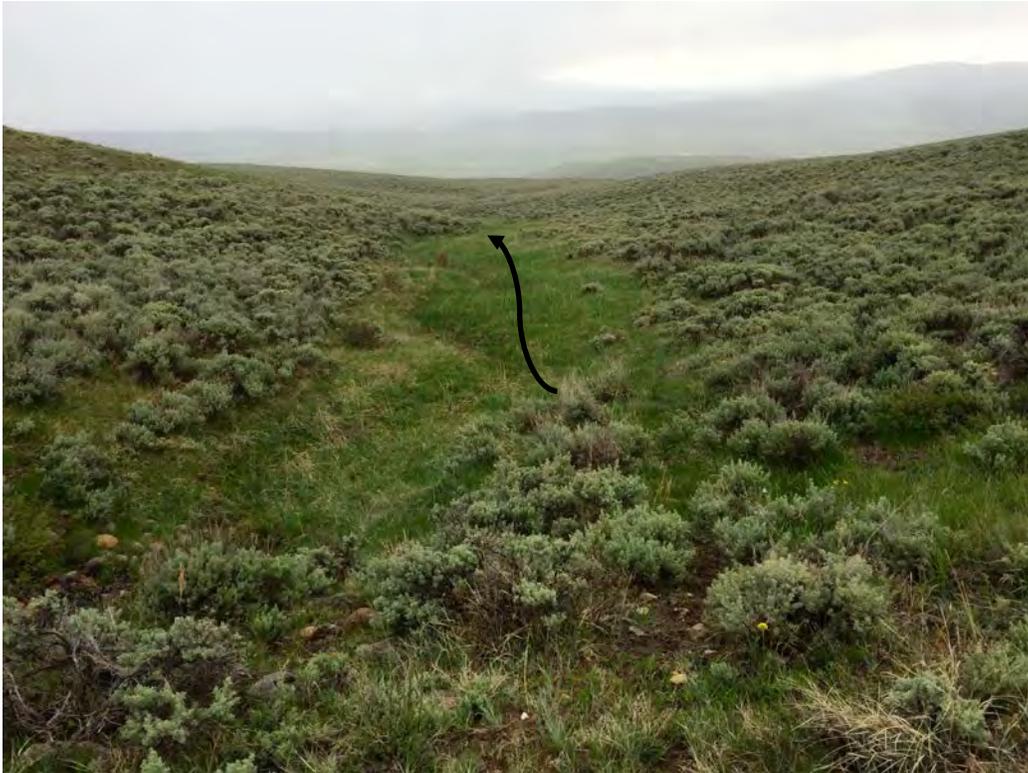
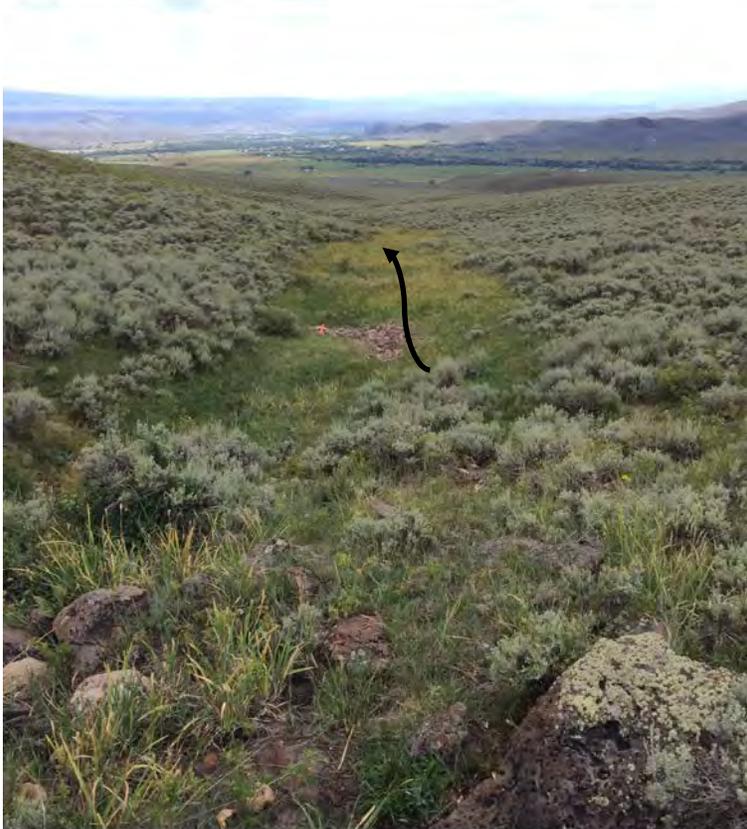
Enhancing Ecosystem Resilience of Riparian/Wetland Habitats in the Upper Gunnison Basin
Site Location: GMUG National Forests, Gunnison Ranger District - Flat Top Mountain

2016 - Pre (May) and Post (August) Treatment Photos, Page 3
➤ Arrow indicates direction of water flow and matches pre and post photo positions

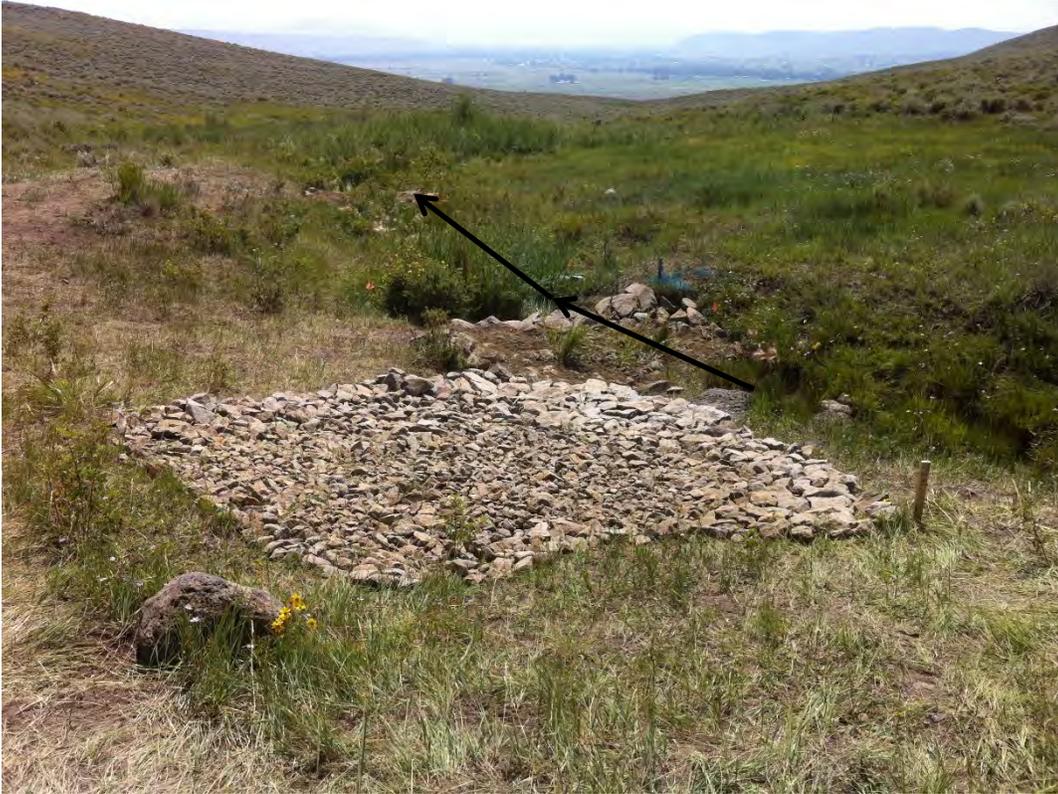
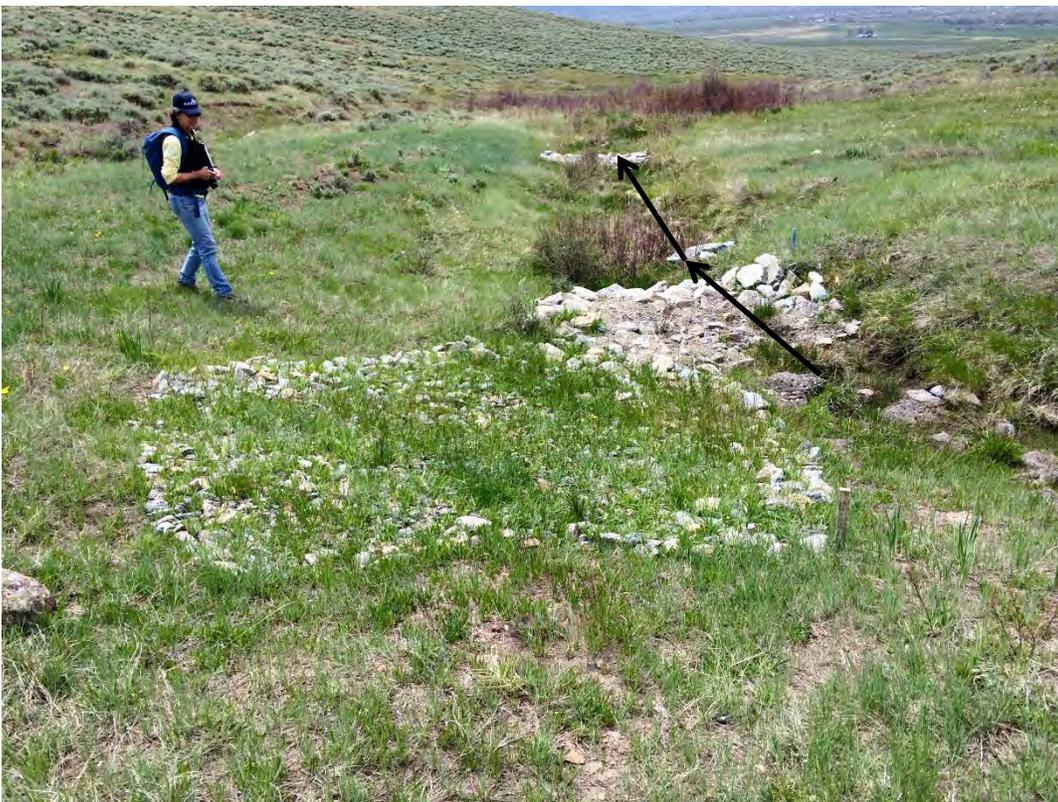
South Cottonwood Private

Top Photo: August 20, 2015 (structure completion date); Bottom Photo: May 26, 2016, Page 5
➤ Arrows indicates direction of water flow and matches 2015 and 2016 photo positions
