Vernal Pool Restoration on the Whetstone Savanna

Earth-moving for habitat conservation and species recovery

The Nature Conservancy in Oregon 2020

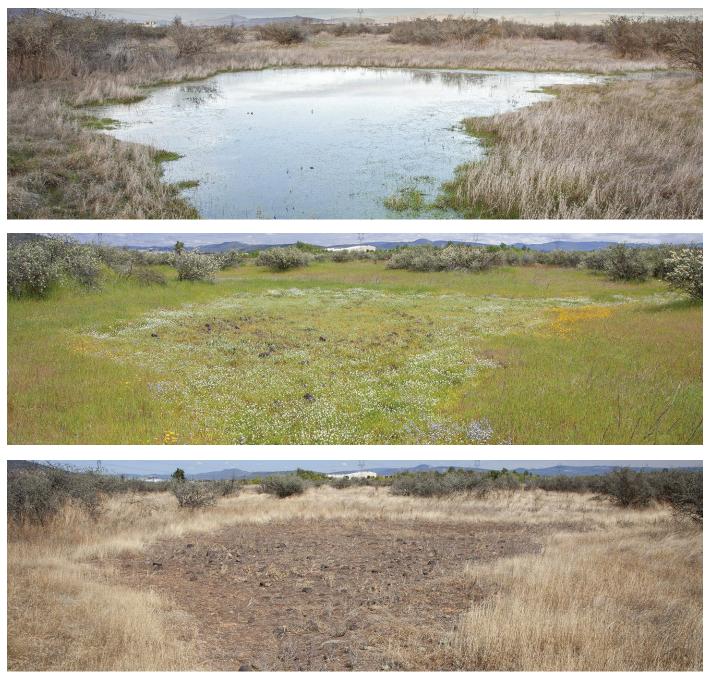
FIGURE 1. Three-photograph time series of seasonal transformation for a Rogue Valley vernal pool. Top: the pool fully inundated with rainwater during late winter. Middle: the same pool in the spring with surface water replaced by abundant wildflowers. Bottom: the pool in late summer, with soils and vegetation dry and dormant, waiting for rain. © *Evan Barrientos*

What is a vernal pool? Vernal pools are a distinctive type of wetland habitat found in a wide variety of forms all around the world. They are shallow ephemeral water bodies that seasonally inundate for relatively short spans of time, then dry out completely for extended periods before re-filling (Figure 1). Alternately too wet for upland species and too dry for typical aquatic species, vernal pools host specialist plants and animals that are uniquely adapted to their profound cycles of inundation and desiccation.⁵ Vernal pools are also important to more familiar species: as spawning habitat for frogs and salamanders, stopover and feeding grounds for migratory waterfowl and songbirds, or as a seasonal food and water source for a range of grazing and foraging mammals.

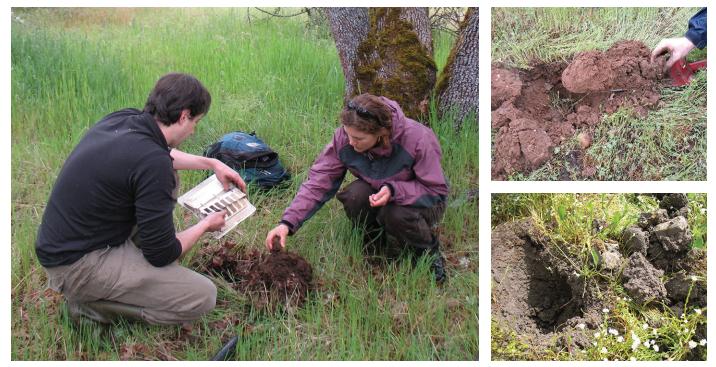
Staff from ODOT and TNC examine soil in test pits. Soil pits in damaged pools revealed a layer of rust-red upland Agate soil (upper right) burying the gray wetland Winlo clay found at the surface of intact pools (lower right). © *Keith Perchemlides/TNC*

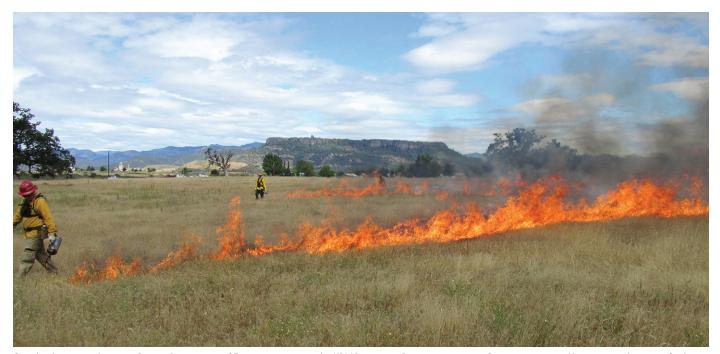
Grassland ignitions during an Oregon Department of Forestry training on the KPMS property. Burning removes surface vegetation and litter accumulations to facilitate grading restoration of the area. © *Keith Perchemlides/TNC*

Before we started earth-moving, we used prescribed burning (or mowing) to clear surface vegetation and litter from the project area to allow for effective grading. Accumulations of plant material in the soil would otherwise interfere with equipment, leaving an irregular restored surface, limiting stabilizing soil compaction and causing excessive post-grading settling. Thinning and pile-burning of small trees and shrubs has been important in oak woodlands for both habitat restoration and preparation for grading.

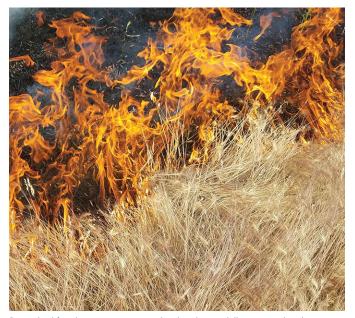
Prescribed fire devours invasive medusahead grass, killing its seed and preparing the ground for restoration. © *Keith Perchemlides/TNC*

Burning in early summer, before grading, has been ideal for vegetation removal and provides multiple ecological benefits. In addition to consuming surface material, a well-timed burn helps control invasive weeds by killing standing plants and stopping new seed production. Fire-adapted native plants benefitted from burns with increased germination, growth, or flowering the following year. And fire-adapted native trees and shrubs were highly resistant to fire damage, especially during early-season burns. Burning off surface vegetation greatly improved visibility of important fine-scale topography, disturbance scars, and variation in soils - and allowed for clear layout marking. When a burn was not possible, close mowing was the next-best alternative. Burning or mowing also improved the accuracy of new lidar (or drone orthophotography) surface mapping by removing obscuring vegetation.

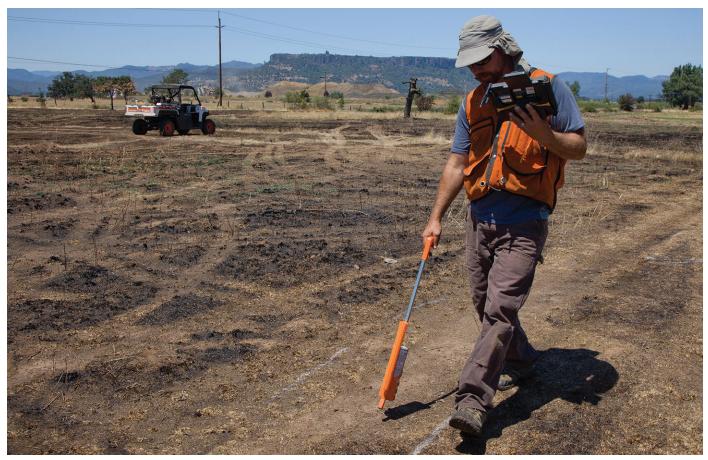
Marking out a vernal pool basin perimeter for excavation using construction marking paint, guided by the restoration grading plan on a survey-grade GNSS tablet. The area was burned earlier in the season to clear vegetation. © *Evan Barrientos/TNC*

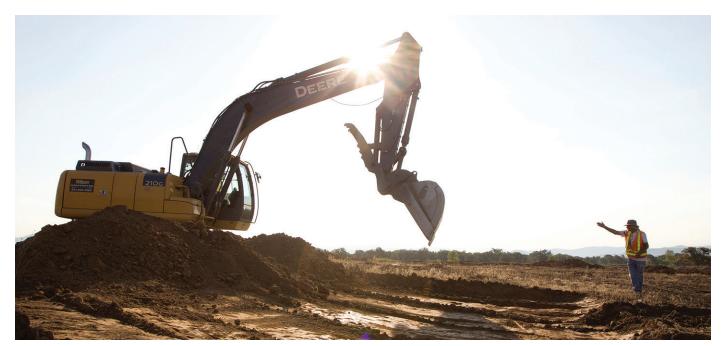
Working together, an equipment operator and ecologist remove upland soil from a filled vernal pool basin, using hand-signals and radio communication to adjust the depth and extent of excavation. © *Evan Barrientos/TNC*

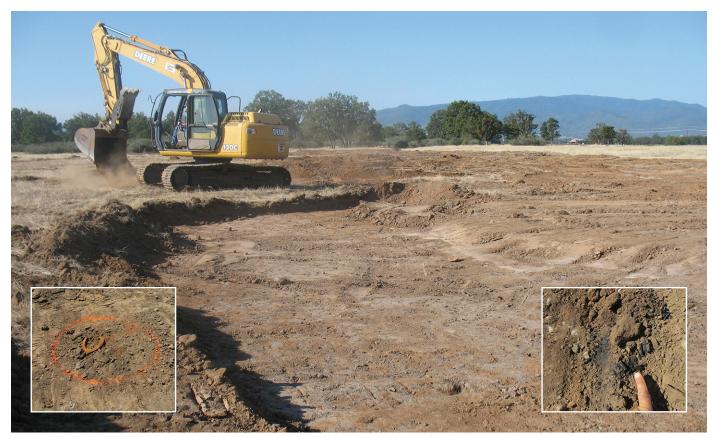
A buried surface of gray wetland Winlo soil is revealed as excavation removes several inches of rust-red upland Agate soil fill from a vernal pool basin during restoration grading. Insets: horseshoe artifact (left) and buried charcoal (right) uncovered at the wetland soil surface provide further evidence of the historic terrain. © *Keith Perchemlides/TNC*

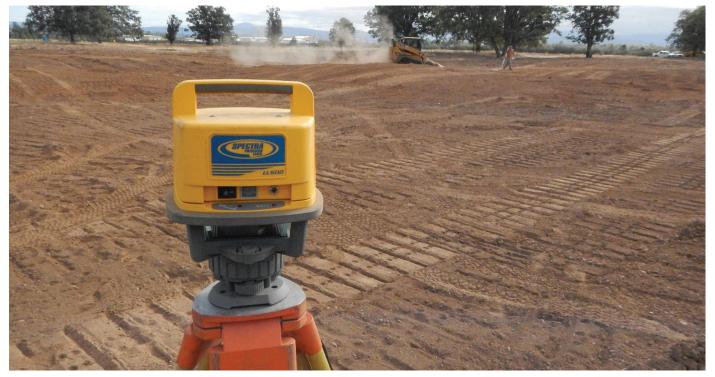
Surveyor's laser level in use for precise relative elevation measurements across a series of newly excavated vernal pool basins during grading checks. Background: a track loader builds up an outflow invert to increase basin depth. © Karen Hussey/TNC

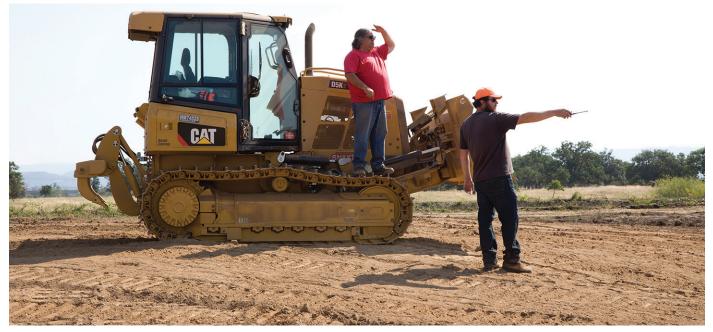
Equipment operator and ecologist review and discuss final grading adjustments on-site. Photo. © Evan Barrientos/TNC

The second round of grading work progressed from rough to finished grade while implementing the recommendations mapped during the first check. The grading crew added their own review and judgment to best fit the adjustments to the soils and conditions in each basin. Additional major fill removal or mound re-configurations required an excavator or bulldozer. Simply maneuvering these heavy machines back across the work area caused soil disturbance, so we learned to intentionally leave the first grading rough until the second dig was completed. Adjustment of depth-controlling invert heights, removal of shallow fill,

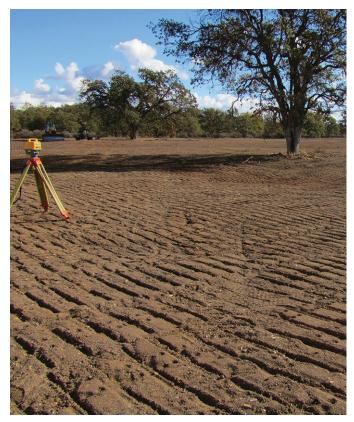
Track-walking imprints from a bulldozer's cleated treads line the restored terrain. The operator uses the weight of the machine to stabilize and settle the soil after final grading. © *Keith Perchemlides/TNC*

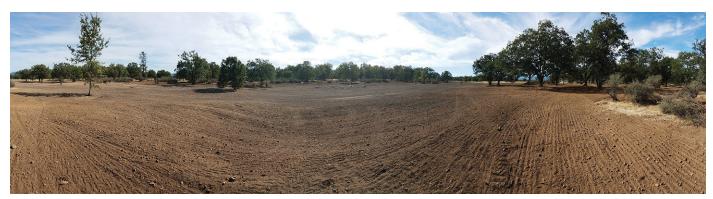
Newly restored terrain in late summer just after final grading. Track-walking followed by chain-harrowing stabilizes soils and provides an ideal fine-textured seedbed for fall sowing of native plant seed. © *Keith Perchemlides/TNC*

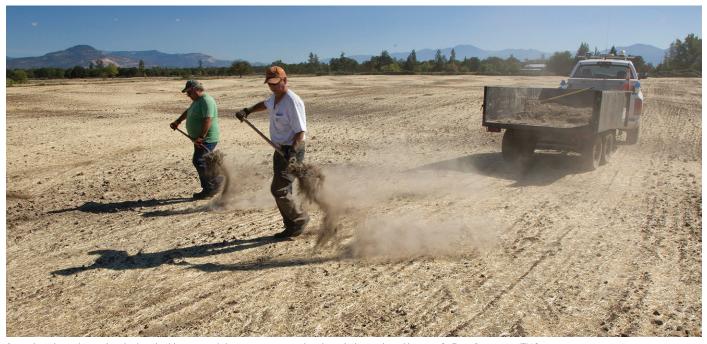
Spreading dry soil inoculum by hand adds essential diversity to restored and seeded vernal pool basins. © Evan Barrientos/TNC

Seeding and inoculum transfer were completed as soon as possible after final grading and before soil-wetting rains. Sowing early allowed for seed exposure to important on-site germination cues of temperature and moisture, setting the native seed on a competitive timeline relative to non-native species - an important factor in this first-come-first-serve growing environment.¹¹⁷ Each habitat zone was sown separately to ensure specialist species went where they would thrive, and to make the most efficient use of valuable and limited native seed. Upland seeding mixes were broadcast sown, often with a tractor-driven seed-spreader to cover large areas. Flank and basin mixes were generally hand-sown to target their relatively limited and narrow habitat. Meadowfoam and desert parsley seed were included in the flank mix or sown independently to target the specific microsites where they

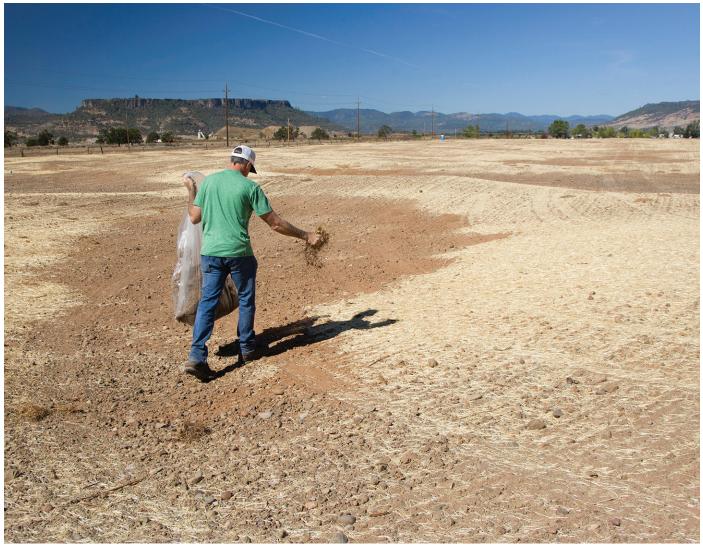
Hand sowing endangered large flowered woolly meadowfoam seed (and chaff) from agricultural grow-out along the winding flanks and flow paths of restored vernal pool wetlands in early fall. © *Evan Barrientos/TNC*

would best establish and persist. We usually dragged a flexible chain-harrow across the seeded area again after sowing to improve seed-soil contact and germination success.

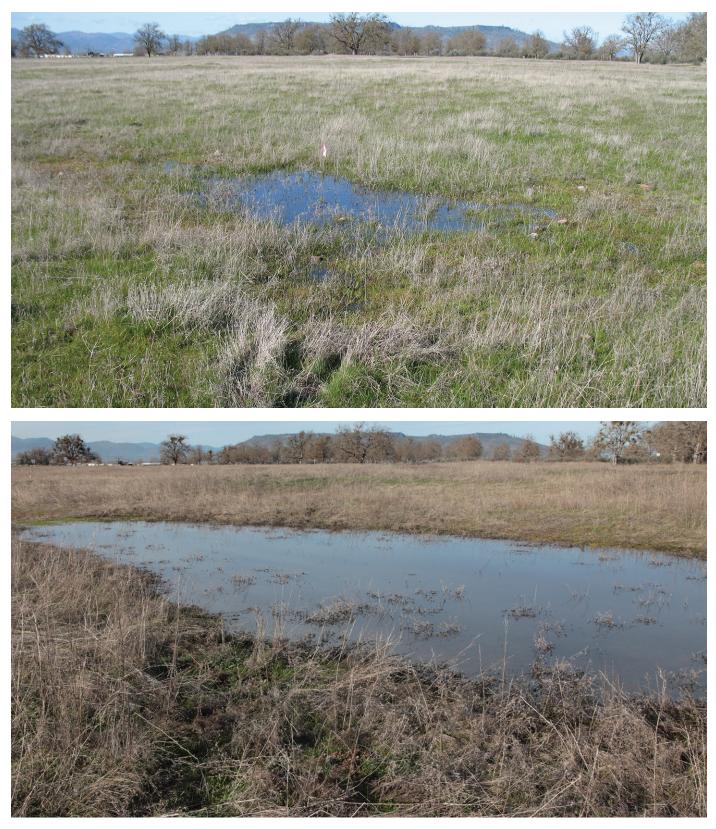
FIGURE 4. Repeat photography of a grassland vernal pool on the VPMCB at maximum wet-season inundation, before restoration (2009), top, and after restoration (2017), bottom. Restored in 2015, this pool demonstrates a typical increase in inundation after removal of fill. © *before, Keith Perchemlides/TNC; after, Evan Barrientos/TNC*

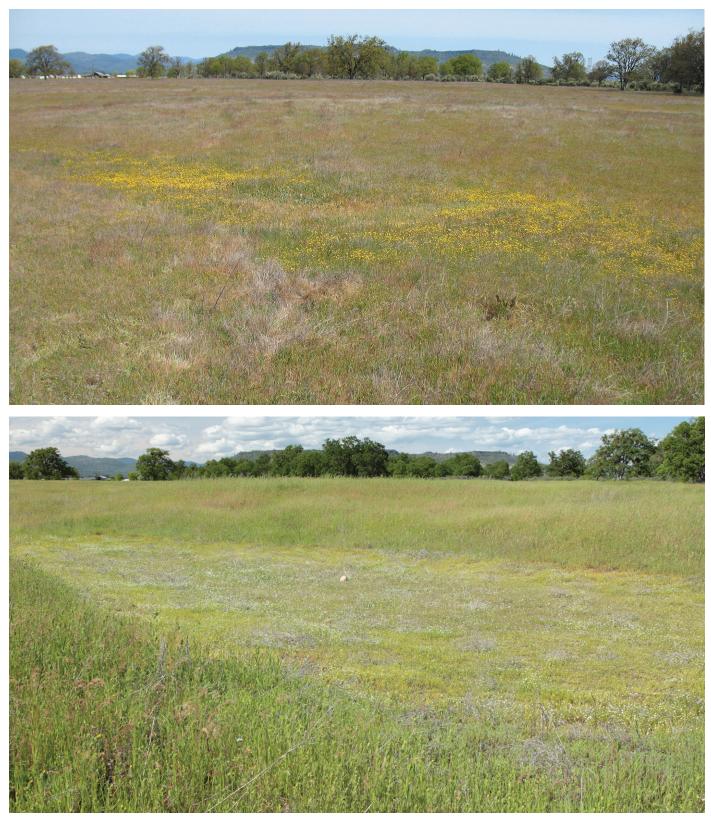
FIGURE 4. (continued). The same vernal pool during peak spring growth, before restoration (2009), top, and after restoration (2017), bottom. Restored in 2015, this pool illustrates the strong establishment of native plants with restored hydrology, seeding and inoculum. © *before, Keith Perchemlide /TNC; after, Evan Barrientos/TNC*

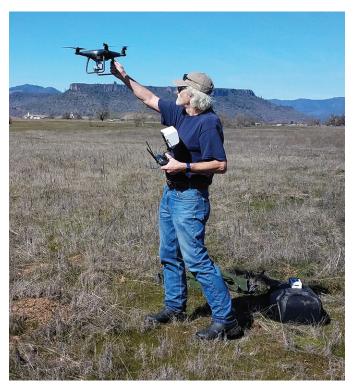
Catching a drone at the end of an orthophotography flight sequence. © *Keith Perchemlides/TNC*

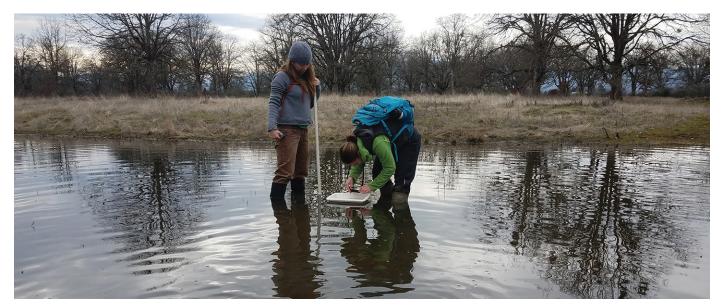
Catch-and-release: monitoring vernal pool fairy shrimp in mid-winter. Fairy shrimp were captured by sweeping the pools with fine-mesh nets, then field-identified in observation trays before being returned to their pool. © *Keith Perchemlides/TNC*
