Lower Dolores River
2017 McPhee Reservoir
Managed Release
Ecological Monitoring & Evaluation

Volume 1: Summary
February 2018

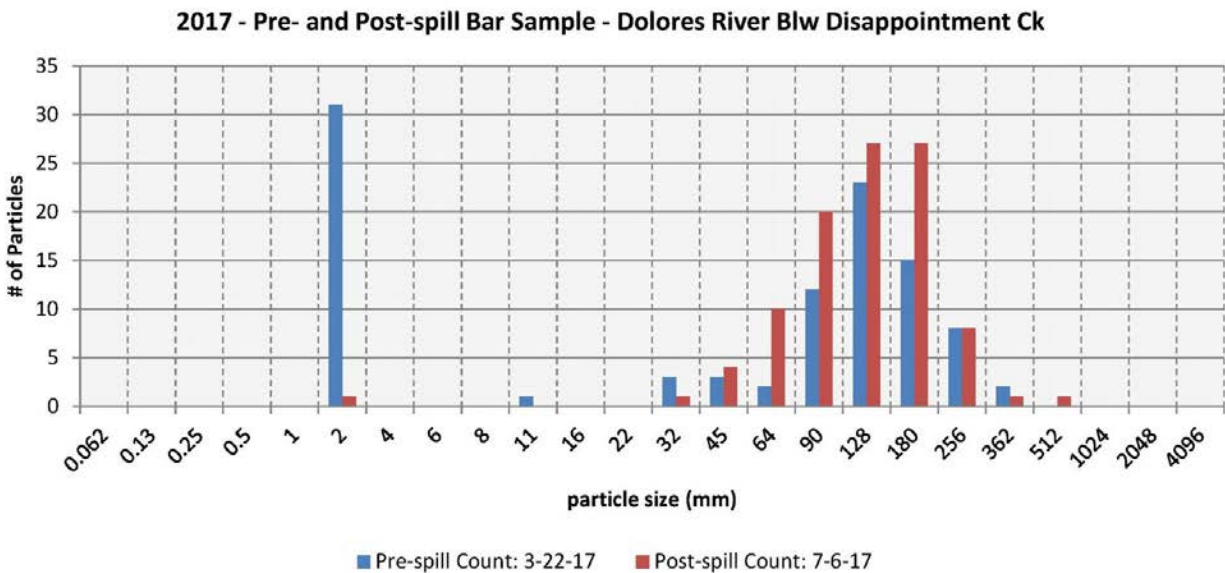
- D50 coarsened from 85mm to 108mm on a high energy, low-floodplain environment at the Slickrock Downstream site, considered the best surrogate for in-channel processes that occurred in riffle habitats.
- At the Slickrock Downstream Site, erosion stakes on a low floodplain, high energy site showed substantial scour (Figure 3). Some cobble movement was observed into and out of the painted patch, indicating that larger particles were also mobilized with the managed release.
- At the Slickrock Downstream site, the 3-D elevation survey conducted by FLC researchers showed minimal lateral bank erosion, but found substantial deposition of sand occurring on the floodplain (up to 3 feet), particularly where river flow was slowed by dense willow, and notable incision (up to 2 feet) occurring in the pre-existing side channel.
- Reactivation of side channels was observed at several sites.

Figure 2. Slickrock Downstream (Below Disappointment Creek) site Wolman pebble count results 2017. These important results show that 2 mm particles were almost completely removed from the site.

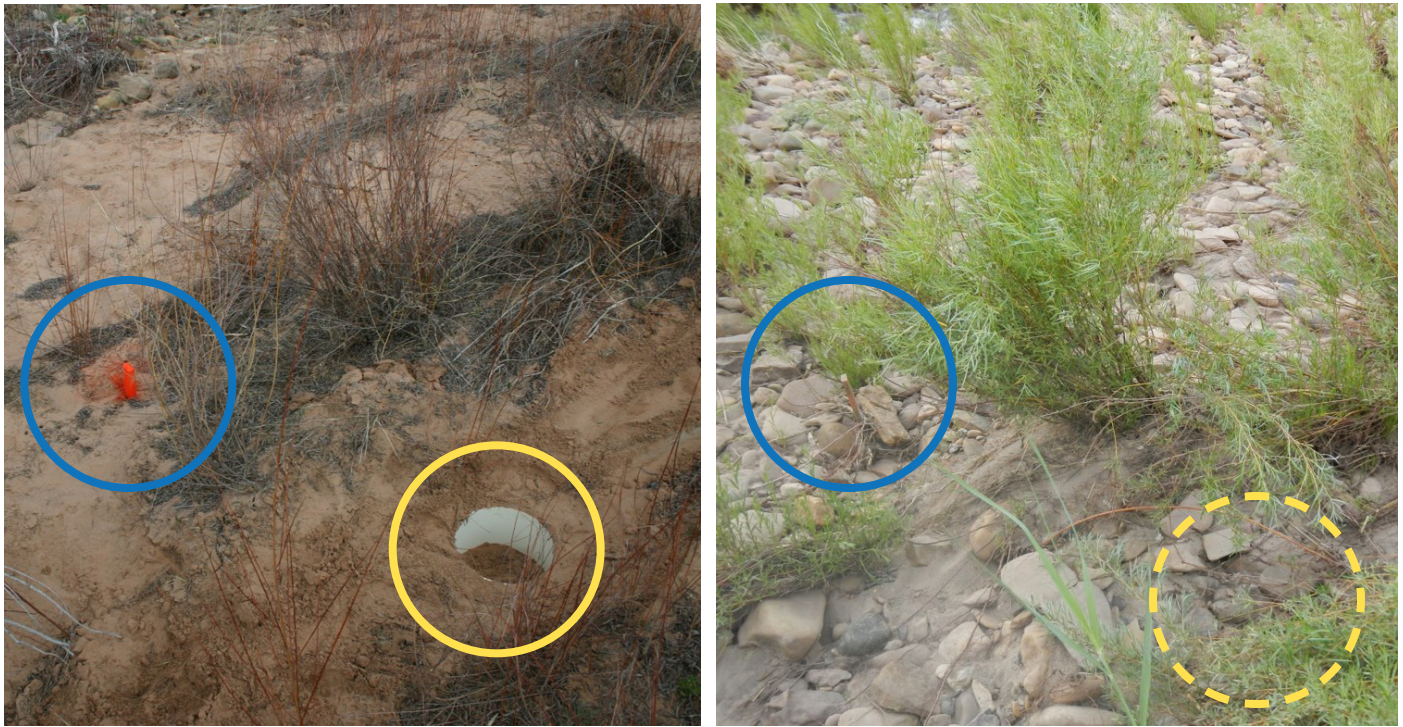
Figure 3. Slickrock Downstream sediment trap (yellow circle) and erosion stake (blue circle); pre-release photo on left (3/22/17), and post-release photo on right (7/6/17). Note the scouring of fine material observed with the orange erosion stake between pre- and post-release. It is estimated that the sediment trap was washed away with strong scouring flows during the managed release (absence of sediment trap post-release).

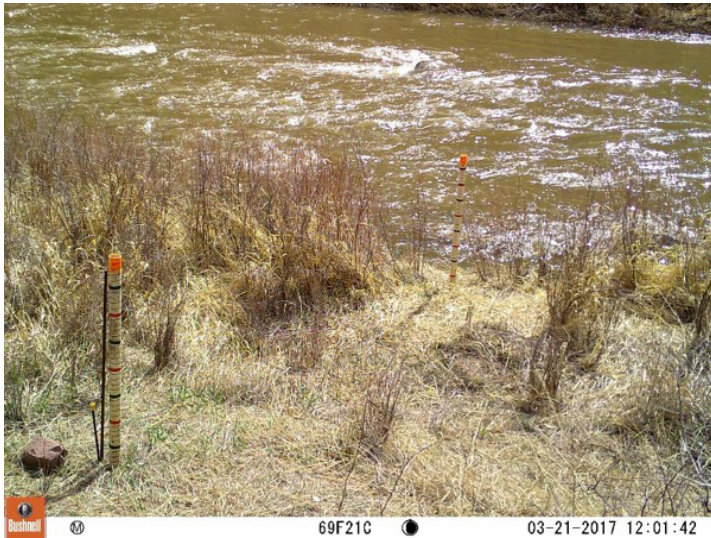
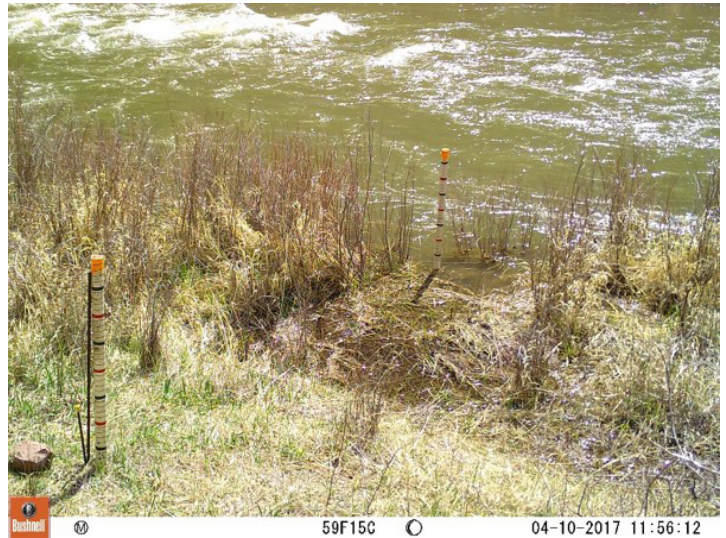
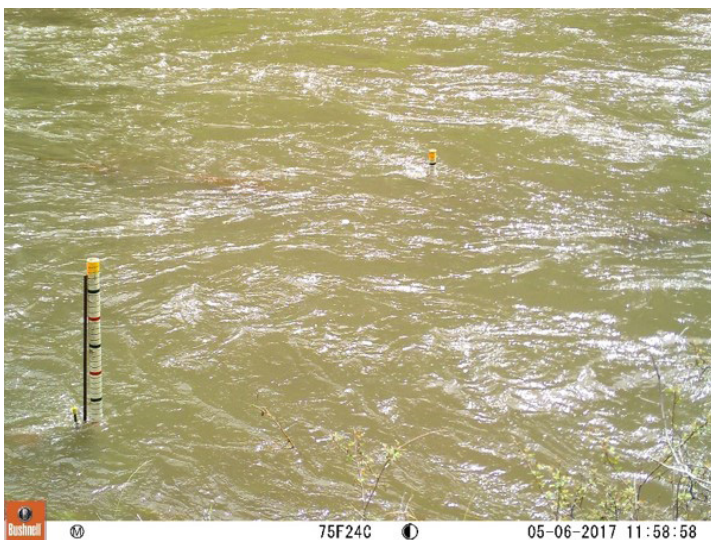
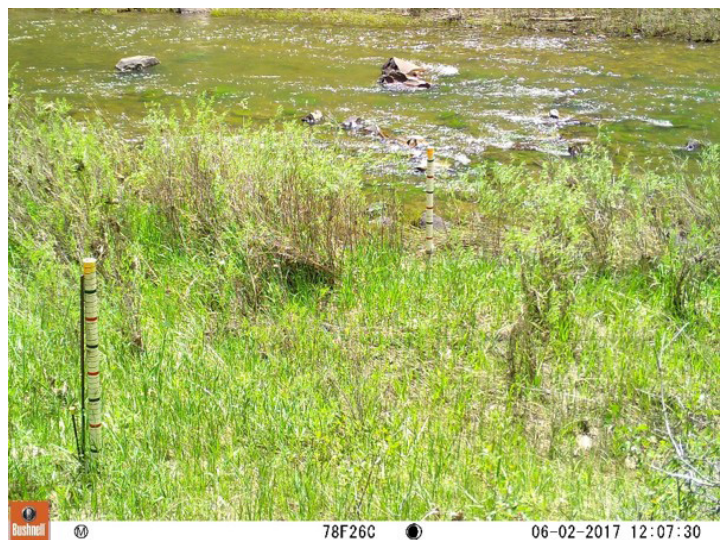
Figure 4. Dove Creek staff gage at pre-release, rising water, peak-release, and post-release. Notice river rising substantially out of its banks at peak-release but with very little change in the amount of woody vegetation.

- Cameras captured the river rising substantially out of its banks at multiple sites during peak-release, an important benefit of the managed release, resulting in noticeable sediment deposition and scour, and crucial recharging of the alluvial aquifer (see Figure 4 below).
- Images do, however, also show minimal bank erosion, providing further evidence of the substantial ‘armoring’ of the banks at multiple sites.

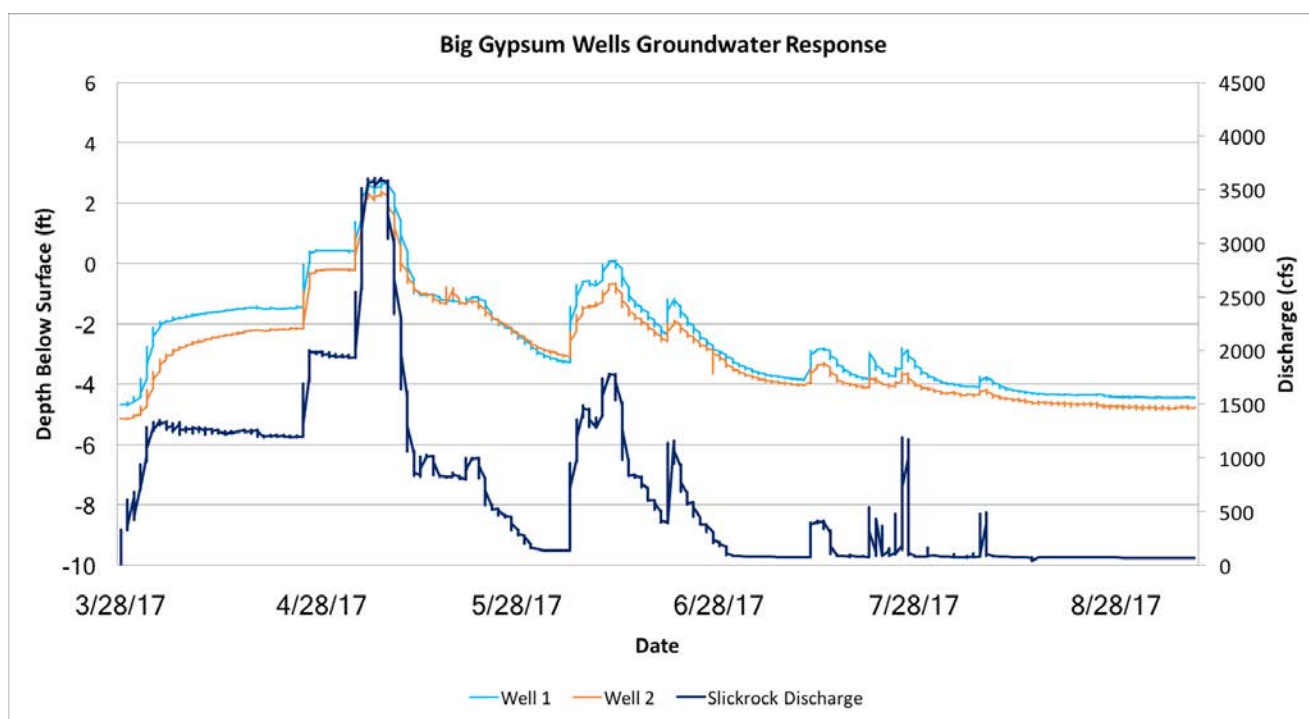
- The 2017 peak release (~4,070 cfs) resulted in peak discharge at Slickrock (the closest gage to the Big Gypsum site) of 3,630 cfs, and this resulted in floodplain inundation and groundwater levels above baseflow conditions for 89 days at Lone Dome & 91 days at Big Gypsum.
- The 2011 moderate release (peak release ~1,500 cfs) resulted in groundwater levels above baseflow conditions for 46 Days at Lone Dome & 31 Days at Big Gypsum.

Figure 5. Big Gypsum site in 2017, showing Slickrock Discharge and groundwater well data for a high-flow release. Note that both Well #1 and Well #2 show groundwater depths of 2 feet or less from the beginning of April through the end of July.

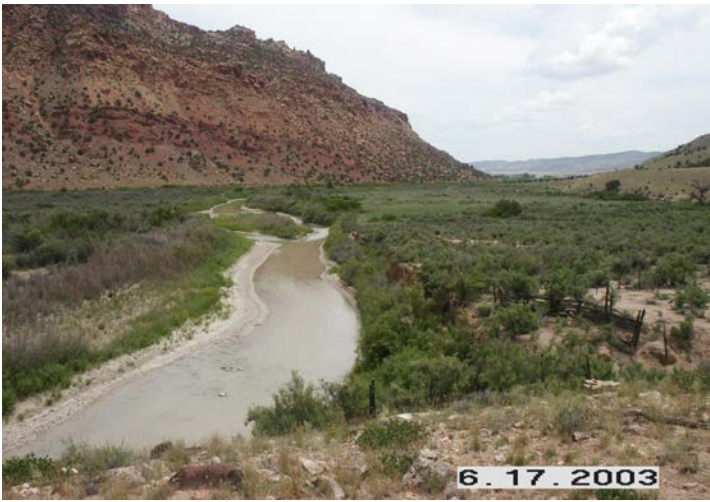
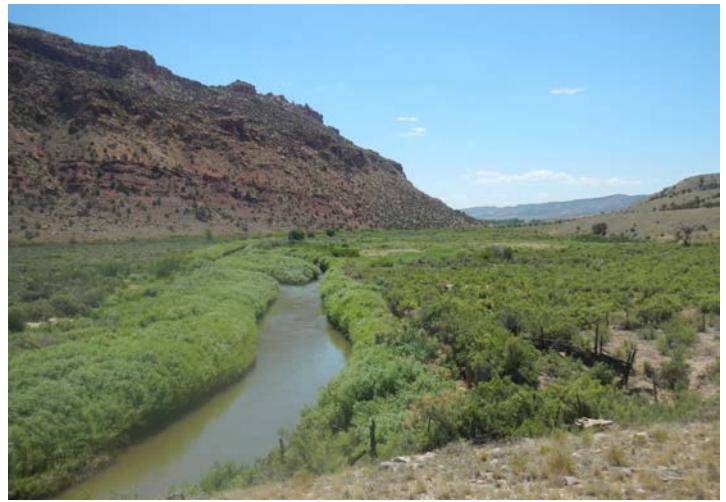
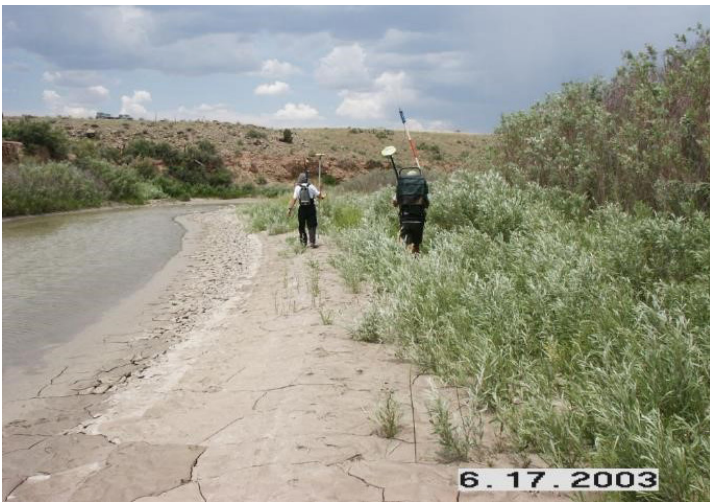
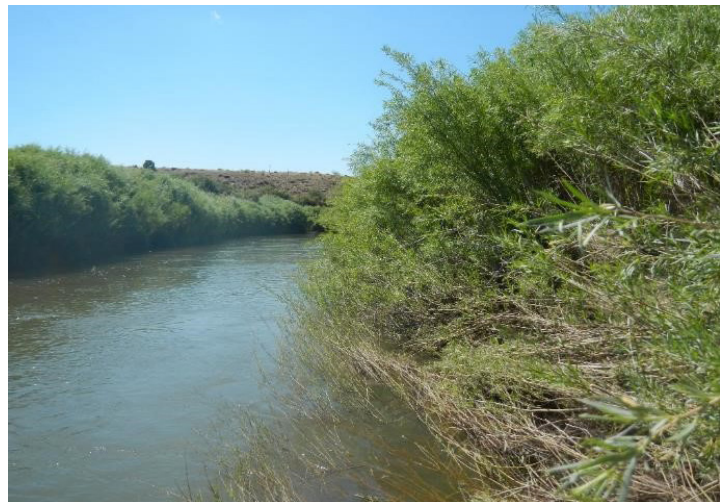
Figure 6 (a-d). Historic Big Gypsum Photo Point #2 (top photos) and Photo Point #6 (bottom photos) taken in 2003 (6/17/03) (photos on left) and 2017 (6/26/17) (photos on right). The photos show how, between these years, riparian vegetation increased in size, cover and density, and bare ground between plants decreased.

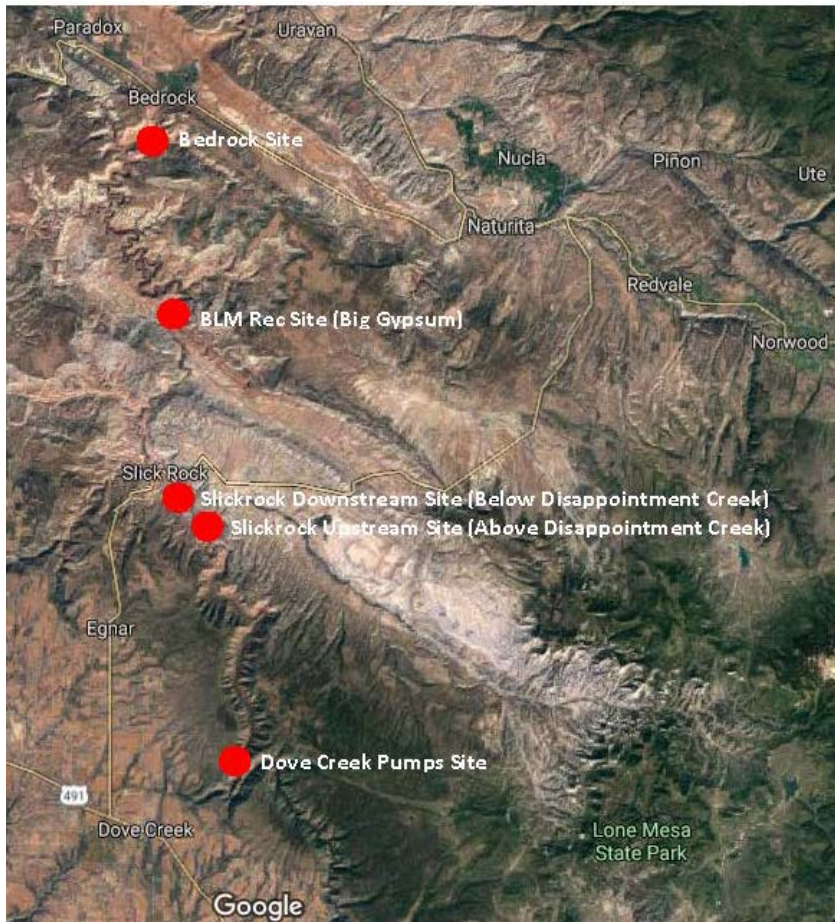
Figure 1. Five new ecological monitoring sites established in 2017 along the Lower Dolores River to evaluate the effect of the 2017 managed release on sensitive native fish and in-channel and riparian habitat, in line with the measurable benchmarks in Table 4 of the 2014 Plan.

Five new ecological monitoring sites were established on the Lower Dolores River in March 2017, between McPhee Reservoir and the confluence with the San Miguel River (Figure 1). The five sites are (from upstream to most downstream): Dove Creek Pumps, Slickrock Upstream (Above Disappointment Creek), Slickrock Downstream (Below Disappointment Creek), BLM Rec (Big Gypsum), and Bedrock. The Slickrock Upstream and Slickrock Downstream sites were located near each other to compare changes above and below a sediment-heavy tributary (Disappointment Creek). For more information on the five newly established ecological monitoring sites see *Appendix 1. Ecological Monitoring Sites – Site Locations and Descriptions*.

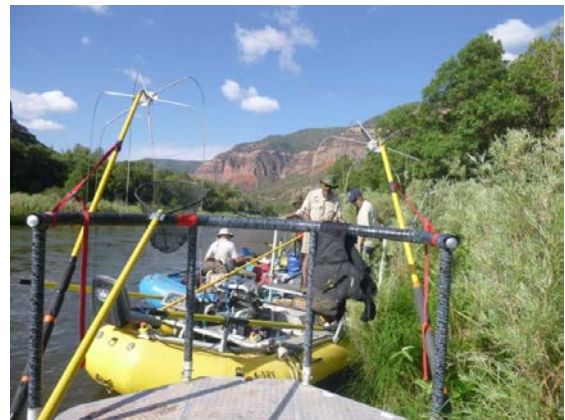
Figure 3. Non-native fish removal efforts on the Dolores River in 2017.

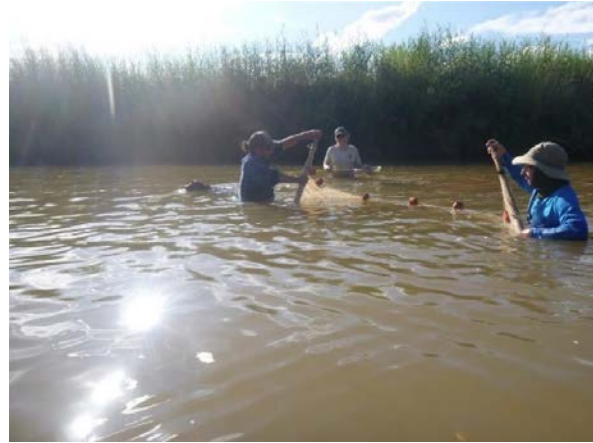
Figure 6. Fish sampling on Dolores River.

Assessment of fish reproduction was conducted August 21-24 through seining (Figure 6), electro-fishing, and angling. A crew of 12 was used at 3 locations (Dove Creek Pumps, Big Gypsum, and James Ranch). A total of 1,053 fish were captured. Forty-two percent of the fish were native, consisting of bluehead sucker, flannelmouth sucker, roundtail chub, and speckled dace. Red and sand shiners comprised 44% of the catch. Twenty-five smallmouth bass were also captured, which comprised 2% of the catch. These results are aggregated across all sites (Figures 7 and 8).

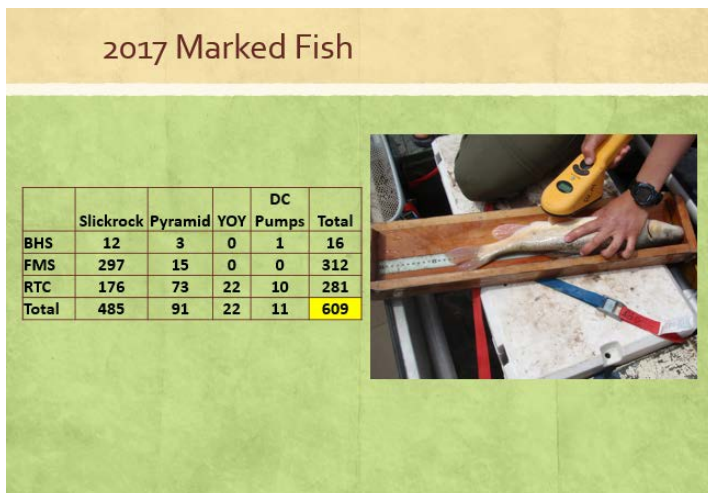
Figure 9. Bluehead suckers, flannelmouth suckers, and roundtail chub PIT tagged on the Dolores River in 2017.

A total of 609 fish were marked with passive integrated transponder (PIT) tags over the summer of 2017. This included bluehead suckers, flannelmouth suckers, and roundtail chub (Figure 9).

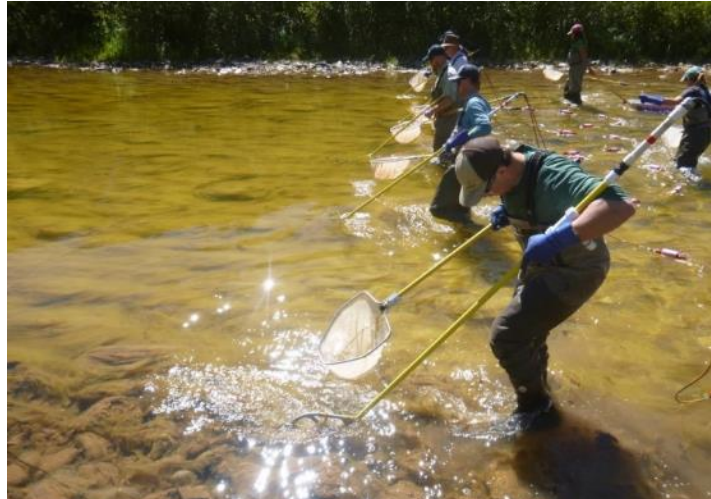
The annual coldwater survey (Figure 10) has been running since 1989. In 2017, four sites were surveyed at 40 cfs, using a crew of 10 over 2 days. The survey found close to 30 pounds/acre of trout in the first 12 miles of the river below the dam, with the amount of water having a positive influence on biomass (Figure 11). At the habitat improvement site in Lone Dome, the trout biomass increased to over 30 pounds/acre.

Figure 10. Annual coldwater survey on the Dolores River.

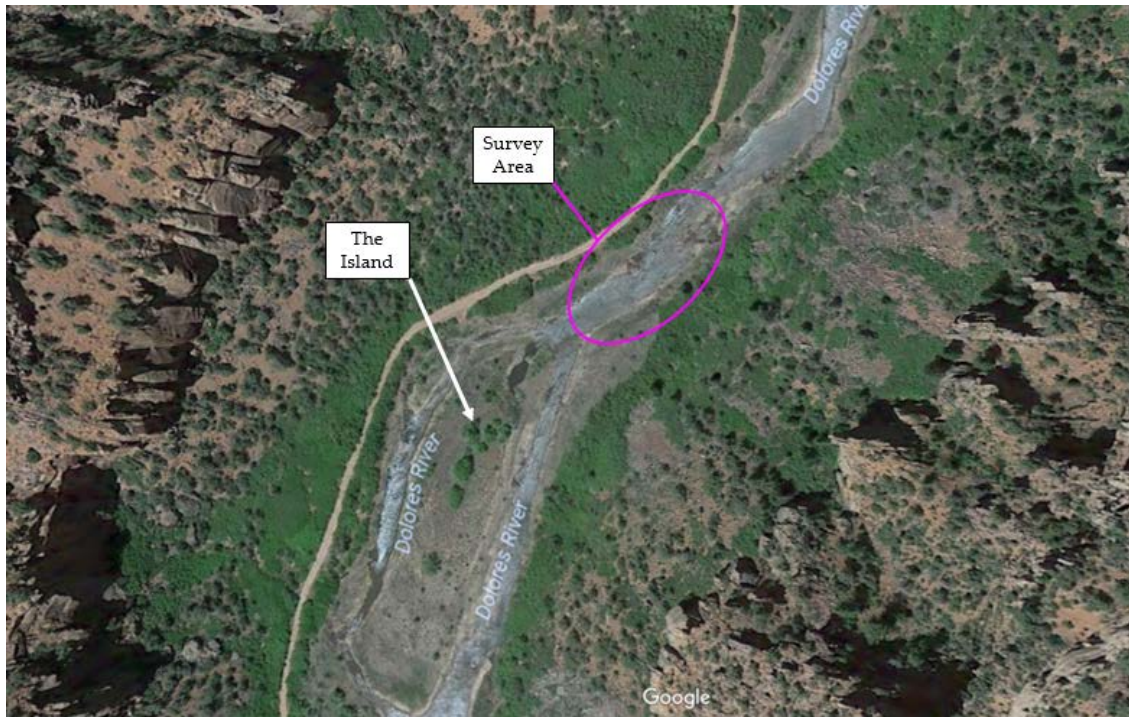
Figure 14. Dove Creek Pumps site overview, showing the location of the survey area circled in purple.

The Dove Creek Pumps site (Figure 14) is a confined, colluvial U-shaped valley type, with relatively stable, moderate side slopes, and a moderate valley slope. Located within a portion of the Dolores with steep canyon walls and a very narrow riparian corridor, there is a relatively low sediment supply, but areas of high sediment supply can occur. There is also large, woody debris here.

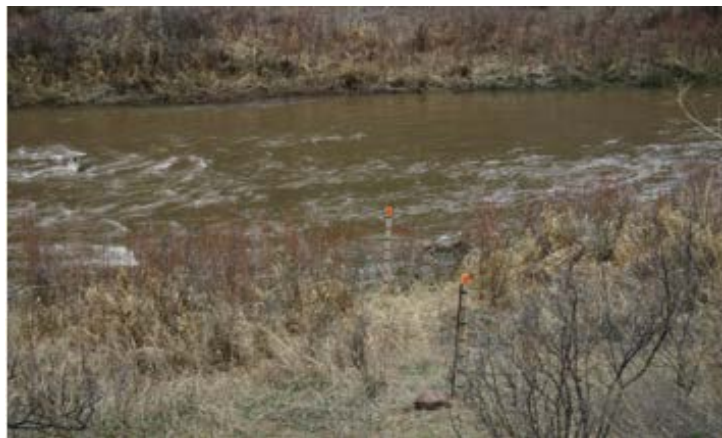
Figure 15. Dove Creek Pumps Site, upstream riffle cross-section. This is a pre-release photo of the riffle (March 2017).

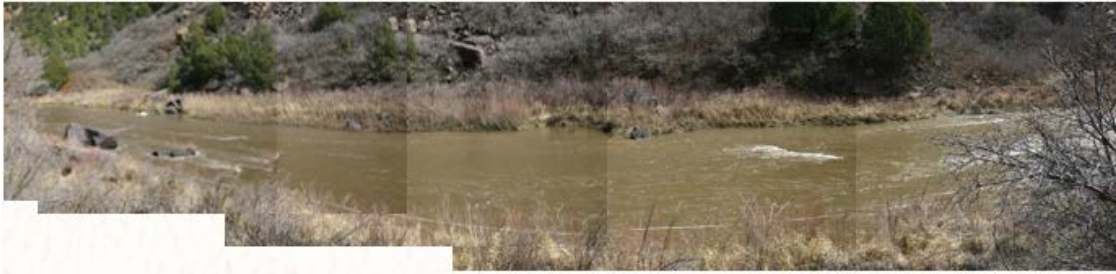
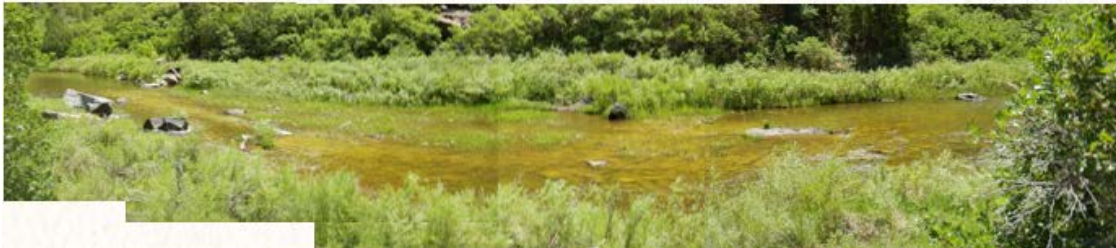
Figure 18. Dove Creek Pumps Site, pool cross-section, shown for 2017 pre-release (March 20) and post-release (July 8).

Pre- and post-release 2017 cross-section comparisons for the riffle at this site show little change (Figure 16); the Dove Creek Pumps site almost represents a control reach, as it is a very stable, narrow riparian corridor. There was also not much change observed in the cross-sections when compared to 2004 (Figure 17). The pool cross-section also showed little change (Figures 18 and 19)

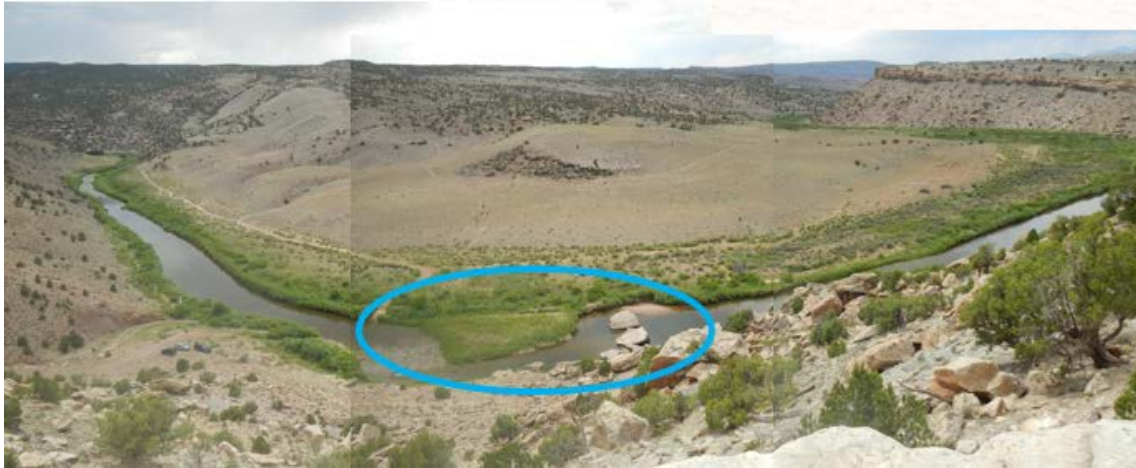
Figure 20. Slickrock Upstream Site Overview. Circle in blue shows the survey area. This is a post-release photo (8/6/17).

The Slickrock Upstream site is a semi-confined, alluvial valley type, with alluvial deposition and a narrow floodplain. It has a meandering riffle-pool system, with streambank erosional processes and a productive riparian community; there is not a lot of sinuosity in the stream (Figures 20-22).

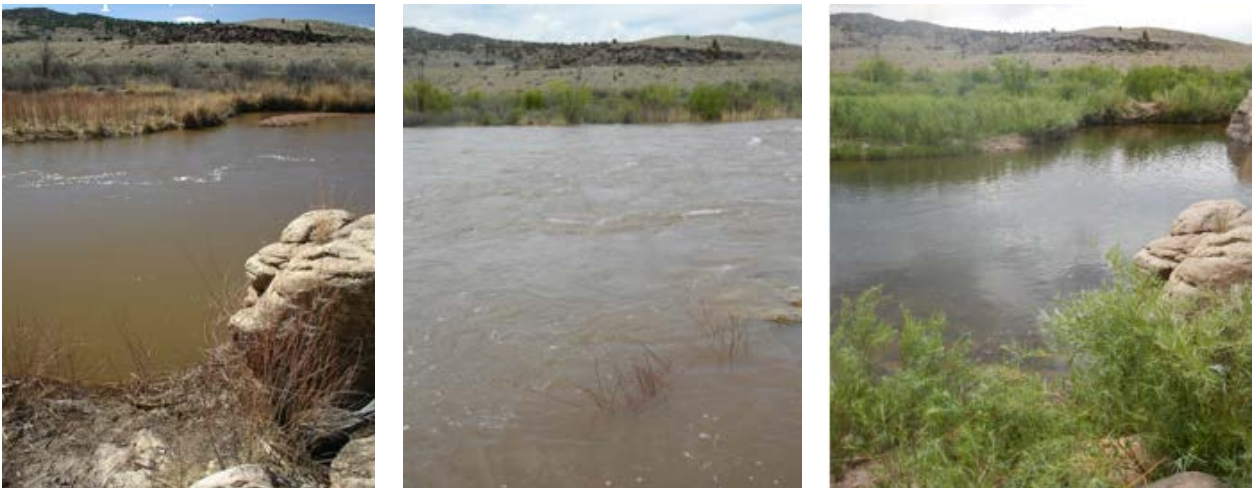
Figure 21. Slickrock Upstream Site, downstream pool. Photos of the pool are, from left to right, pre-release (3/24/17), peak-release (5/6/17), and post-release (7/6/17).

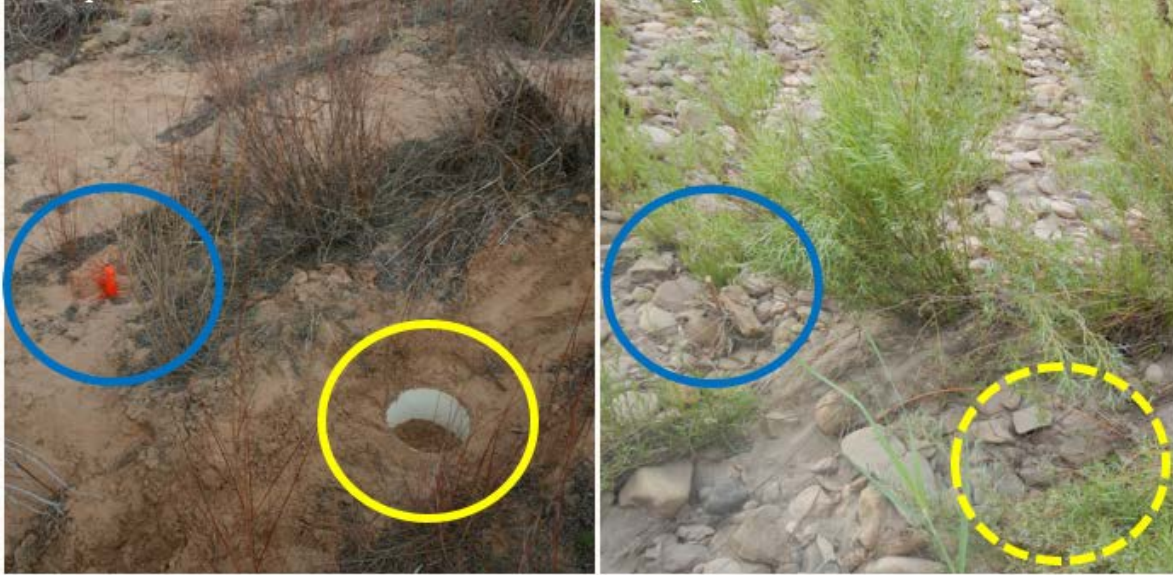
Figure 26. Slickrock Downstream sediment trap and erosion stake; pre-release photo on left (3/22/17), and post-release photo on right (7/6/17). Note the scouring of fine material observed with the orange erosion stake circled in blue between pre- and post-release. It appears that strong flows ripped out sediment trap pre- versus post-release.

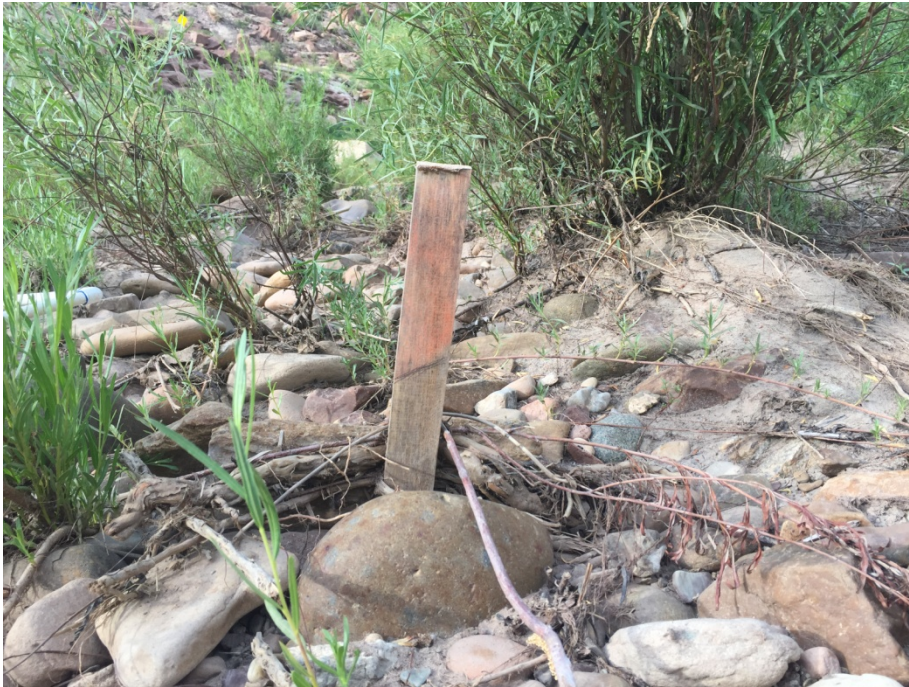
Figure 27. Post-release scour on low floodplain at Slickrock Downstream site. Stake painted to depth installed pre-release (3/22/17). Approximately 0.5 feet of material was scoured from this location.

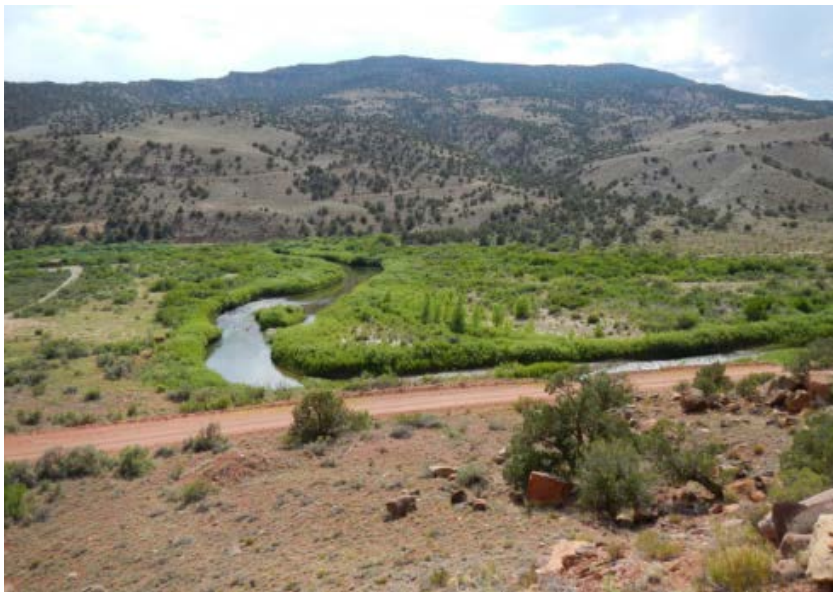
Figure 31. Overview of BLM Rec (Big Gypsum) site post-release July 8, 2017.

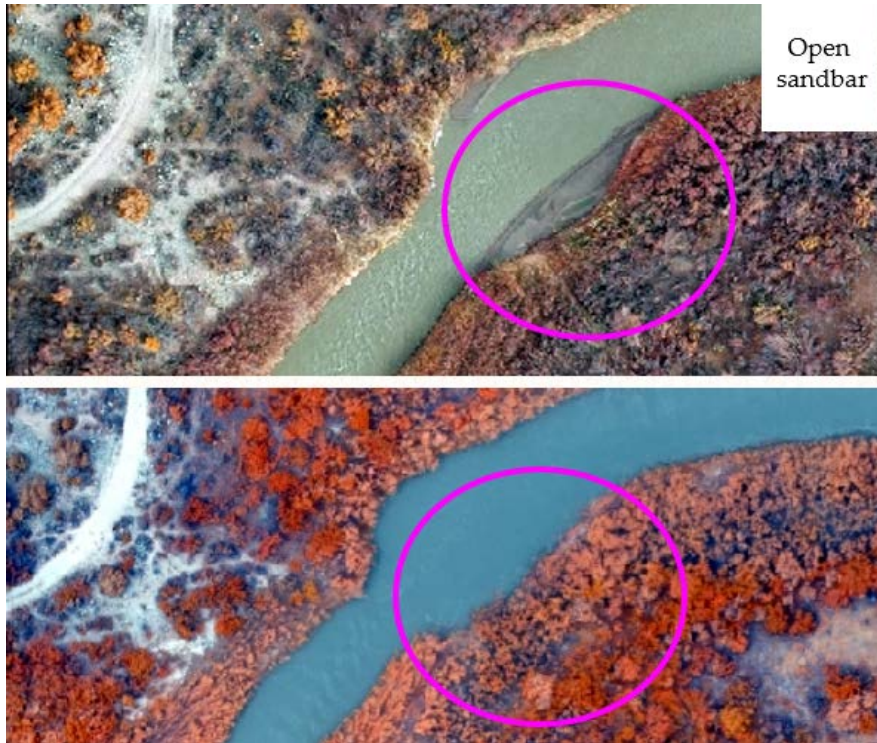
Figure 32. BLM Rec (Big Gypsum) Site, showing area of cross-section survey pre-release in March (top), and post-release in June (bottom) 2017.

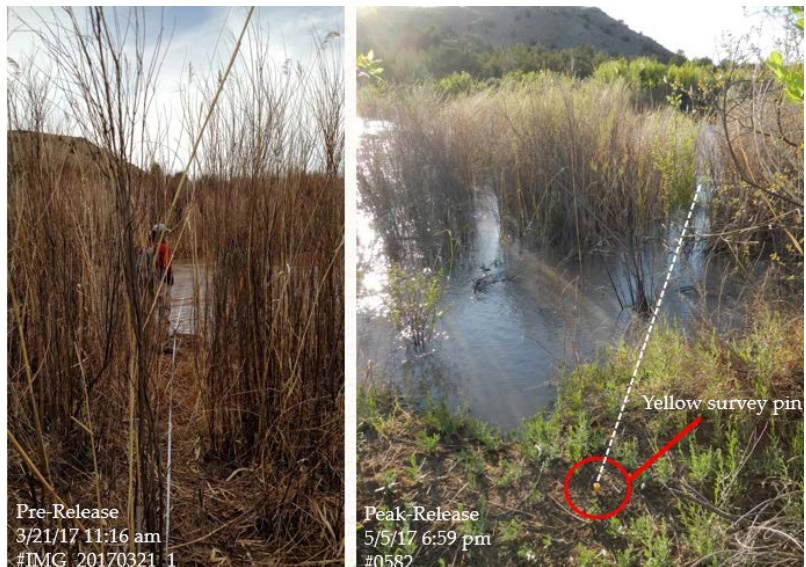
Figure 33. BLM Rec (Big Gypsum) Site, showing cross-section line pre-release (3/21/17; on left), and estimated line trajectory if it had been run at peak-release (5/5/17; on right), 2017.

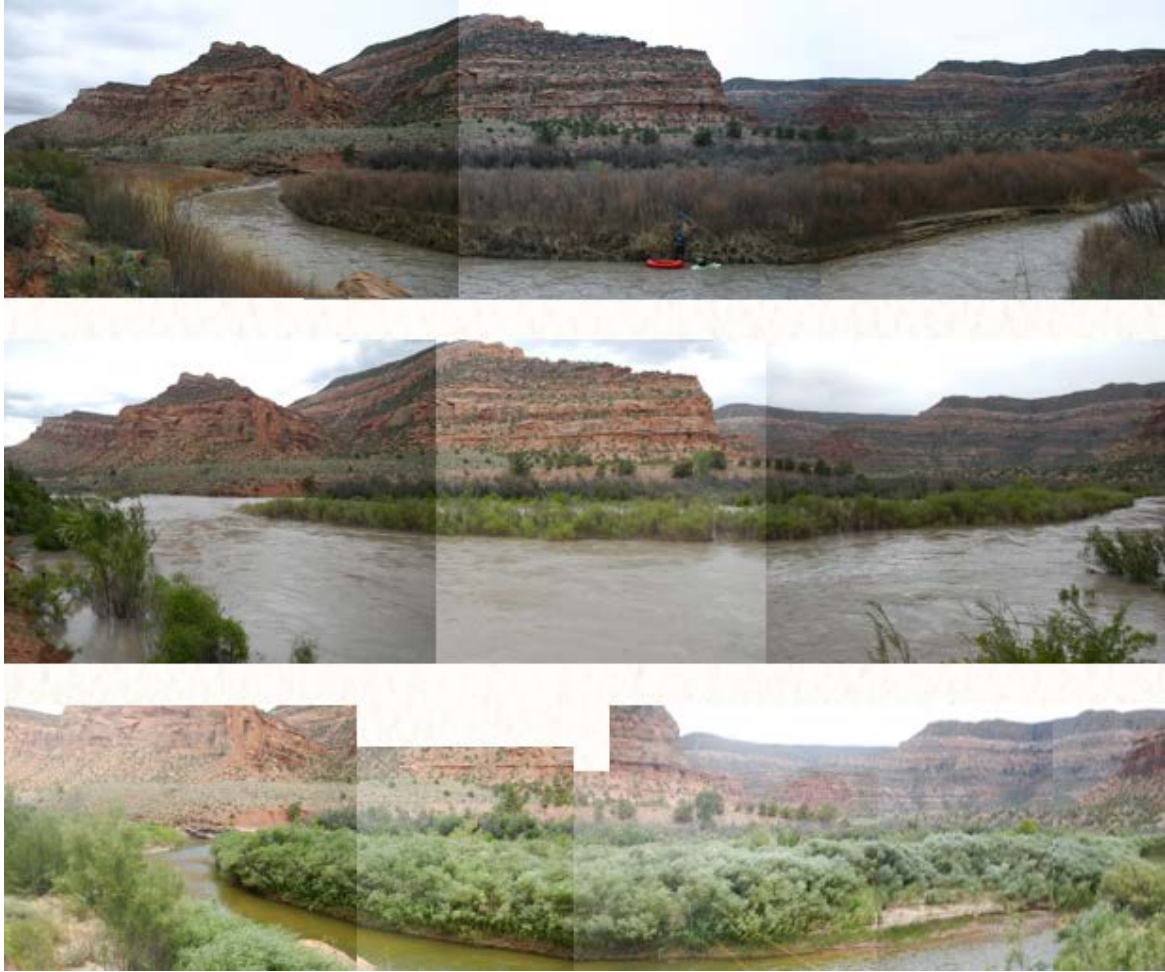
Figure 35. Overview of Bedrock site pre-release (3/23/17; top), peak-release (5/6/17; middle), and post-release (7/7/17; bottom).

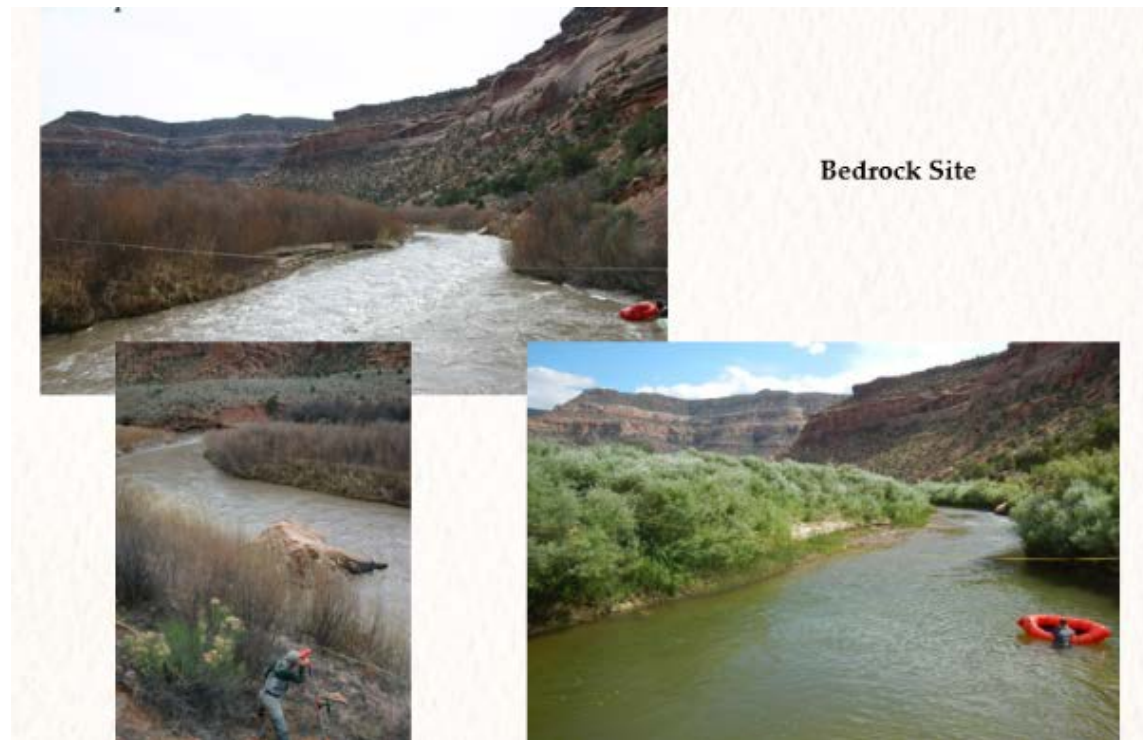
Figure 36. Bedrock Site, showing area of cross-section survey in March (top), and in July 2017 (right).

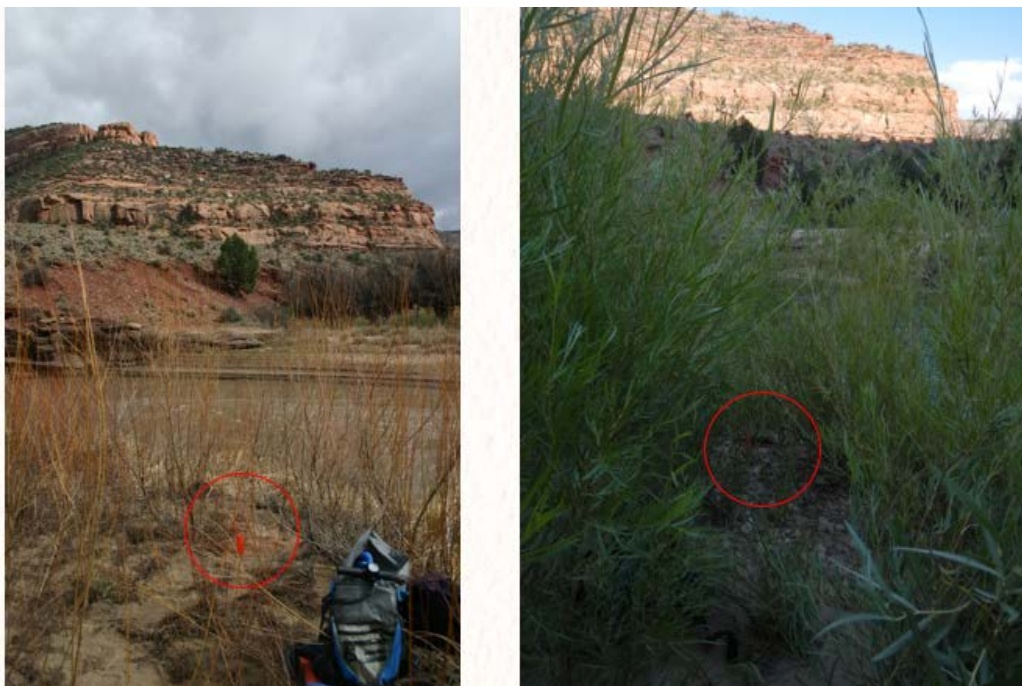
Figure 38. Bedrock erosion stake monitoring, Stake #1 (closest to the water) pre-release (3/23/17, left) and post-release (7/8/17; right). Note scour of sediment.

At the Bedrock site there was not much change in the channel but some scour did occur (Figure 37 and 38). Deposition of material occurred on the right bank (Figure 39). An estimated 260 tons of material at this site was eroded and released into the river (based on bank loss calculations). There was good mobilization of material. Riffle habitat was reset, and water accessed the floodplain (Figure 40).

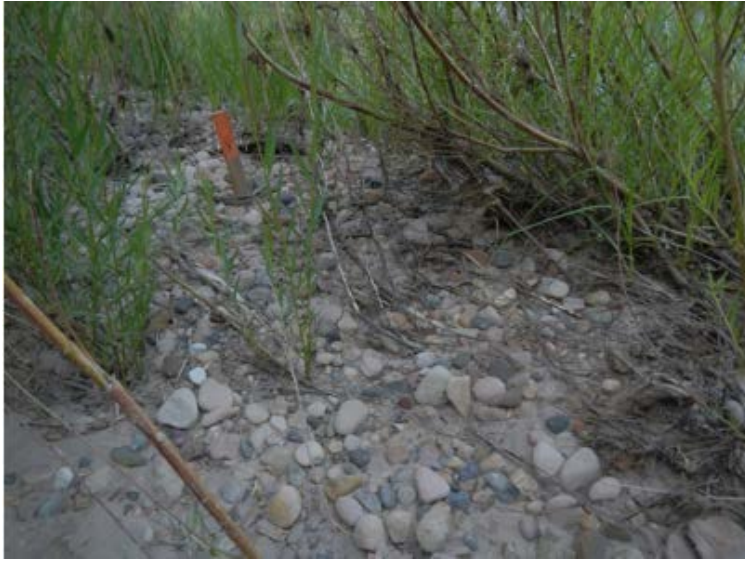
Figure 39. Bedrock erosion stake monitoring, a close-up view of stake #1 post-release. The bare wood below the blaze orange is the depth of scour.

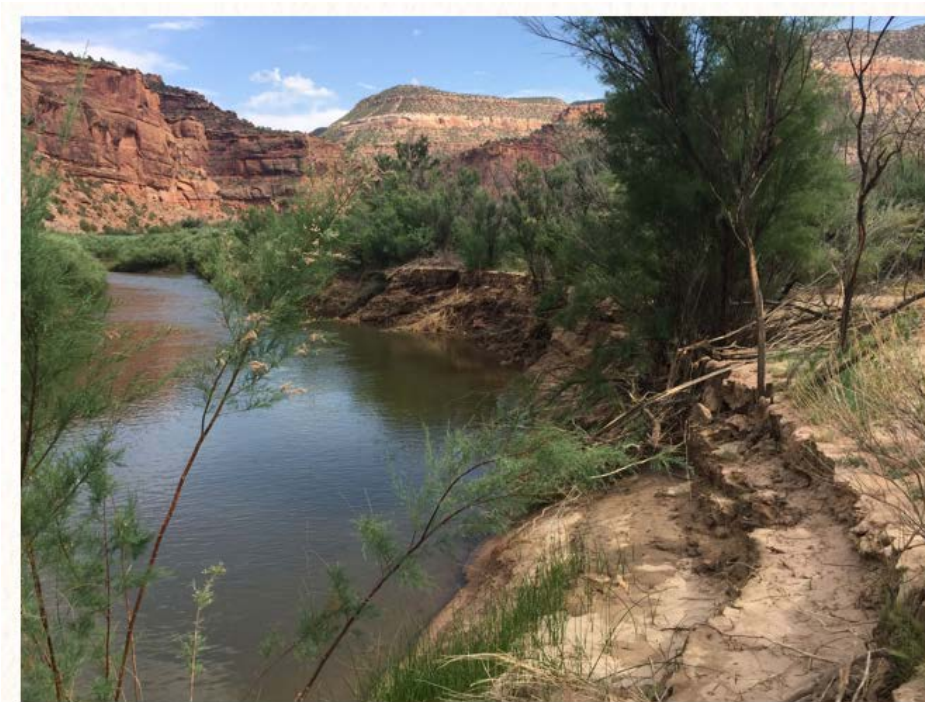
- Bank Erosion (Extreme)**
- Study bank height—5.5'
 - Bankfull height—3'
 - Root depth—8"
 - Bank length—125'
 - Root density—5%
 - Bank angle—80°
 - Surface protection—2%
 - Bank material—Silt

**Estimated Material = 260
TONS, or about 13
truckloads**

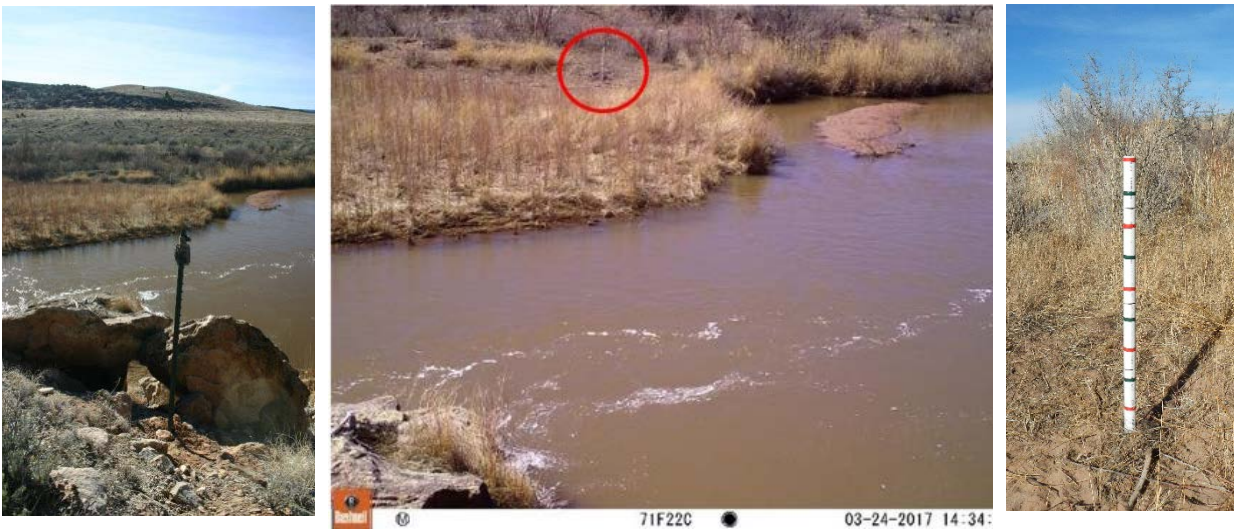
Figure 43. Installation of staff gage and wildlife camera at the Slickrock Upstream site in March 2017. From left to right: installed camera, shot from camera at time of installation (staff gage circled in red), and staff gage close-up (post-release).

Wildlife cameras and staff gages were installed at each of the five new ecological monitoring sites between March 20-24, 2017 to capture important changes in river flow stage height prior to, during, and after the 2017 McPhee Reservoir managed release (see Figure 43 for example). One Bushnell wildlife camera and one staff gage were installed at each site, with the exception of the Dove Creek site, where two staff gages were installed. Wildlife cameras were attached to stable objects or installed posts to capture images at regular intervals of the staff gages. Staff gages were typically installed across the river (on the opposite river bank) from the location of the wildlife cameras, with one exception (Dove Creek Pumps). All staff gage locations were benchmarked to the local datum, so that data could be correlated with other flow and survey data. For detailed information on locations and installation information of the wildlife cameras and staff gages, see *Appendix 3: Ecological Monitoring Sites – Staff Gage and Wildlife Camera Installation*.

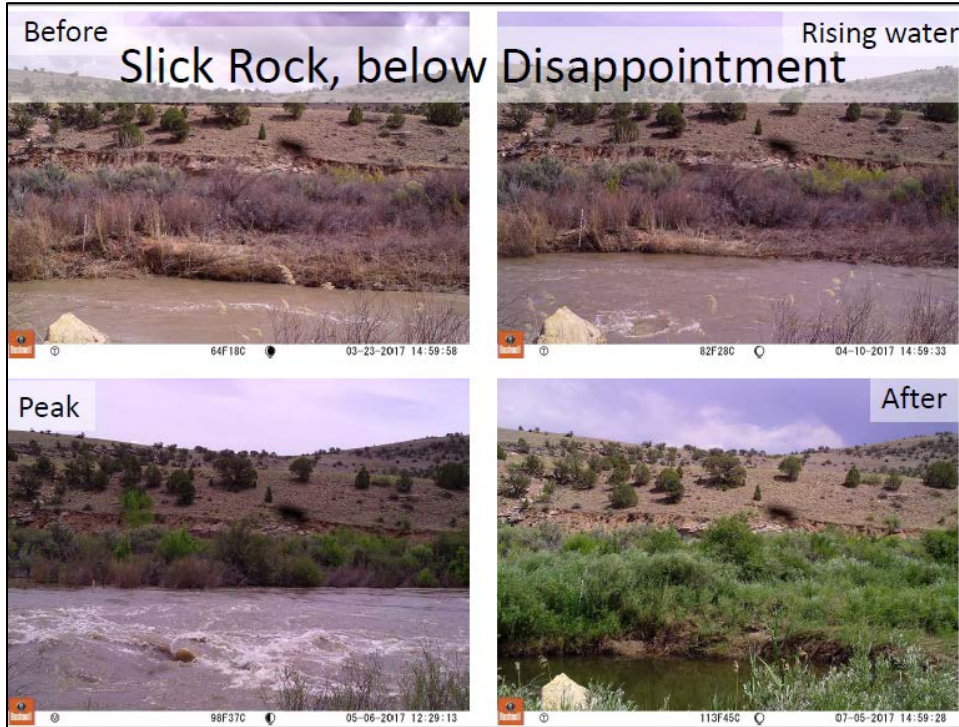
Figure 45. Slickrock Downstream staff gage at pre-release, rising water, peak-release, and post-release.

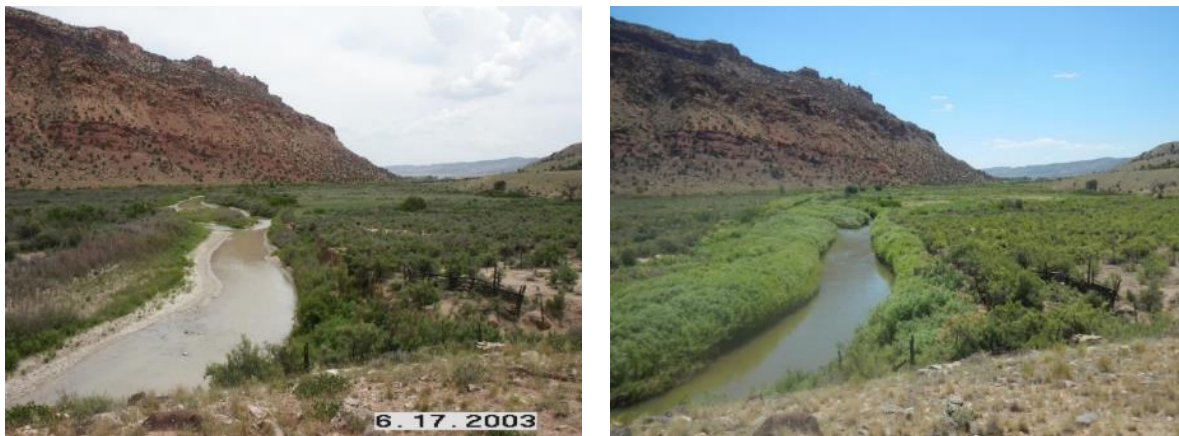
Figure 57. Historic Big Gypsum Photo Point #2 taken in 2003 (6/17/03; top) and 2017 (6/26/17; bottom). Note substantial increase in willow along bank. It should be noted that flows are higher in 2017, so some difference in photos is due to this.

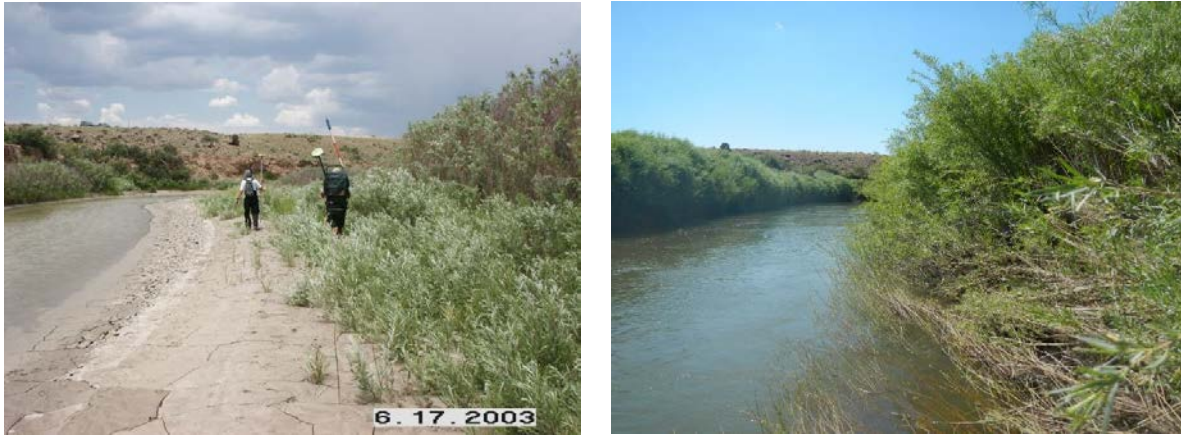
Figure 58. Historic Big Gypsum Photo Point #6 taken in 2003 (6/17/03; top) and 2017 (6/26/17; bottom). Notice how willow has filled in the bank over time. As above, it is important to note that flows are higher in 2017, so some of the observed difference is due to this.
