Lower Dolores River
2017 McPhee Reservoir
Managed Release
Ecological Monitoring & Evaluation

Volume 1: Summary
February 2018

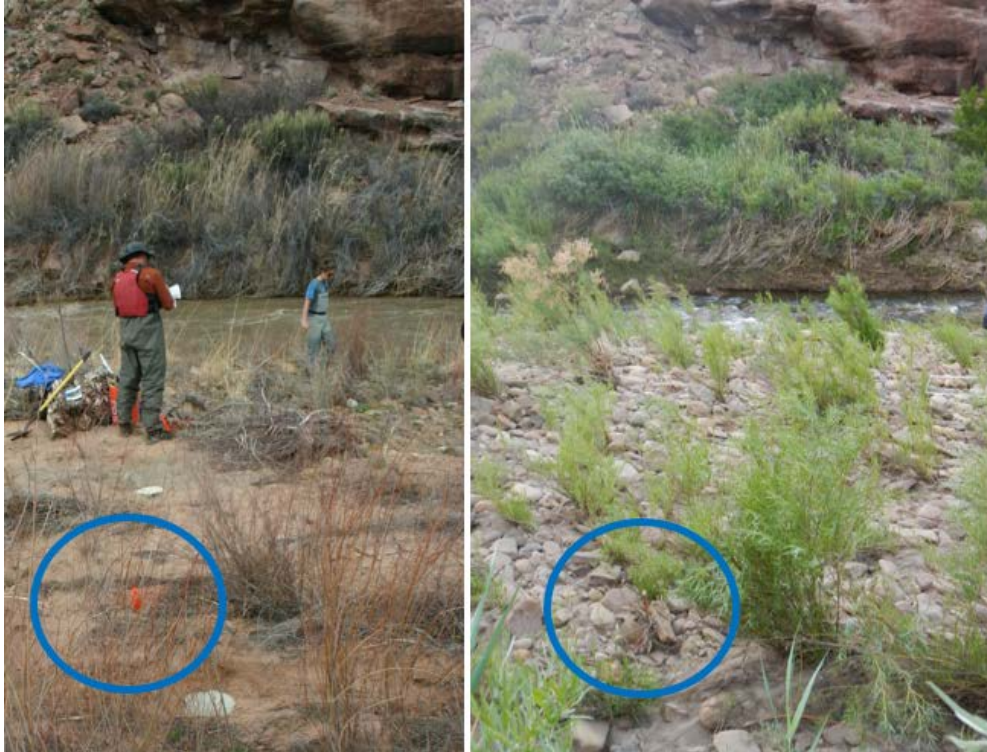
Figure 59. Erosion stakes at Slickrock Downstream (Below Disappointment Creek) Site; close-up of sediment scouring (taken from river left, standing on bar), pre-release 3/22/17 on left, post-release 7/6/17 on right. Note the scouring that has taken place pre- versus post-release.

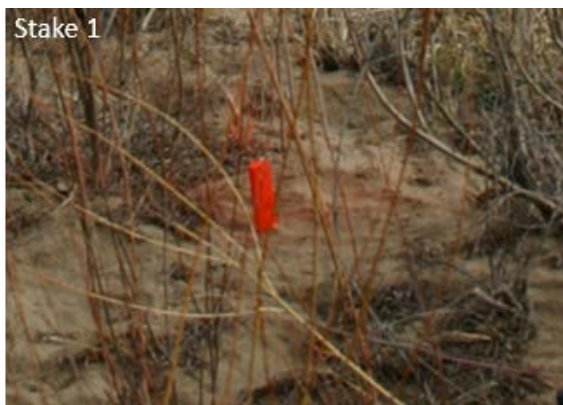
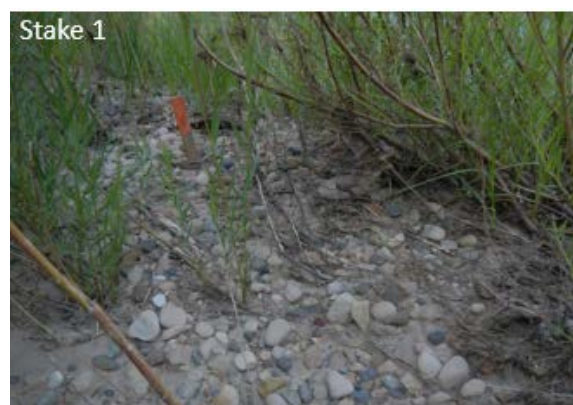
Figure 60. Point bar at Bedrock Site, close-up of sediment scouring (Erosion stake #1, river left), pre-release 3/23/17 on left, and post-release 7/8/17 on right.

At the Slickrock Downstream Site, we observed noticeable evidence of scour in the survey area (Figure 59). We also observed evidence of scour at the Bedrock Site (Figure 60).

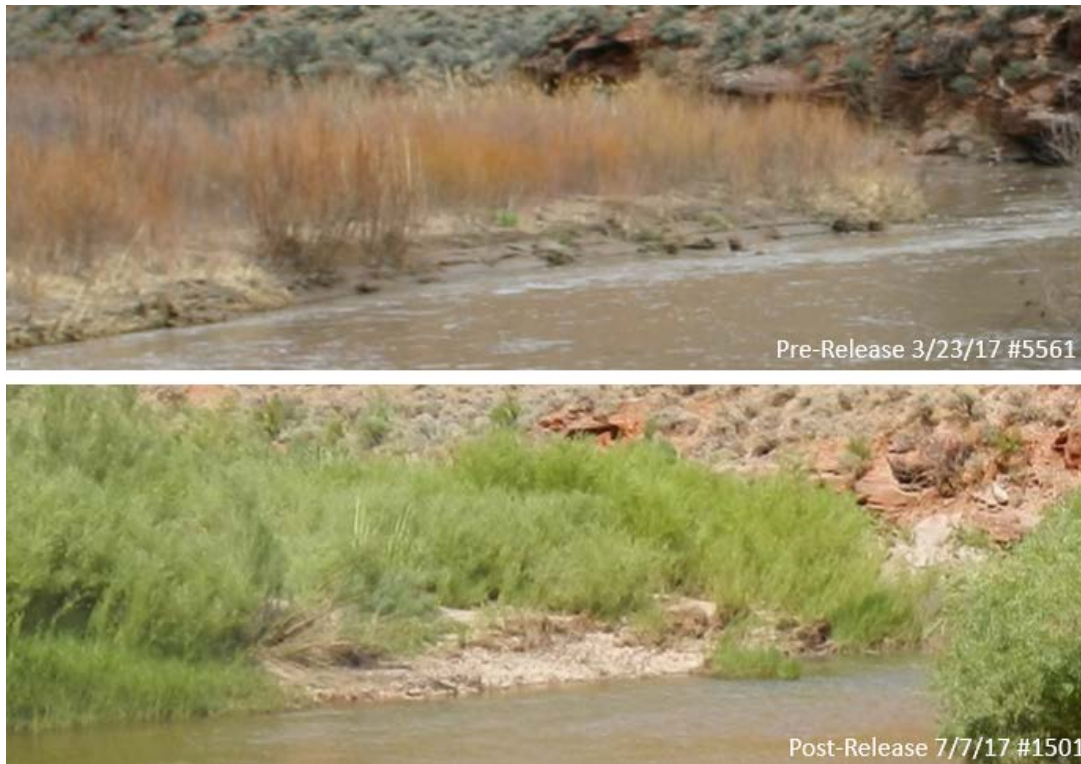
Figure 61. Point bar at Bedrock Site, upstream view of some bank/sediment scouring in same general area as above photo set (taken from river left). Photo at top pre-release (3/23/17; #5561); photo at bottom post-release (7/7/17; #1501).

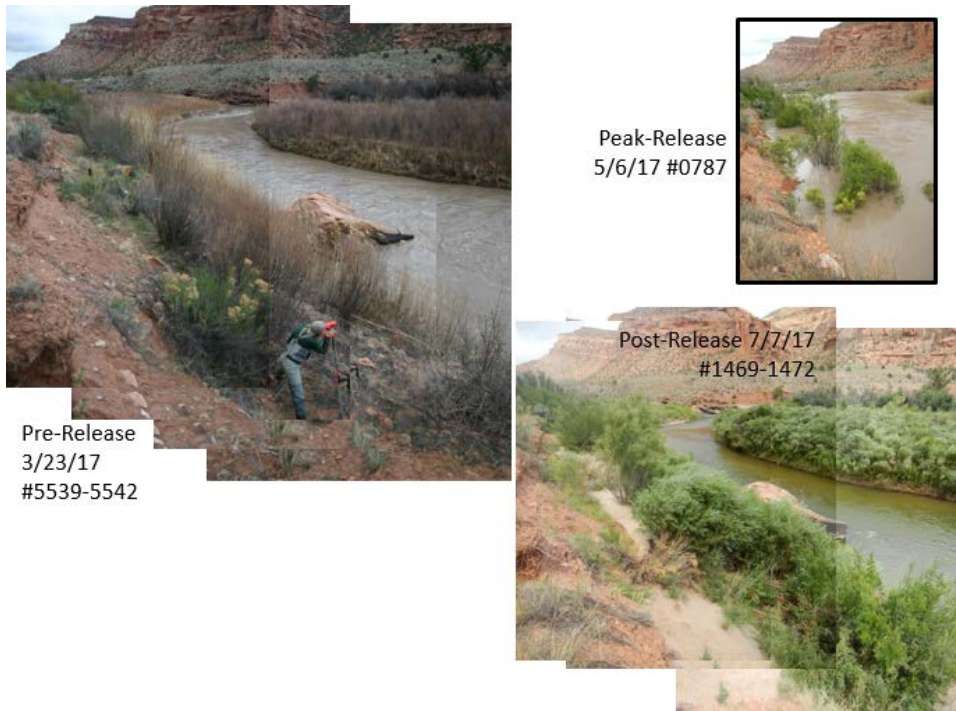
Figure 62. New sediment accumulation at main Bedrock Site, high on river bank Photos taken from river left, looking downstream, at pre-release (3/23/17), peak-release (5/6/17), and post-release (7/7/17).

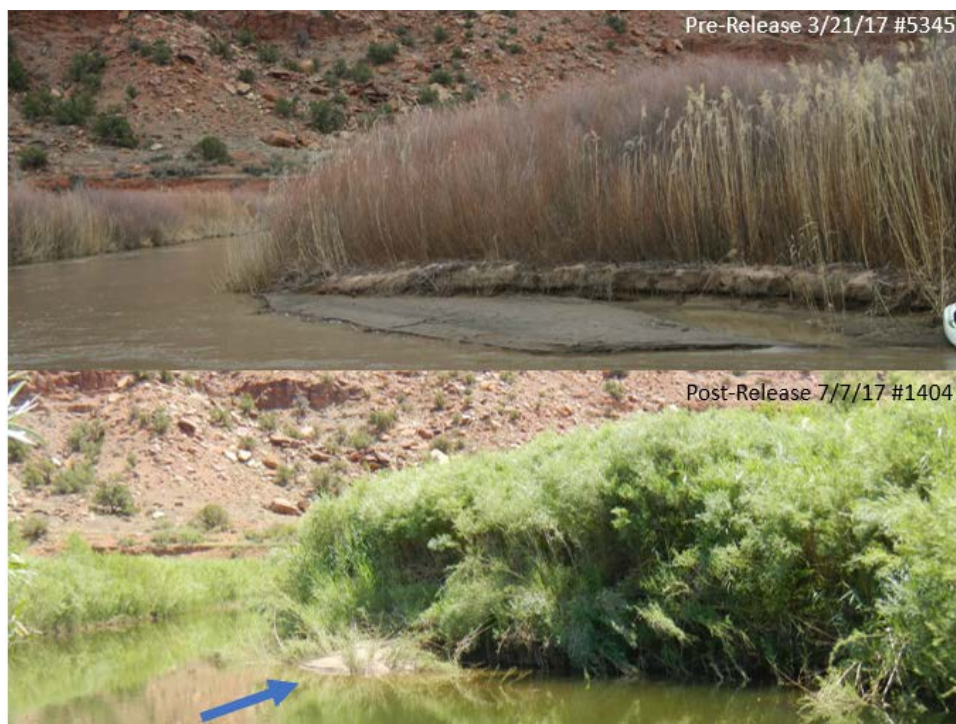
Figure 63. Young willow quickly colonizing recently bare ground at the BLM Rec (Big Gypsum) site post-release, indicated by blue arrow. Photos taken pre-release (3/21/17; top) and post-release (7/7/17; bottom) from river left, looking downstream.

In other areas where new sediment was deposited to create new bare areas lower on the river bank/floodplain (closer to rivers' edge), both willow and Phragmites (*Phragmites australis*) were observed to quickly colonize (or re-colonize) these bare areas. See Figure 63 below for an example of young willow colonization at the BLM Rec (Big Gypsum) Site. Also see the next subsection for evidence of Phragmites colonization of newly bare areas (resulting both from scour, and from new sediment deposition).

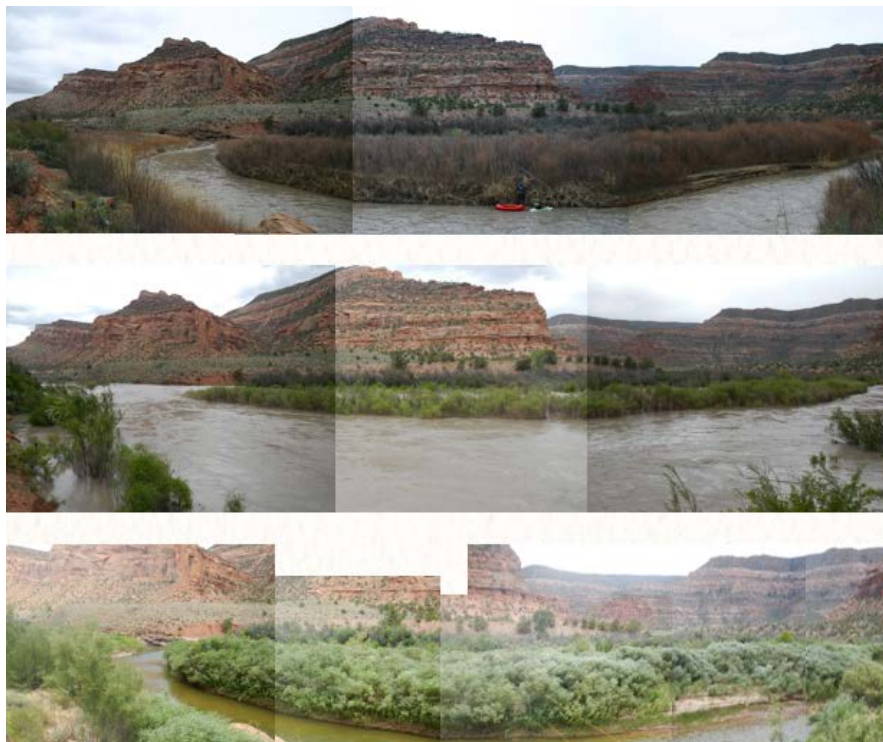
Figure 64. Thick willow armor bank at main Bedrock Site, with photo series appearing to show little noticeable change in willow density with flooding. Photos taken from river left pre-release (3/23/17; top), peak-release (5/6/17; middle), and post-release (7/7/17; bottom).

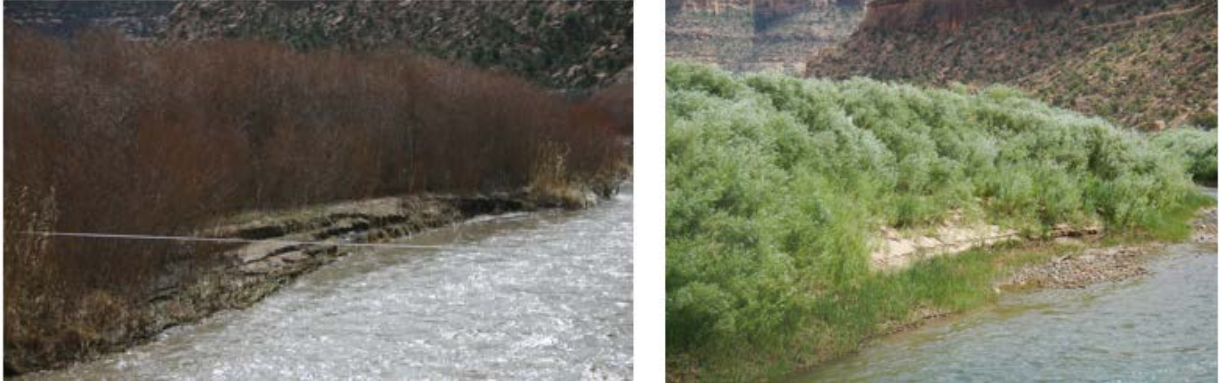
Figure 65. Close-up of upstream portion of above photo series at main Bedrock Site, appearing to show little noticeable change in willow density with flooding (taken from river left). Pre-release on left (3/23/17), post-release on right (7/7/17).

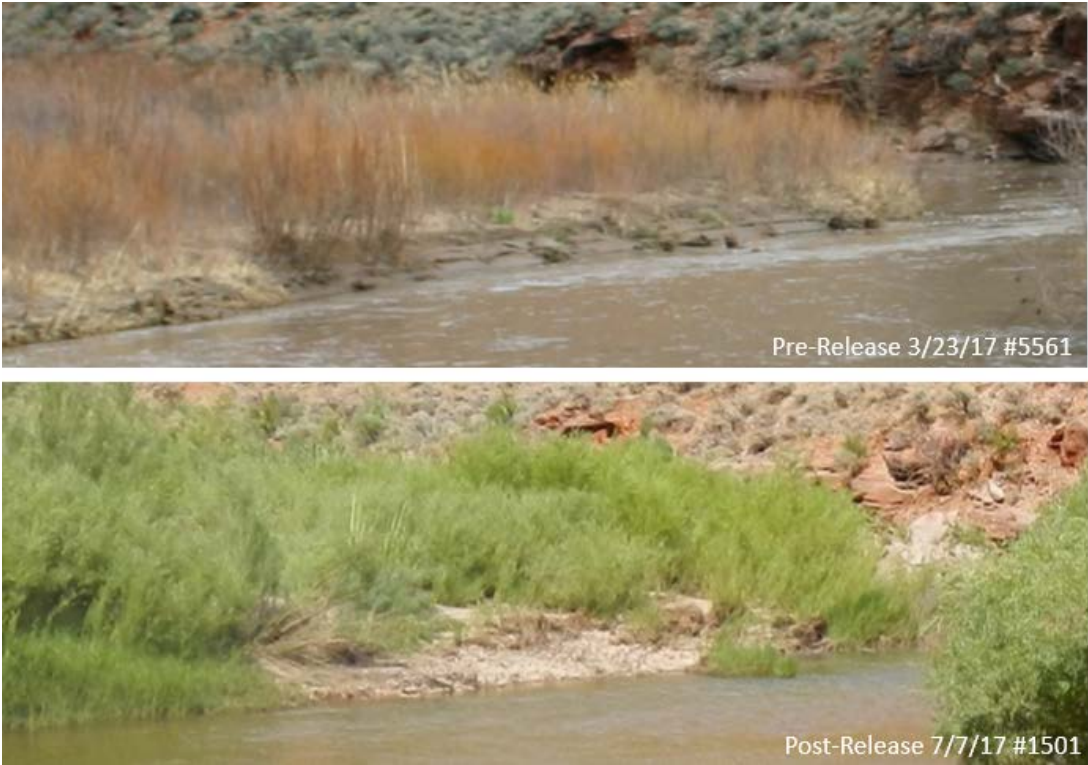
Figure 66. Point bar at Bedrock Site, upstream view of area that saw a small amount of removal of willow with flooding (taken from river left).

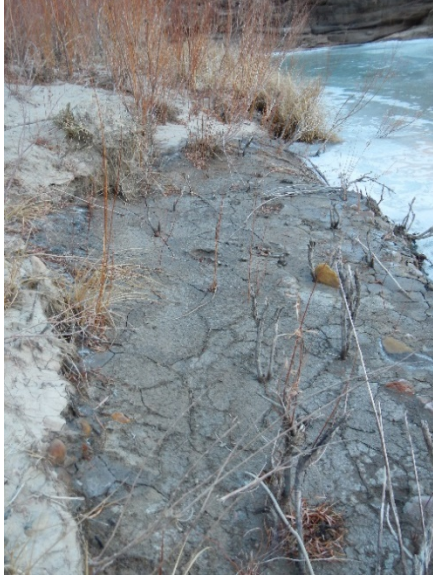
Figure 67. Close-up of point bar at Bedrock Site that saw some removal of willow with flooding (taken standing on bar). However, it appears that regrowth of willow is occurring from remaining willow stumps. 12/29/17, #1972

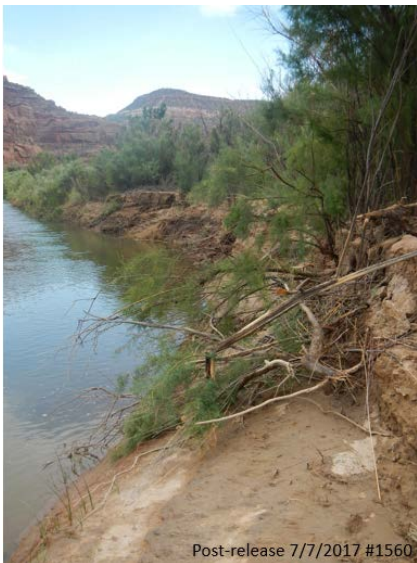
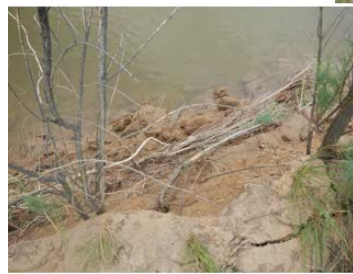
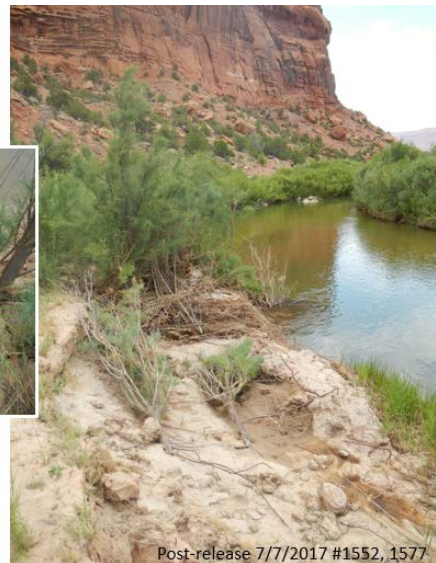
Figure 68. At site just upstream from main Bedrock site; tamarisk loss with bank erosion. Photos taken from river left, post-release (7/7/17).

Just upstream of the main Bedrock Site, however, a separate monitoring site was established. At this site, some limited loss of 'armoring' vegetation (tamarisk) along the river bank was observed (see below photos).

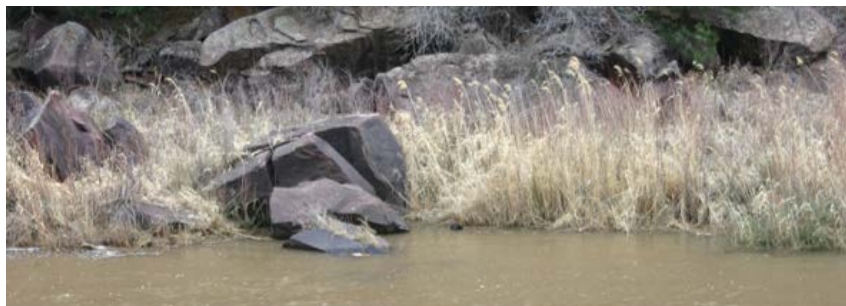
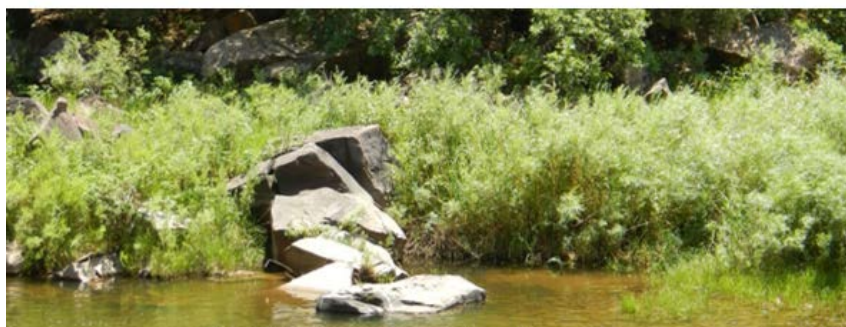
Figure 69. Phragmites population (mixed with willow) at the Dove Creek site, pre- versus post-release 2017 (taken from river left). Pre-release at top (3/20/17), post-release at bottom (7/8/17).

An existing Phragmites population (mixed with willow) at the Dove Creek site did not appear to change noticeably in photos taken pre- versus post-release 2017; or if some Phragmites was removed willow may have filled in the above ground gaps (Figure 69).

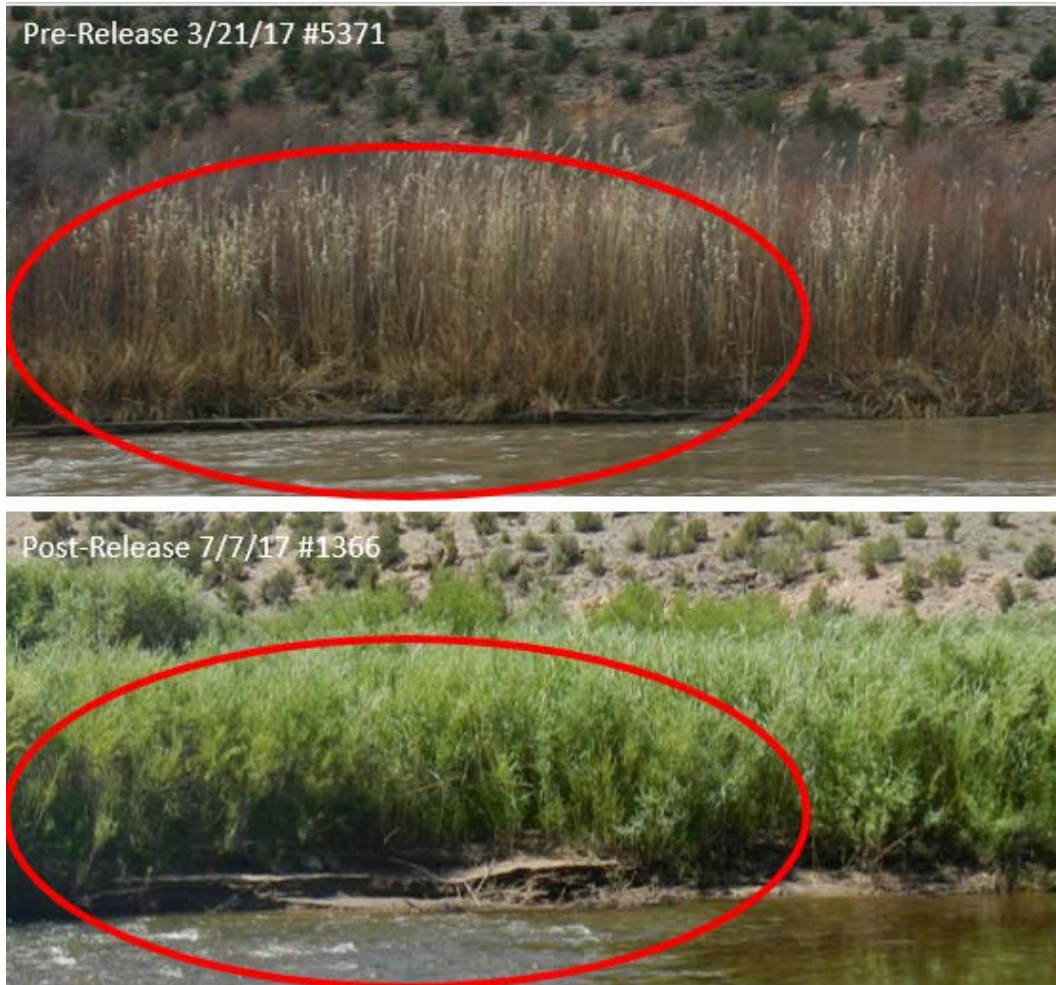
Figure 70. Phragmites population (mixed with willow) at the BLM Rec (Big Gypsum) site, pre-release (3/21/17) versus post-release (7/7/17), taken from river left.

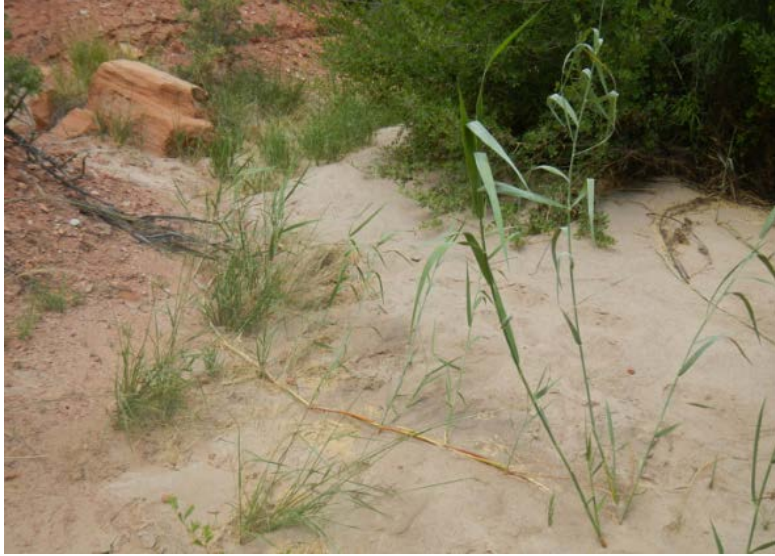
Figure 71. New sediment accumulation at main Bedrock Site, with partially buried Phragmites quickly sending out new runner (stolon) to recolonize new bare area (photo taken from/on river left bank). Post-release 7/7/17, #1536.

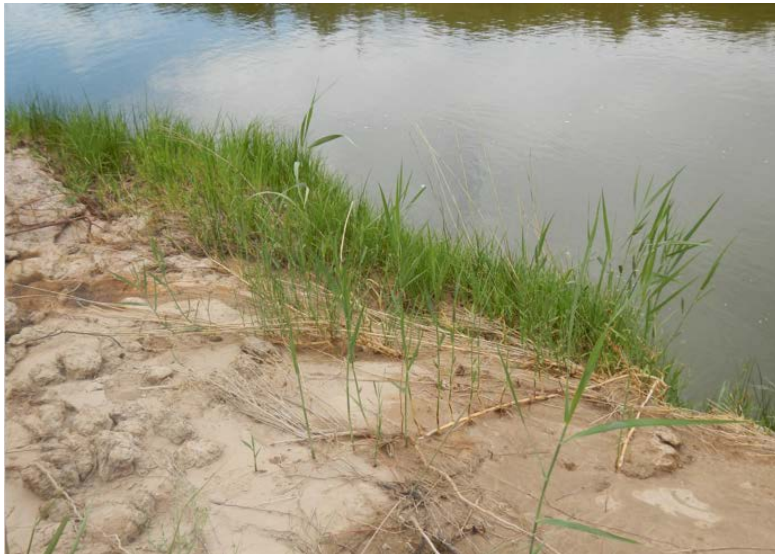
Figure 72. Bank erosion at monitoring site just upstream from main Bedrock Site, with Phragmites runners quickly climbing the bank to recolonize new bare area (photo taken from/on river left bank). Post-release 7/7/17, #1559.

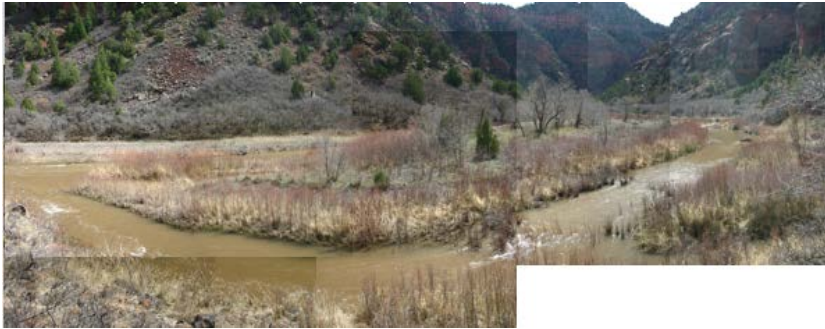
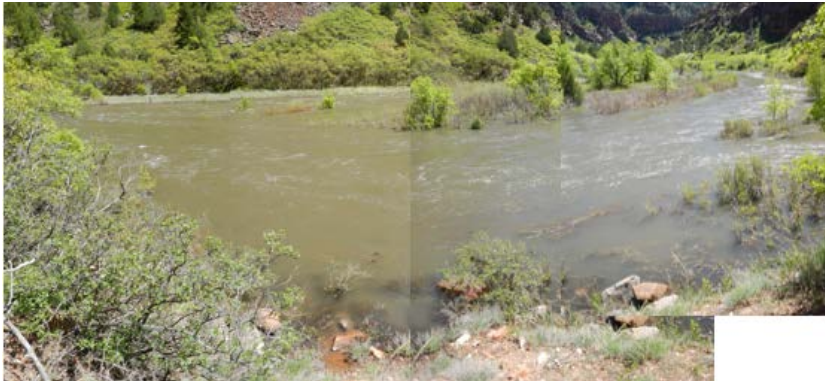
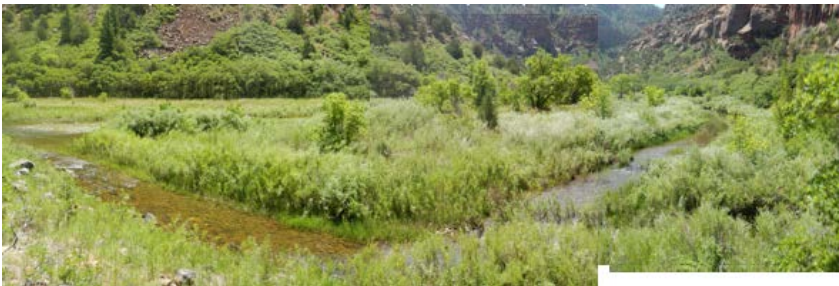
Figure 73. 2017 pre (3/20/17), peak (5/5/17), and post-release (7/8/17) photo series of island just upstream of Dove Creek site (taken from river left).

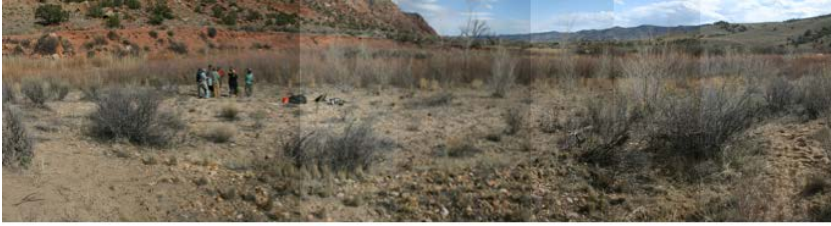
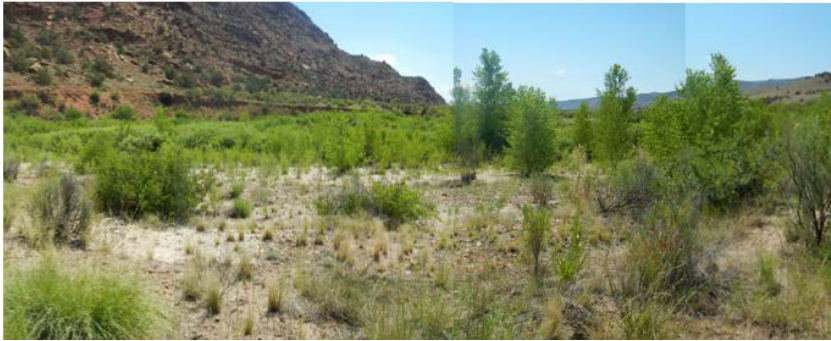
Figure 74. 2017 pre-release (3/21/17, top) and post-release (7/7/17, bottom) photo series of point bar at the BLM Rec (Big Gypsum) site.

A large point bar at the BLM Rec (Big Gypsum) site also appears to be currently maintaining primarily riparian and mesic species (Figure 74). The point bar was mostly flooded at peak release in 2017.

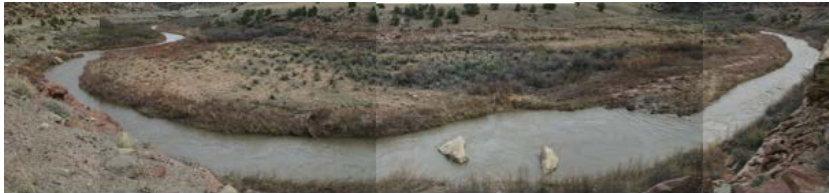
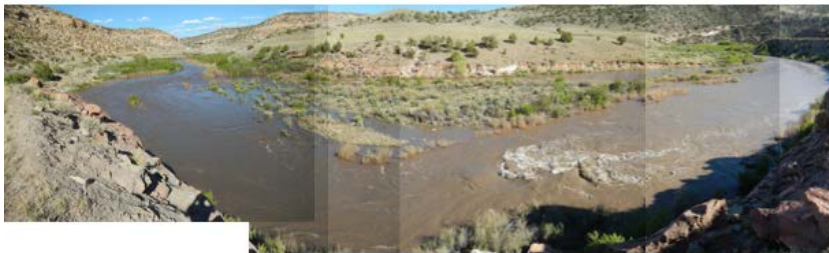
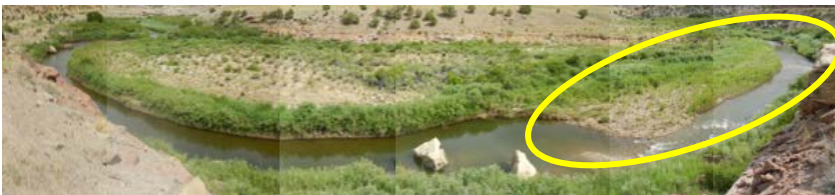
Figure 75. Slickrock Downstream (Below Disappointment Creek) Site pre-release (3/22/17), peak-release (5/5/17), and post-release (7/6/17). Photos taken from river right.

Another site where it will be interesting to track the changes over time is at the Slickrock Downstream (Below Disappointment Creek) site, where rubber rabbitbrush and other mesic species currently dominate much of what was once an active mid-channel bar. Much of this area was flooded in 2017, but based on photo comparison, there does not appear to be a noticeable reduction in this vegetation because of flooding (Figure 75).

It will also be interesting to watch the focus area of our data collection at this site (circled in yellow above in Figure 75). This area is currently dominated by willow and more riparian species, and we are not currently seeing encroachment of more mesic/xeric species (also see photo series below). However, this area likely sees more regular flooding currently, even without release manipulation.

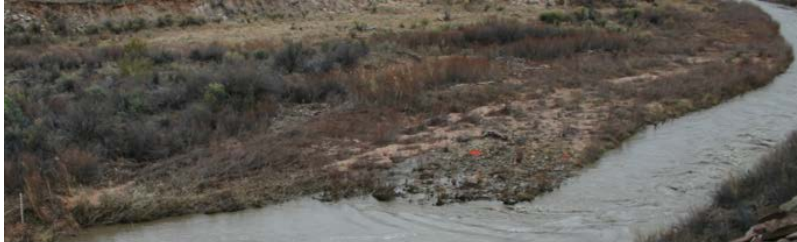
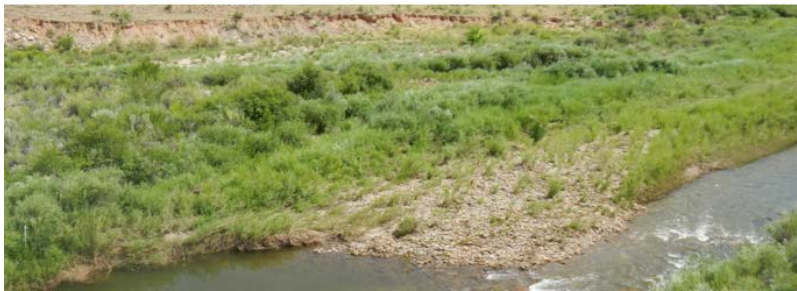
Figure 76. Close-up of survey area at Slickrock Downstream (Below Disappointment Creek) Site taken from river right, pre-release (3/22/17; top) and post-release (7/6/17; bottom).

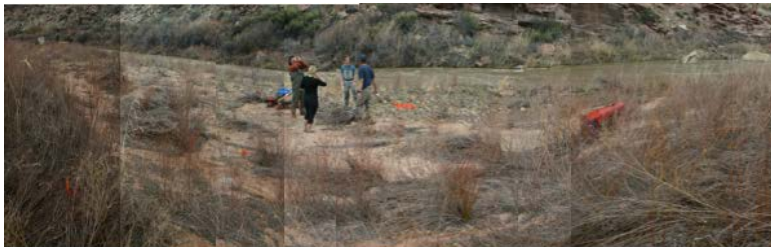
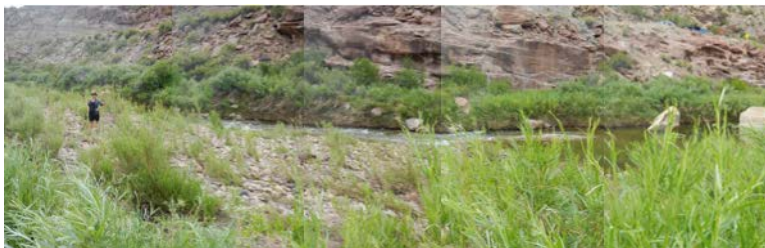
Figure 77. Close-up of survey area at Slickrock Downstream (Below Disappointment Creek) Site, taken from river left standing at edge of survey area, pre-release (3/22/17; top) and post-release (7/6/17).

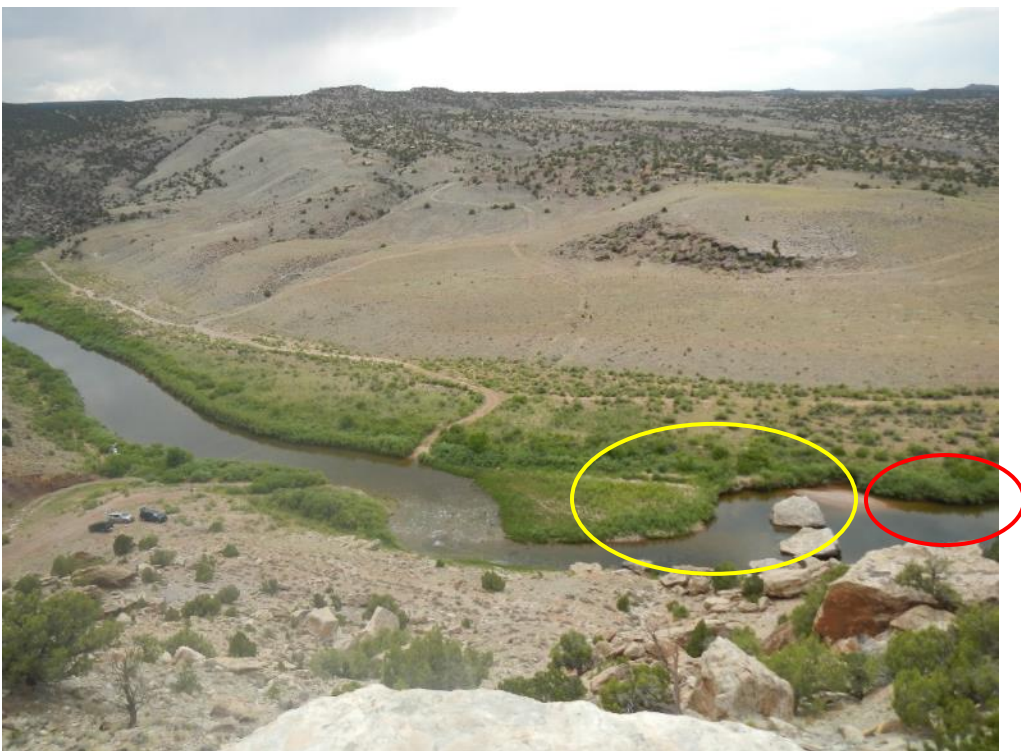
Figure 78. Two cottonwood recruitment survey areas at Slickrock Upstream Site (circled below). Photo from post-release, 7/6/17, #1190.

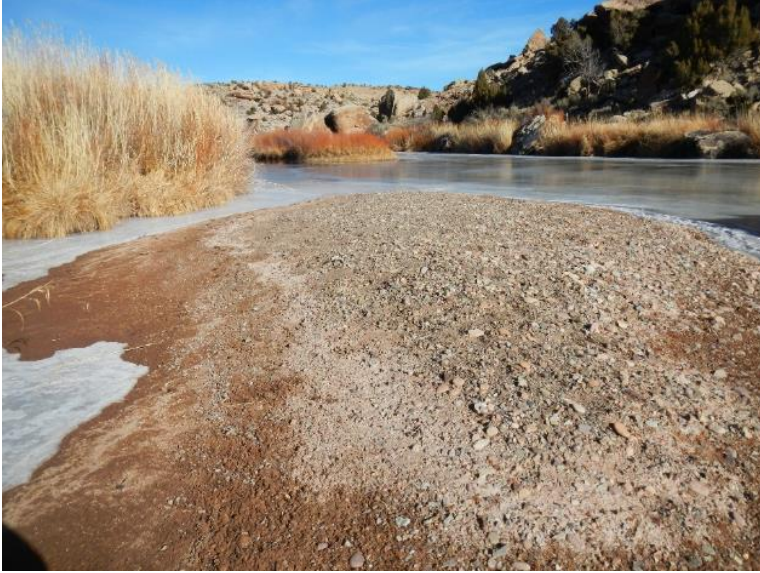
Figure 79. Closeup of new small depositional survey area at Slickrock Upstream Site (circled in red above).
12/29/17, #1897

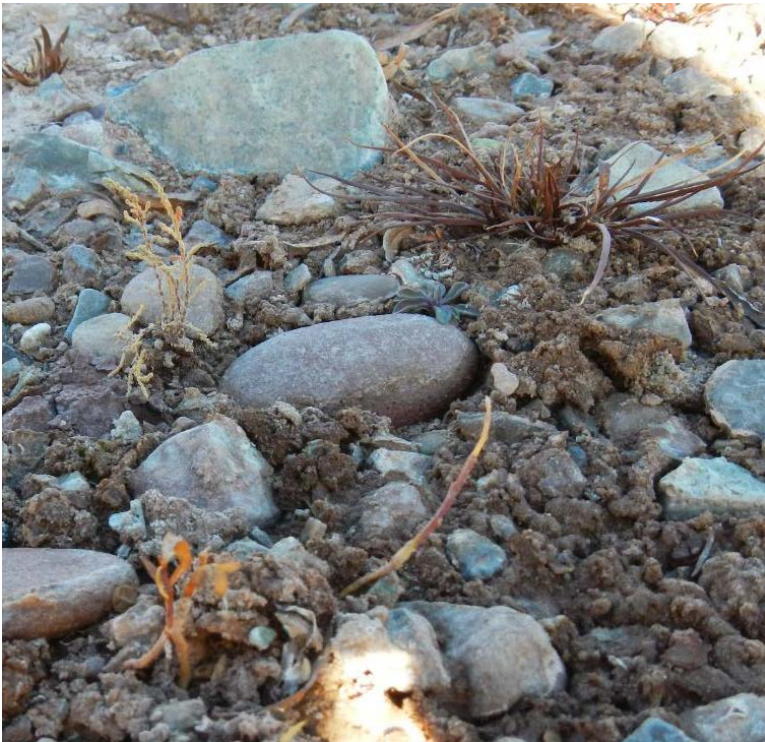
a. Seedlings observed at Slickrock Upstream site, 12/29/17, #1899. Photo is a close-up.

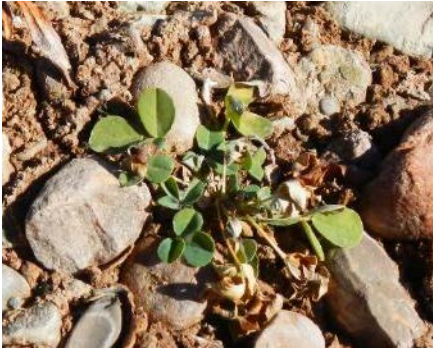
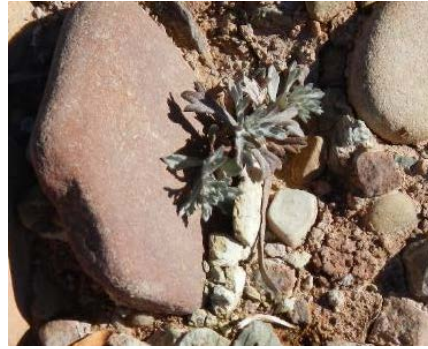
b. and c. Additional seedlings at Slickrock Upstream site. 12/29/17, #1900, and #1901

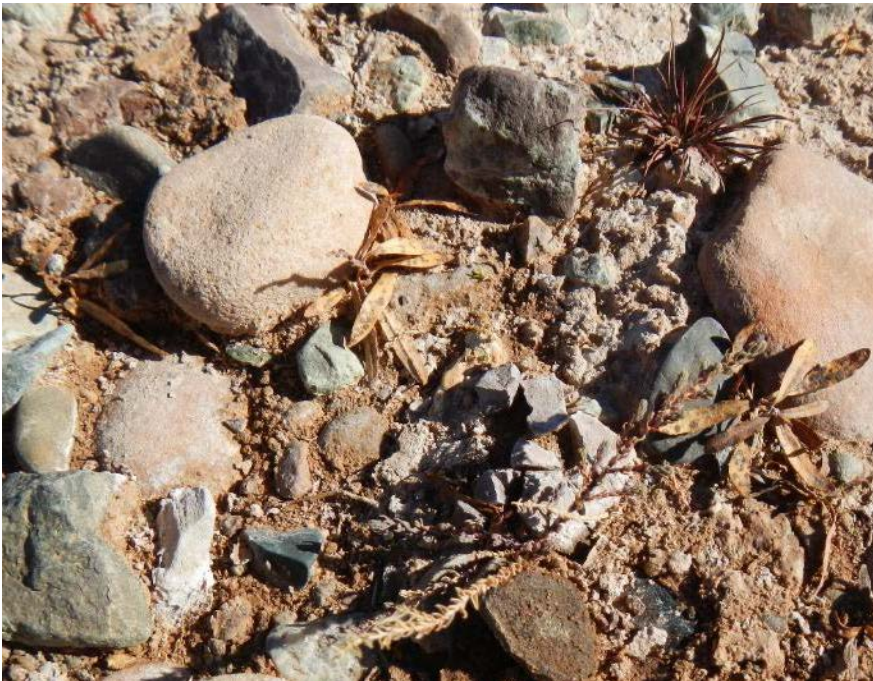
Figure 81. Another closeup of young seedlings found in this Slickrock Upstream survey area. Note numerous willow seedlings. 12/29/17, #1902

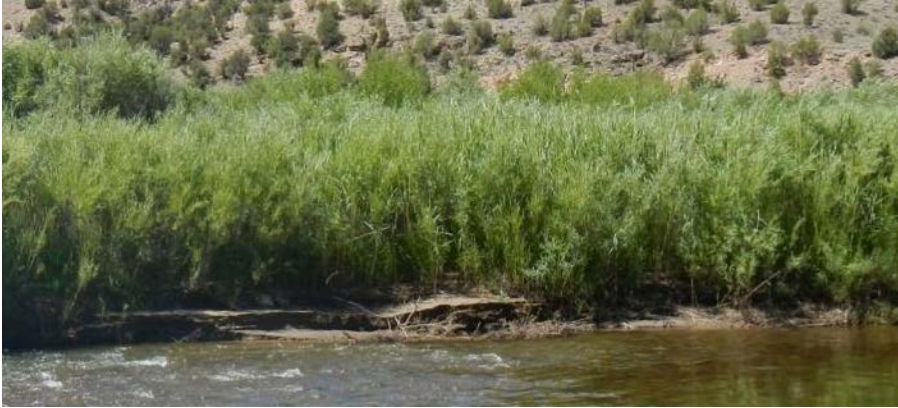
Figure 82. Scoured Phragmites bank survey area at BLM Rec (Big Gypsum) Site, 7/7/17, #1366.

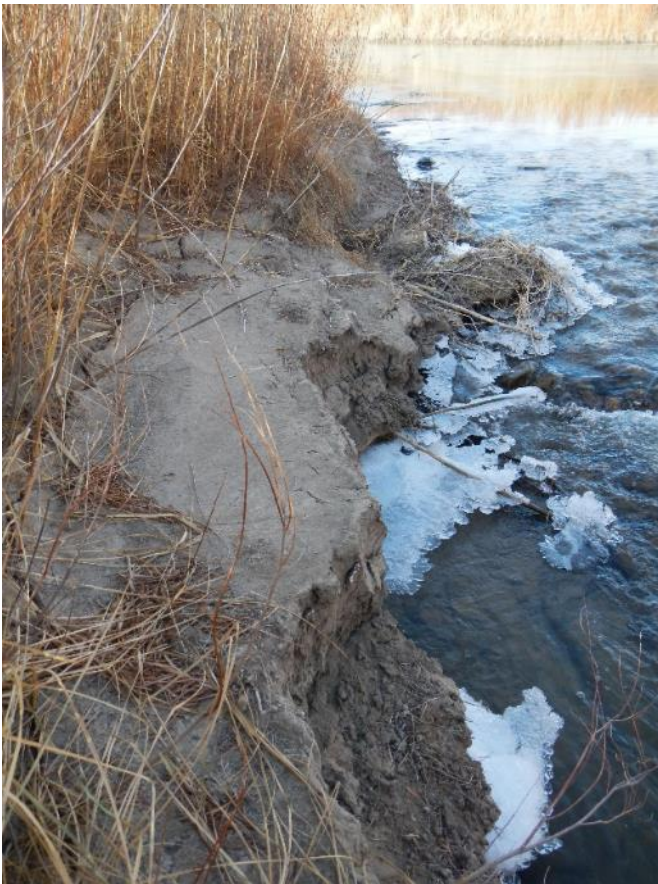
Figure 83. Closeup of scoured Phragmites bank survey area at BLM Rec (Big Gypsum) Site, 12/29/17, #1920. No young seedlings found; only vegetatively spreading Phragmites.

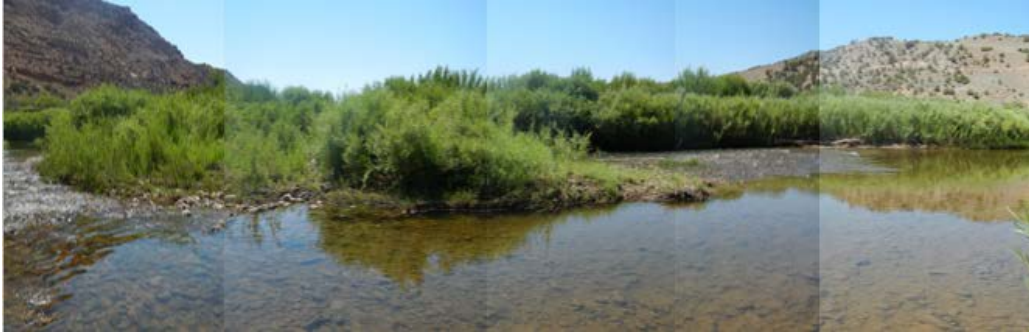
Figure 84. 'The Island' survey area at BLM Rec (Big Gypsum) Site, 7/7/17, #1355-1365 various photos merged.

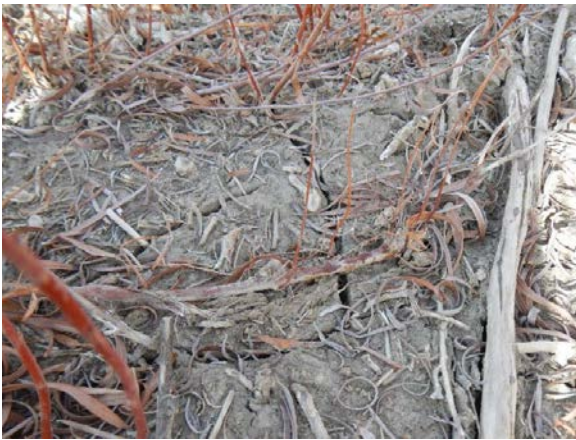
Figure 85. Closeup of willow spreading vegetatively in this area, 12/29/17, #1927.

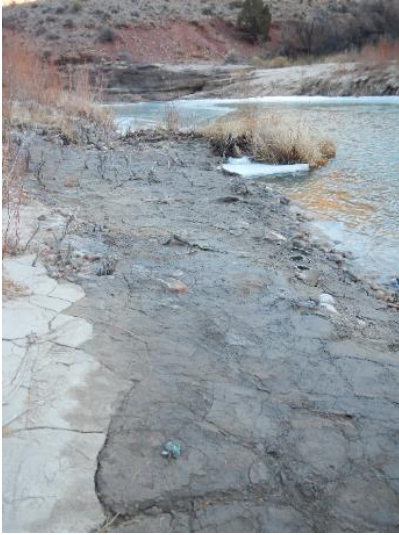
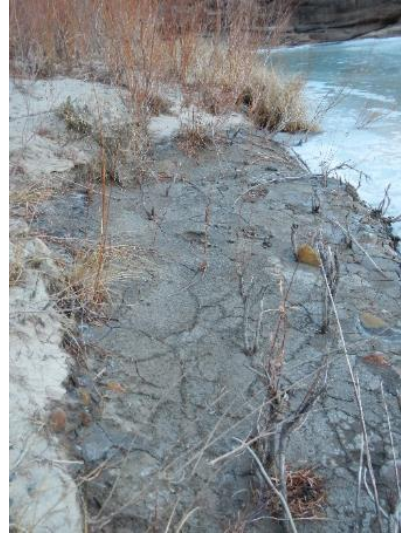
a. One new native seedling in foreground, 12/29/17, #1970

c. Regrowth from willow stumps 12/29/17, #1972

Figure 86 (a-c). Closeup of newly scoured open area (survey area #2) at Bedrock Site.

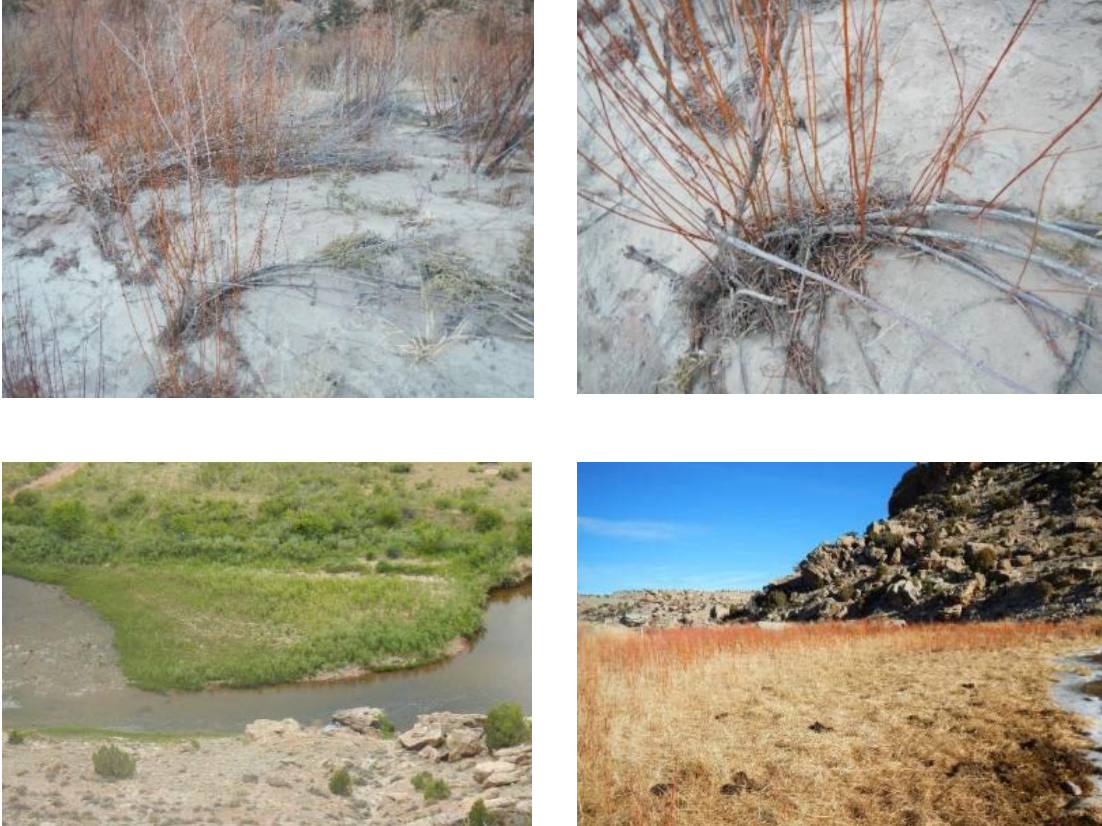
Figure 87 (a-d). Examples of willow and grass spreading into newly scoured/depositional bare areas. Upper right and left photos: willows resprouting at Bedrock Site, 12/29/17, #1978,1979. Lower left: Slickrock Upstream Site diagonal bar post-release, 7/6/17, #1204. Lower right: Slickrock Upstream Site diagonal bar at the end of the growing season, 12/29/17, #1887

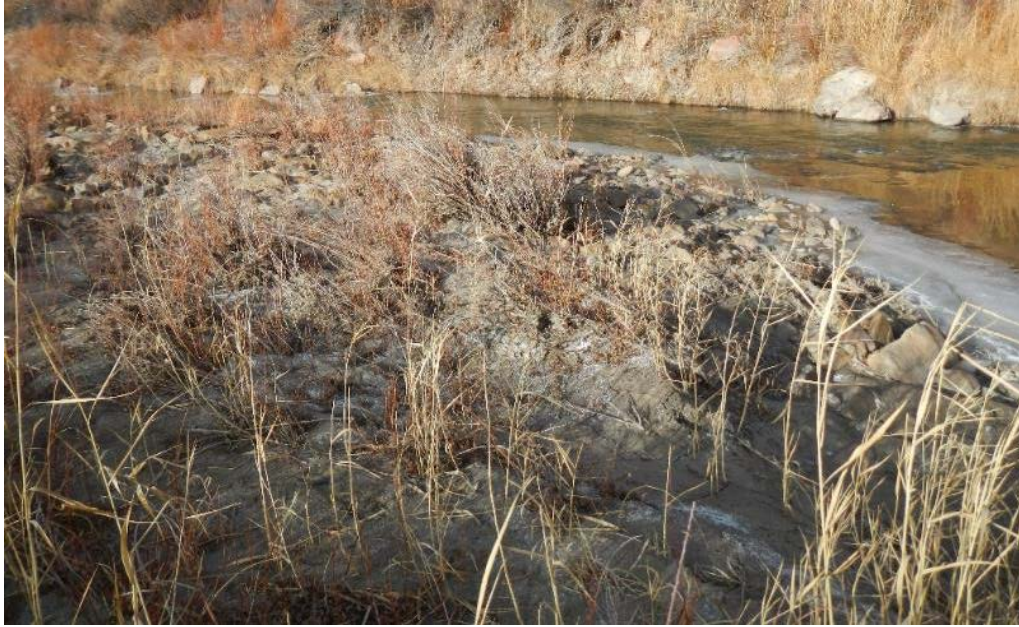
Figure 88. Accumulation of salts (white substance) on soil surface at the Slickrock Downstream site.

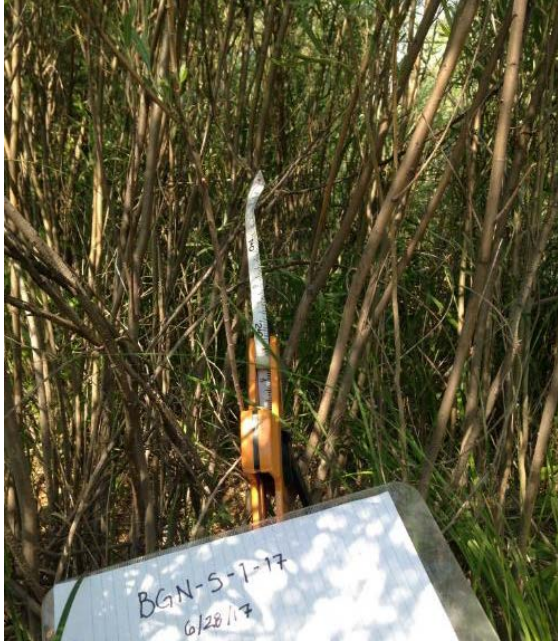
Figure 89. A willow transect along the Dolores River.

In 2010, vegetation transect monitoring occurred at select Slick Rock and Big Gypsum Valley sites along the Dolores River. Select transects were then re-sampled post-release in 2017. Willow stem density was determined in 1-square meter plots evenly spaced along transect lines by conducting counts of willow stems. Percent cover of bare ground versus vegetation litter was also determined.

Analyses of the monitoring of the willow transects found no significant difference in the average willow stem density between 2010 and 2017, indicating that the managed release did not significantly reduce willow stems. There was also no significant difference between sites (Slickrock versus Big Gypsum sites).

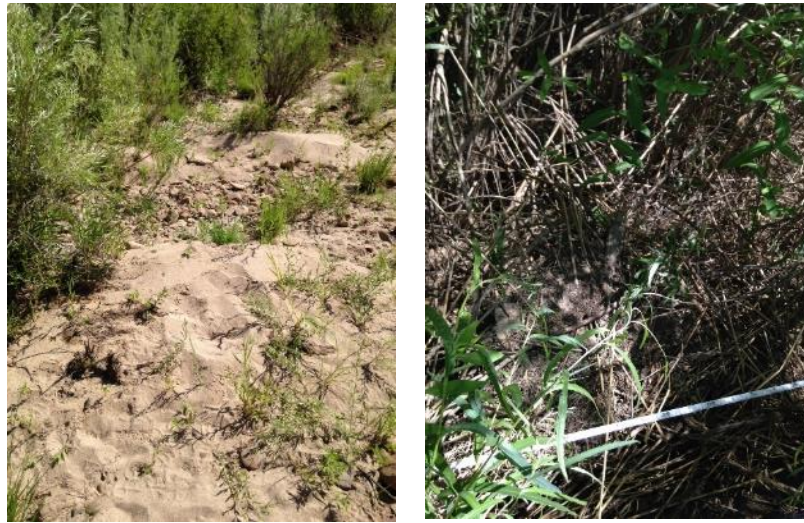
Figure 91. Areas of bare ground encountered during vegetation surveys, 2017.
