APPENDIX E

GEOMORPHOLOGICAL MONITORING REPORT Prepared by Steve Vrooman, Keystone Restoration Ecology September 2013

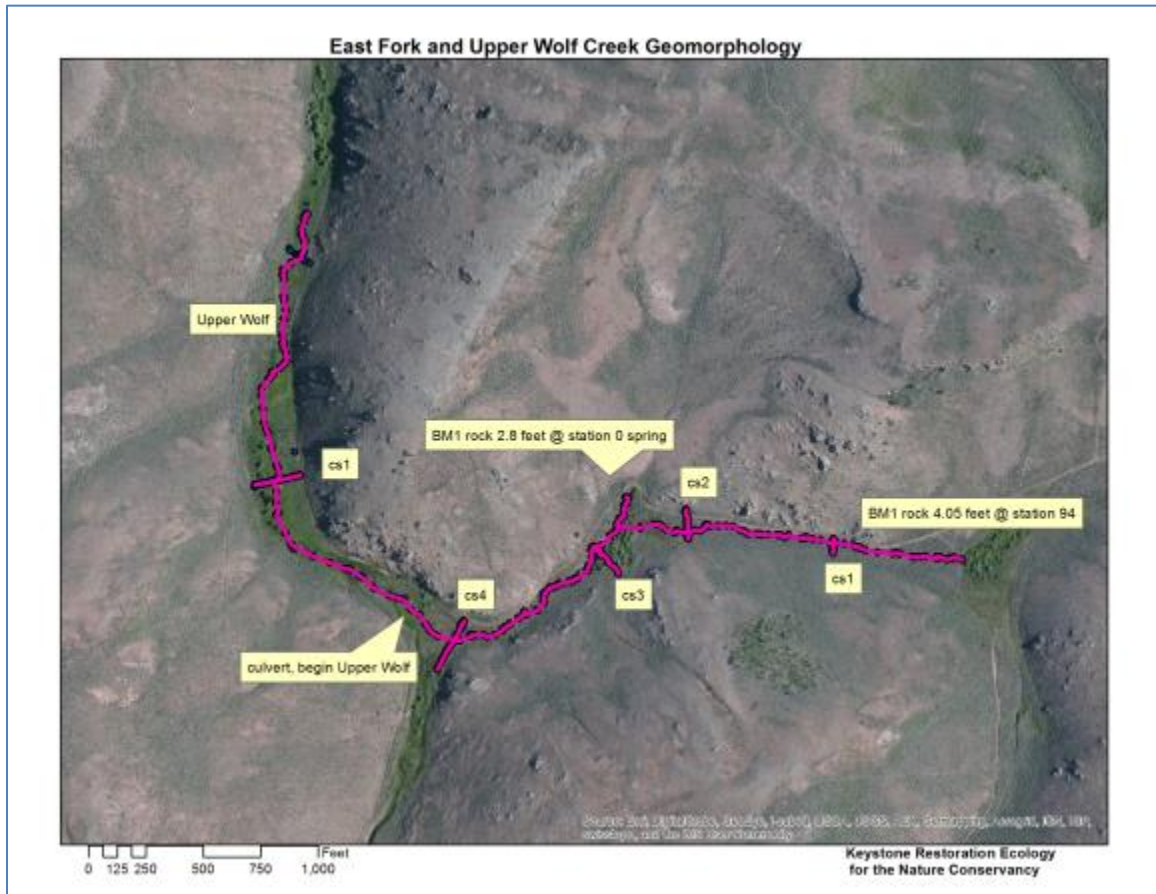
This cross section was taken above the first large “Media Luna” structure in the main channel of Wolf Creek, several hundred feet below the culvert. The water has already been spread across the valley and is not flowing in the lowest channel at station 40. The Media Luna runs from about 85 to 115 on the cross section.
