# A Pictorial Guide to Riparian Changes Following Flow Alteration

## **A pictorial guide to riparian changes following flow alteration**

Thomas Wilding, Colorado State University  
John Sanderson, The Nature Conservancy

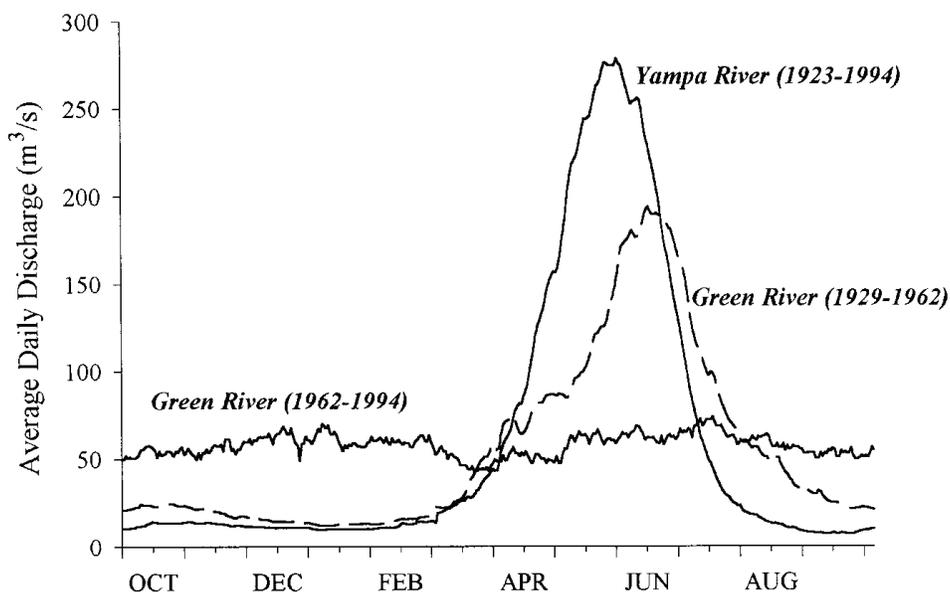
**Figure 1** Typical flows over a water-year (average daily flow, October-September) comparing three sites. The dashed line represents flows for Green River before Flaming Gorge Dam was built – compare that to the post-dam flows for 1962-1994. This graph also shows flows for the unregulated Yampa River. Graph from Merritt and Cooper 2000.

Flaming Gorge reservoir reduced peak-flows, increased the low-flows (Figure 1) and decreased the amount of sediment carried by Green River. As a consequence, the river channel is now less mobile, with little or no active point-bars on the river. These changes are important because cottonwood seedlings take root on active point-bars. We calculated a flow alteration of **-41%** for the Green River (wet year 90 day max at USGS 09234500), placing it in the "High Risk Class" for adult cottonwood and "Very High Risk Class" for cottonwood recruitment (using the flow-ecology methods from the WFET; Wilding and Sanderson 2010).

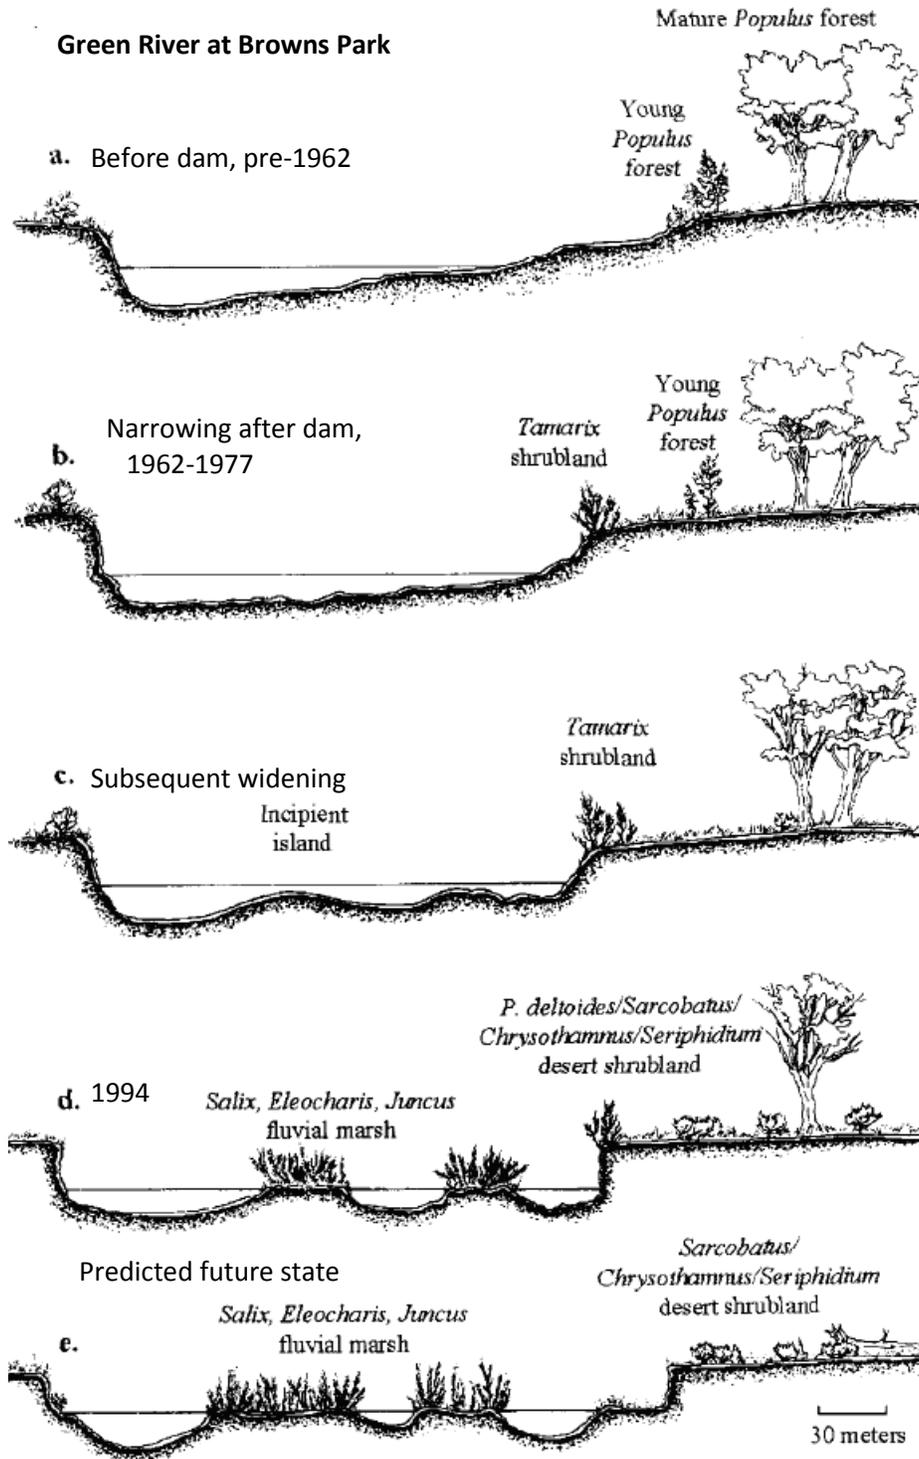
**Figure 2** Changes in channel and vegetation in the Green River at Browns Park, showing typical cross-section before and after construction of Flaming Gorge Dam. From Merritt and Cooper (2000).

This diagram (Figure 2) represents changes in riparian vegetation for the Green River at Brown's Park (sourced from Merritt and Cooper 2000). For 10 years or so after dam construction, the river channel narrowed by 13% allowing young cottonwood and willow to establish in what was an active river bed (Figure 2b). But over the next 20 years (1977-1994) the channel widened and islands formed that were vegetated by wetland herbs and shrubs (Figure 2c & d). Cooper et al. (1999) found that cottonwood seedlings sprouted at Brown's Park, but none survived. Compare that to the unregulated Yampa River (Deerlodge Park) where a small but significant portion survived. There were many other changes in vegetation over time, in addition to reduced cottonwood, with Merritt and Cooper (2000) anticipating that desert shrubland will eventually dominate the area that was riparian forest (e. in Figure 2).

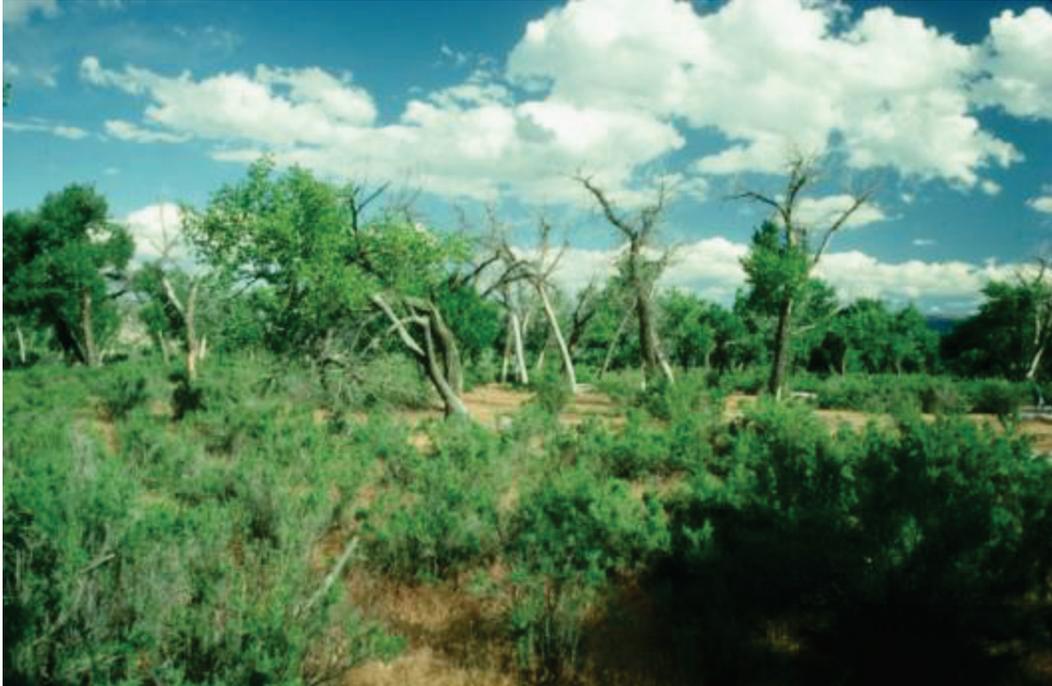
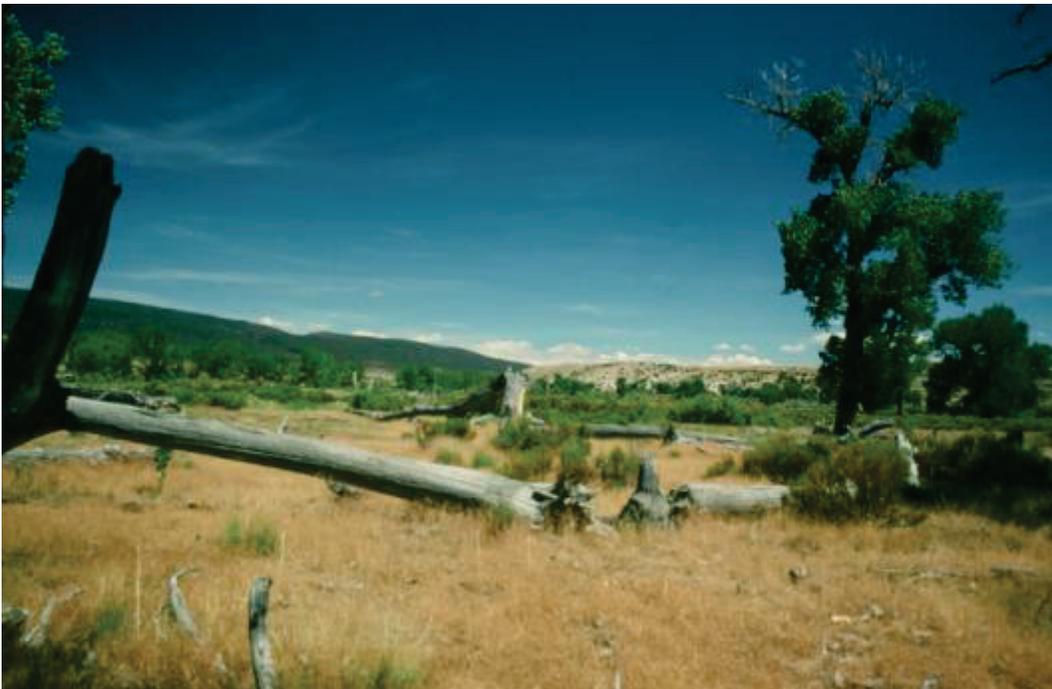
**Figure 3** Green River at Brown's Park after construction of Flaming Gorge Dam. There are no young cottonwood trees and no willows in the understory. Remaining adult cottonwood have "self-pruned" and now have many dead limbs. In the lower photo most cottonwood have died with no young trees to replace them. Dryland vegetation has moved in beneath the cottonwoods. Photos courtesy of David Cooper, Colorado State University.

Photos were available for the Green River to capture the current state of riparian vegetation (Figures 3 and 4). Pre-dam photos were not available, but we do have photos of riparian vegetation from less regulated sites which have healthy riparian forest (Figure 5).

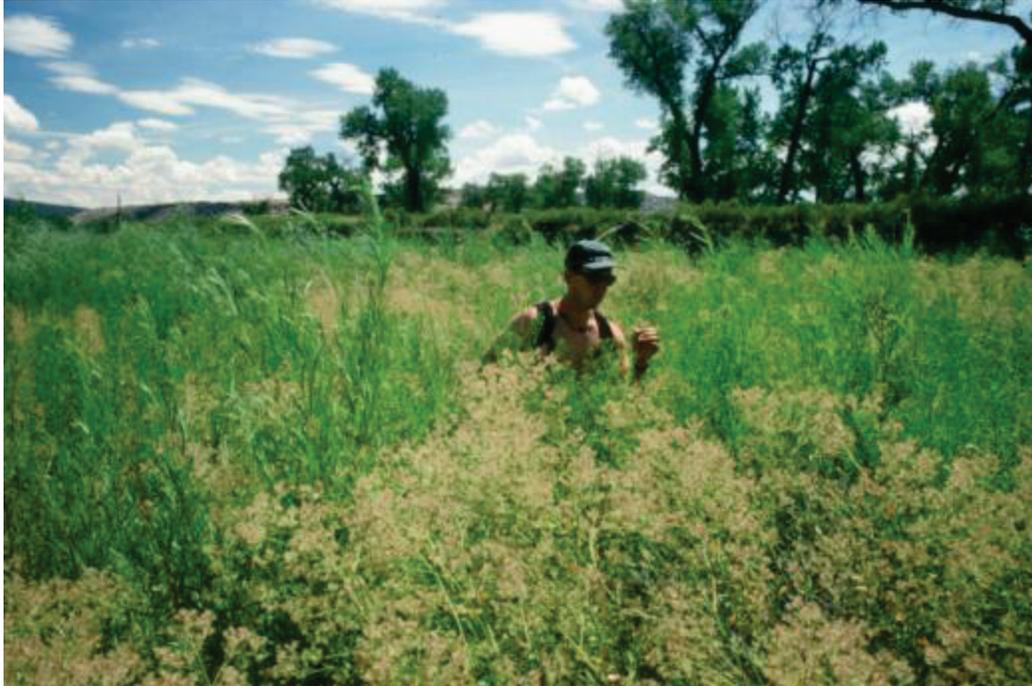
**Figure 4** This photo shows what was an open back-channel of the Green River that was open before dam construction (also from Browns Park). It is now dominated by grasses, willows, and tall whitetop, a noxious weed. Photo courtesy of David Cooper, Colorado State University.

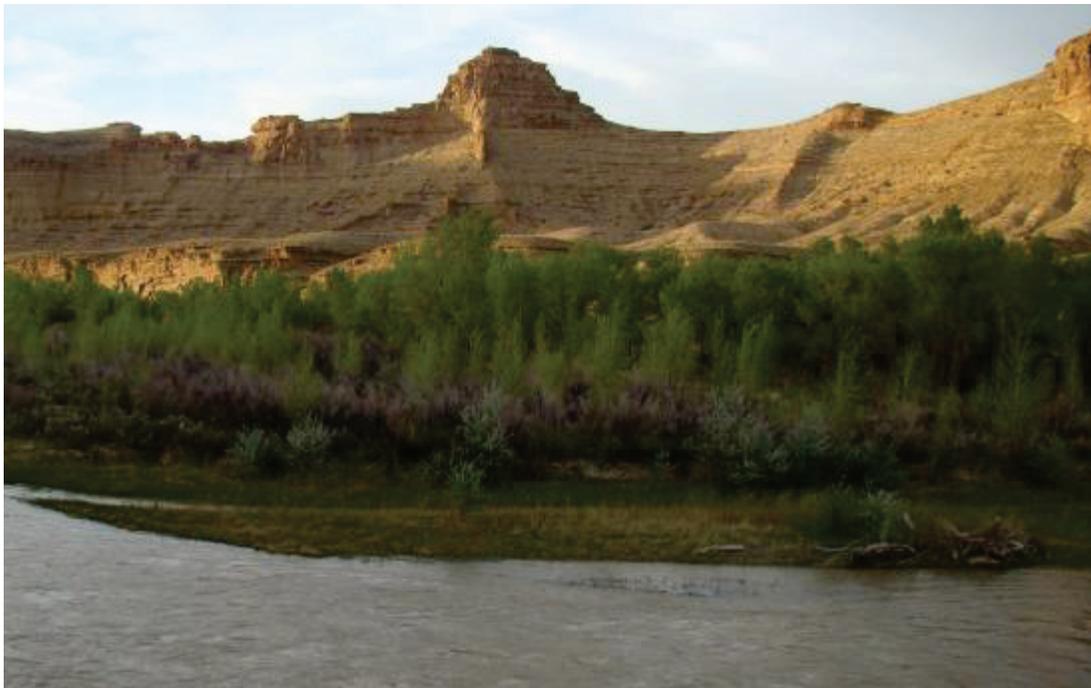
**Figure 5** White River in Utah. This is an example of riparian vegetation with near-natural flows. Note that both young and mature cottonwood are present with no dead limbs. Photo courtesy of Justin Jimenez, Bureau of Land Management.

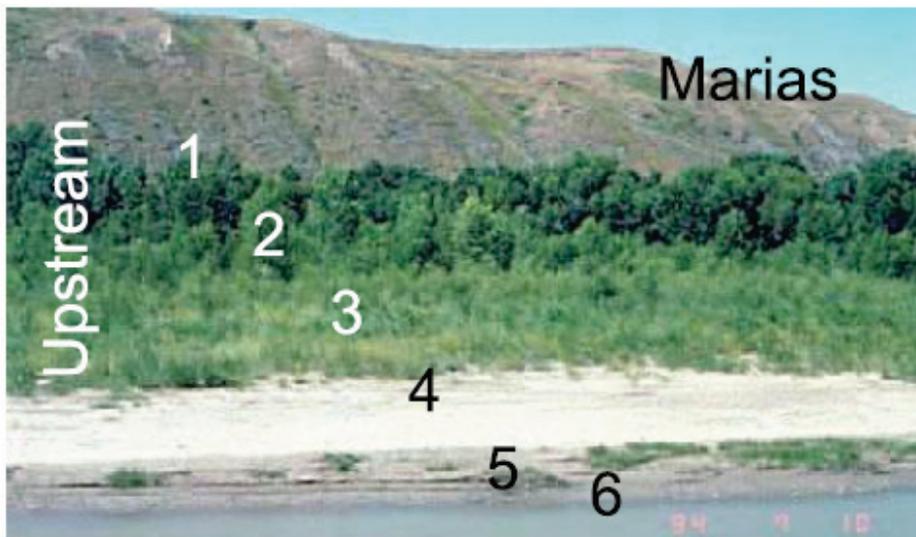
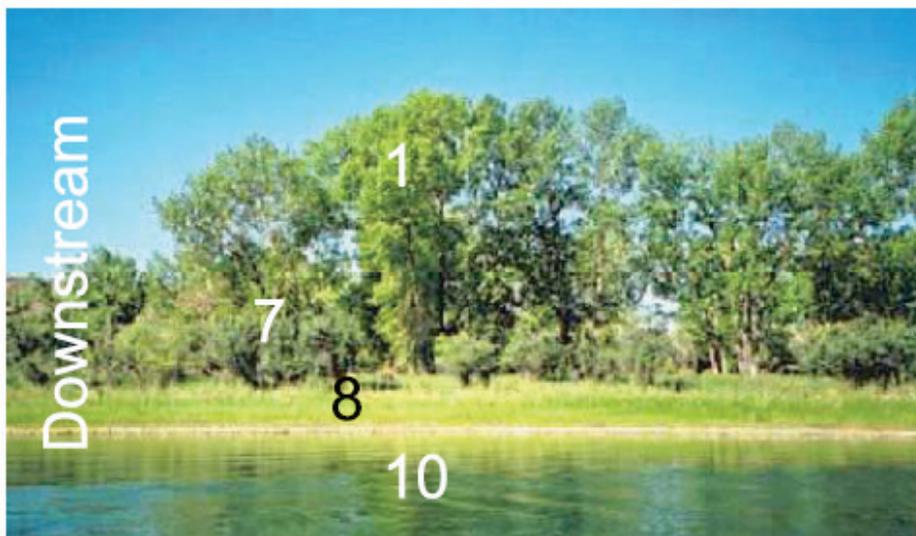
Compare the top photo taken upstream of the Tiber Dam (constructed 1956), to the lower photo taken downstream of the dam. Both sites support mature cottonwood trees (labeled 1 in the photo). Juvenile cottonwood and willow are visible only at the upstream site (2 & 3), whereas downstream the zone adjacent to the cottonwoods supports species also found in uplands (7). Notice that grasses have encroached on the channel at the downstream site (8), with clear sandbars only present at upstream sites (4). Bare sand along the upstream channel shows the moist capillary fringe (5) and even in late summer the water is some turbid (6), in comparison to the clear water downstream (10). These photos are sourced from Rood et al. (2007).

A **flow alteration of -26%** was calculated for the Marias River (wet year 90 day max at USGS 06099500 and 06101500), placing it in the “Moderate Risk Class” for adult cottonwood and “High Risk Class” for cottonwood recruitment (using the flow-ecology methods from the WFET; Wilding and Sanderson 2011).

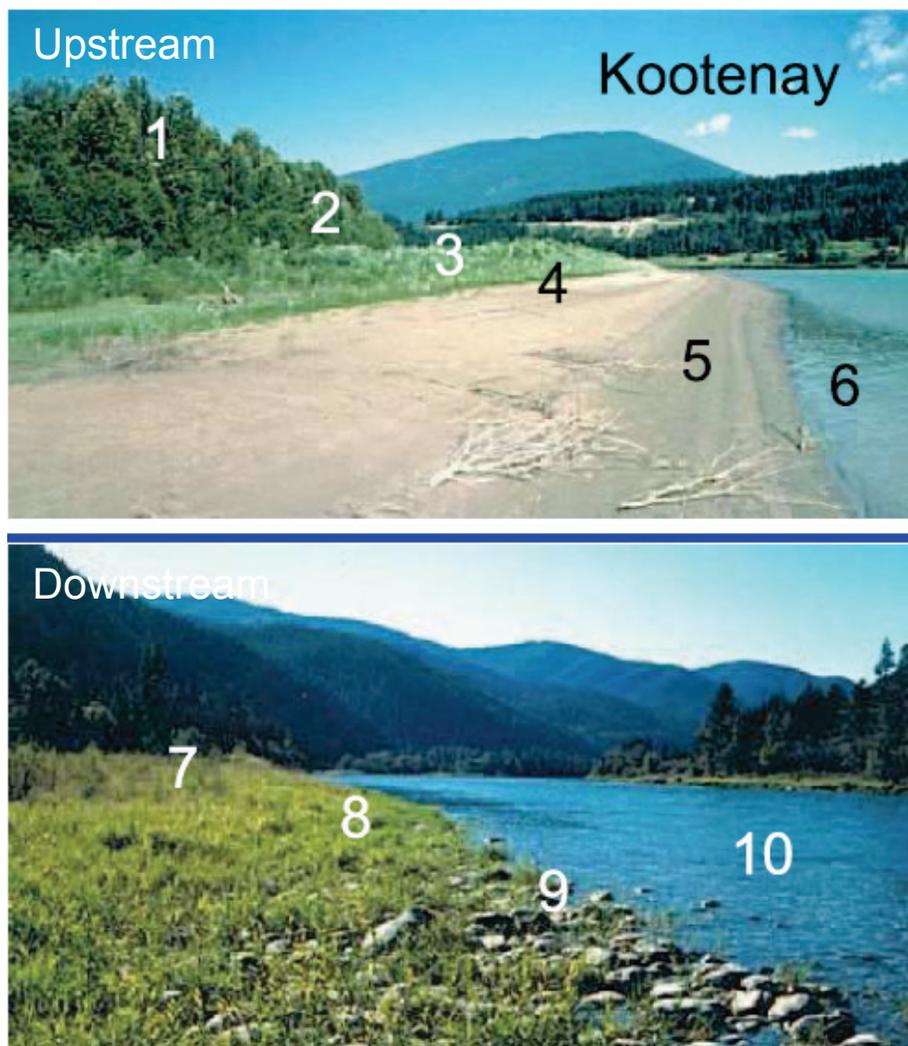
Compare the top photo taken upstream of the Libby Dam (constructed 1971), to the lower photo taken downstream of the dam. Both sites support mature cottonwood trees (labeled 1 in the photo). Juvenile cottonwood and willow are visible only at the upstream site (2 & 3), whereas downstream the zone adjacent to the cottonwoods supports species also found in uplands (7). Notice that grasses have encroached on the channel at the downstream site (8), with clear sandbars only present at upstream sites (4) compared to cobbles along the water's edge downstream (9). Bare sand along the upstream channel shows the moist capillary fringe (5) and even in late summer the water is some turbid (6), in comparison to the clear water downstream (10). These photos are sourced from Rood et al. (2007).

A **flow alteration of -49%** was calculated for the Kootenay River (wet year 90 day max at USGS 12303000 and 12301933), placing it in the “High Risk Class” for adult cottonwood and “Very High Risk Class” for cottonwood recruitment (using the flow-ecology methods from the WFET; Wilding and Sanderson 2011).

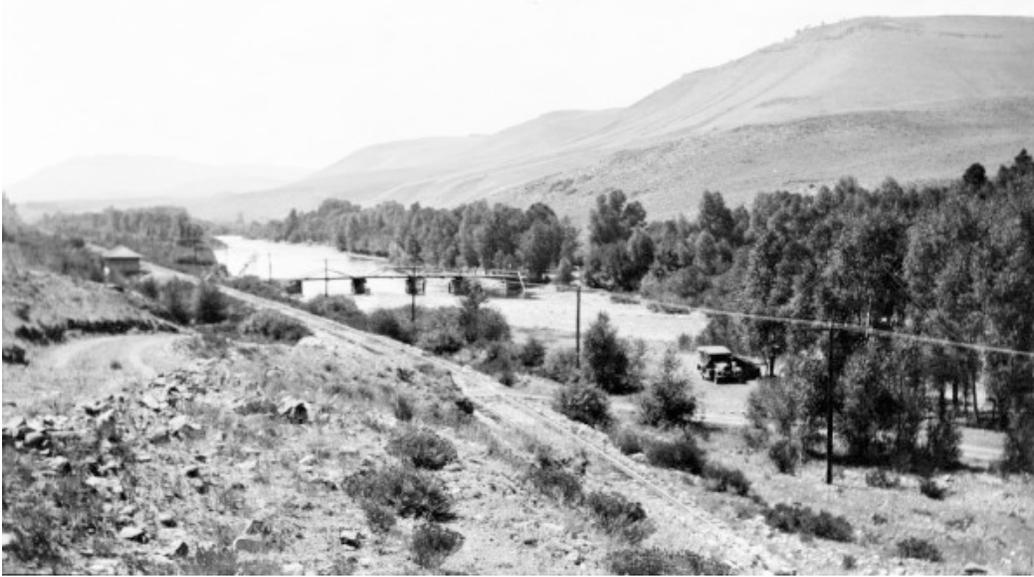
**Figure 6** Photo by Harry H. Buckwalter, taken August 23 1922, looking west along the Colorado River from CO. Rd 57 at the narrowest point of Windy Gap. Image courtesy of History Colorado (Buckwalter Collection, CHS-B1724, scan #20031724).

This confined section of the Colorado River was photographed in 1922 by Harry Buckwalter (Figure 6). We reproduced this photo location in 2011 (Figure 7). The river appears to have narrowed considerably since the construction of Moffat tunnel (1936) and Lake Granby Dam (1954). Cottonwood, willow and grasses have encroached beyond the 1922 stream bank (Figures 7 and 8).

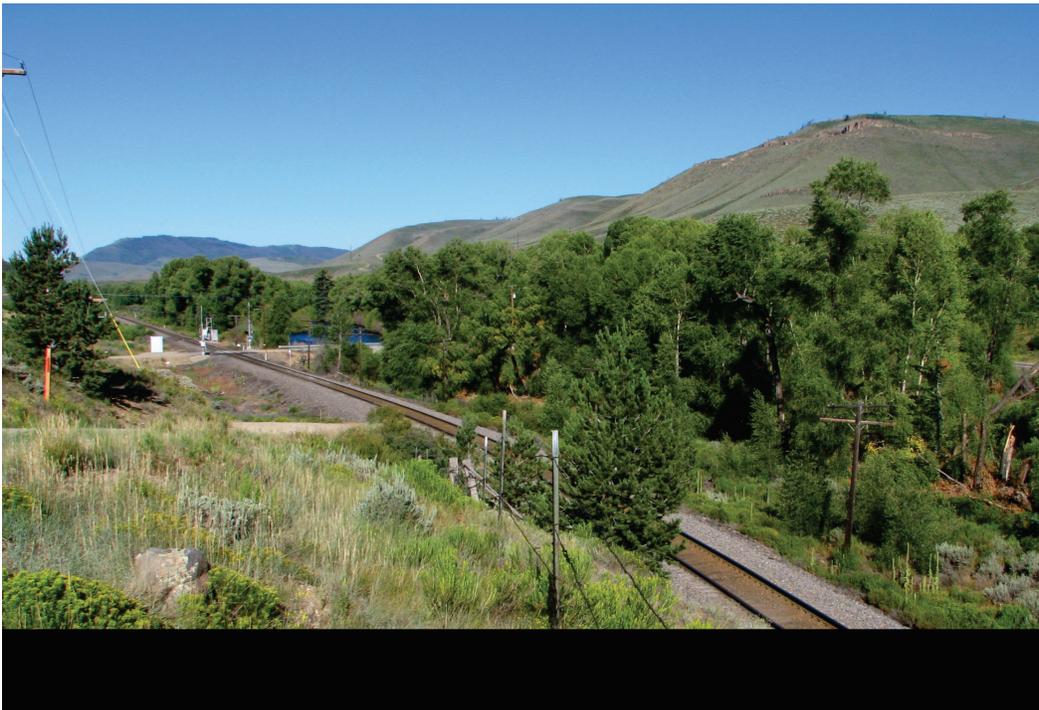
**Figure 7** We estimated the location of the historic photo (Lat. 40.1085, Long. -106.0006, heading -80°) and took this photo August 2011. Cottonwood appear to have exploited the narrowing channel.

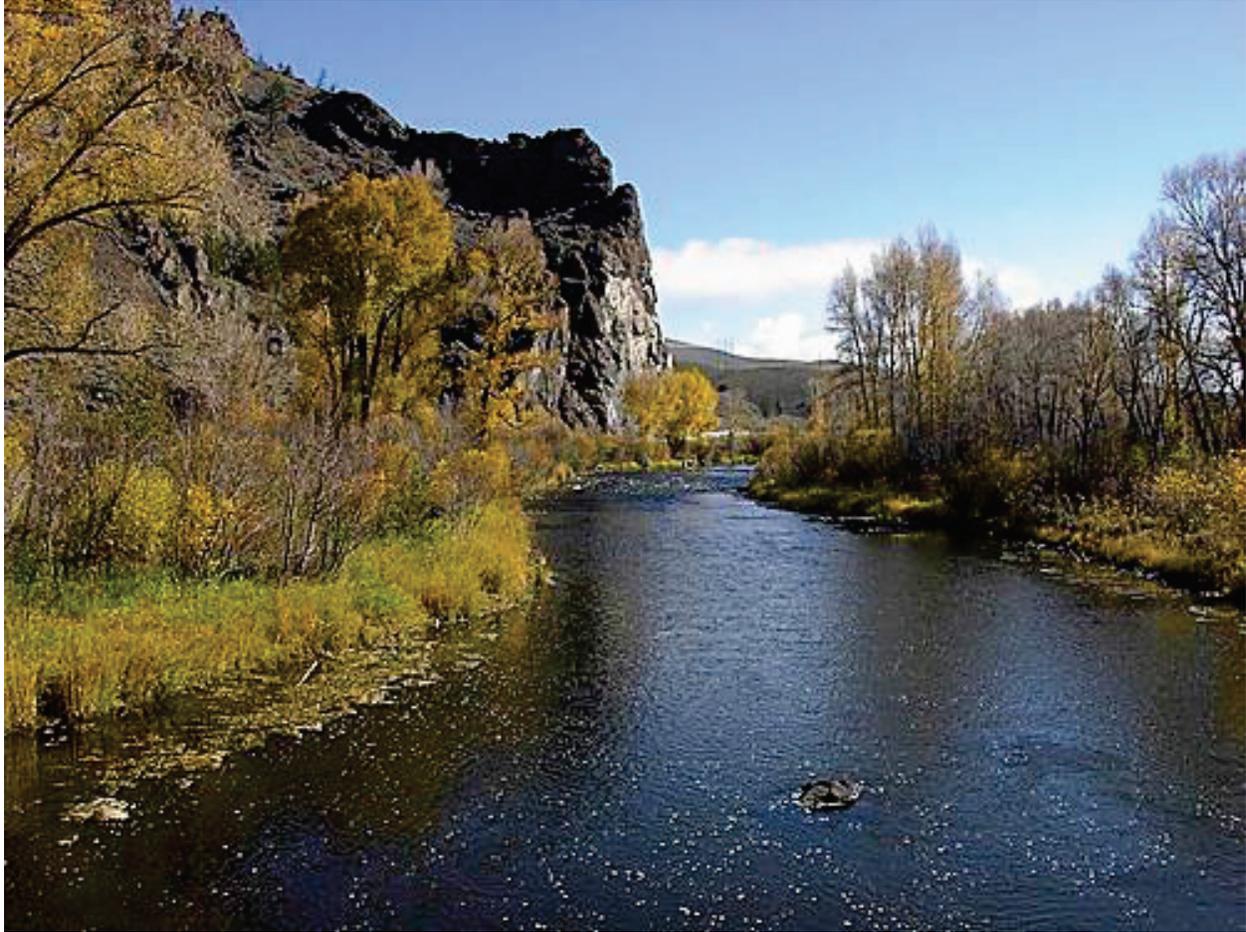
**Figure 8** This photo, taken in 2004 by Pieter en Marianne van de Sande, looks upstream from the bridge (CO. Rd 57) toward Windy Gap (rocky bluff). Shrubs and grasses appear responsible for most of the channel encroachment, though some of the smaller trees to the right (river true left) may occupy 1922 channel.

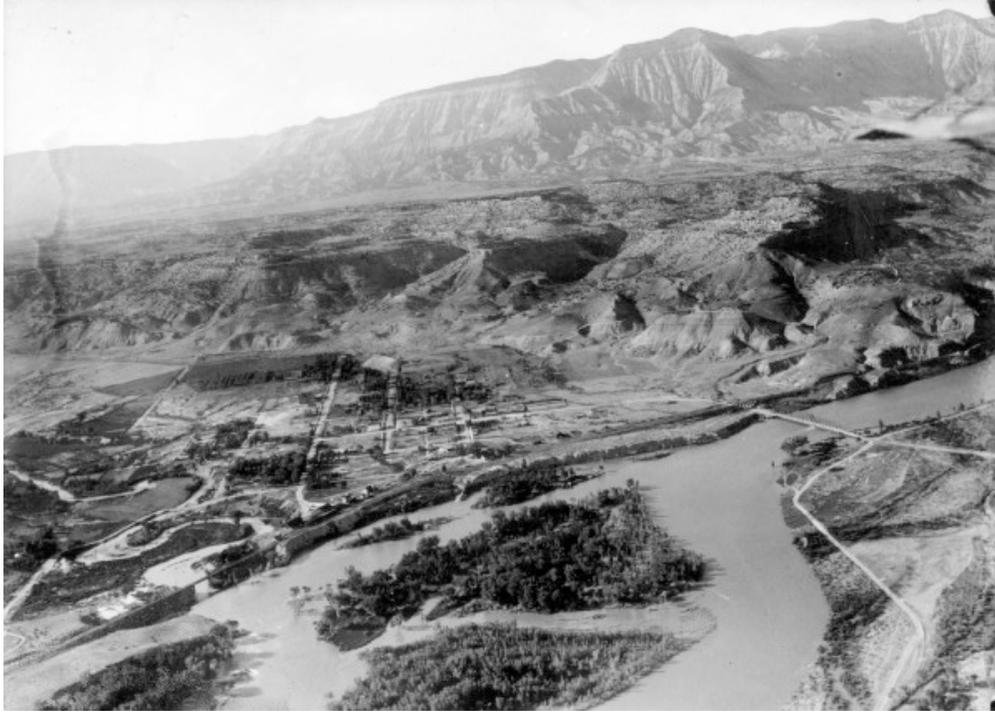
**Figure 9** Aerial photo of De Beque and the Colorado River taken in 1924 (January 21). Image courtesy of History Colorado (Denver and Rio Grande collection, CHS.X4351, scan #2004351).

This unconfined channel of the Colorado River has narrowed considerably between 1924 (Figure 9) and 2005 (Figure 10). Note that USGS09106000 records show the river was not experiencing flood flows at the time of photo (21 January 1924). It does not appear that cottonwood have extensively colonized the old river channel, nor have the island forests persisted. No doubt land use has played a role in the vegetation changes here.

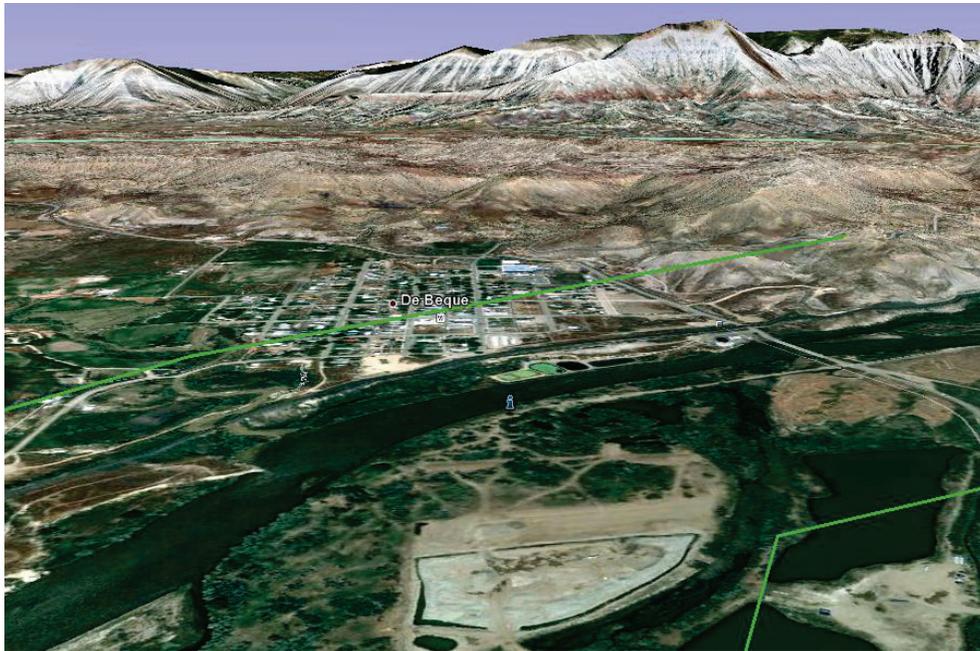
**Figure 10** The location of the historic photo was estimated using the streets of De Beque as reference points to produce this image in Google Earth (based on 9 June 2005 aerial photography), looking north across the Colorado River (Lat. 39.3234 Long. -108.2134, heading 7°). The channel has narrowed considerably since 1924. It does not appear that cottonwood have extensively colonized the old river channel, nor have the island forests persisted.
