A Framework for Setting Watershed-scale Priorities for
Forest and Freshwater Restoration
on Prince of Wales Island

September 30, 2008

**The Nature Conservancy
Alaska Field Office
Juneau, Alaska**

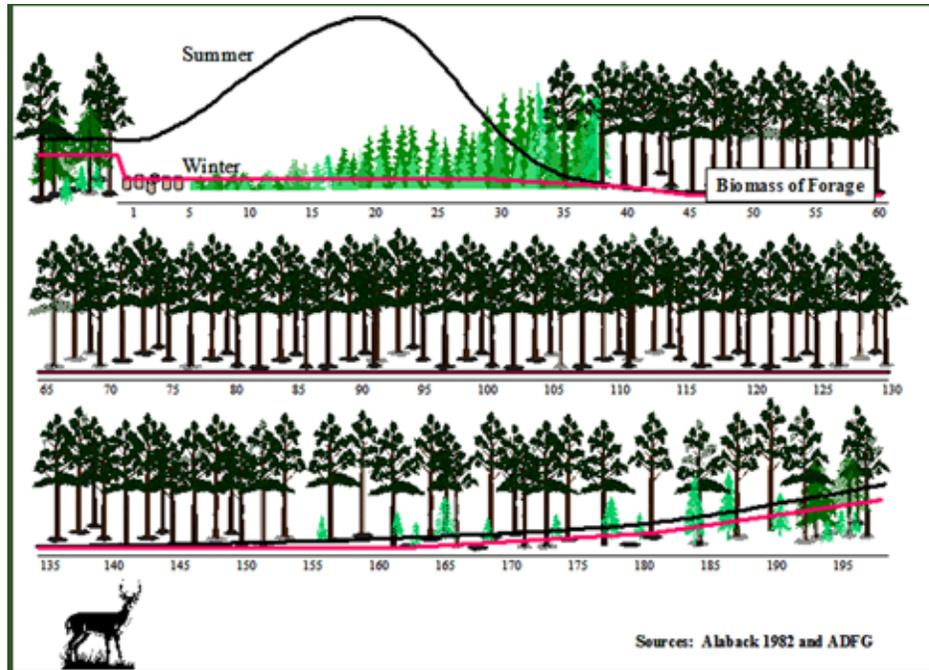
Figure 1. Chronology of forest succession and productivity for deer after logging.

The natural pattern of small-scale disturbance within coastal forest ecosystems maintains a structurally complex and diverse canopy that allows both snow intercept and understory productivity for deer in winter (Schoen et. al 1988). In contrast, the practice of clear-cut logging alters the successional pathway of a stand, and results in predictable changes in productivity of forage for deer over time (Fig. 1). In years immediately following clear-cut logging, availability and biomass of forage for deer is high during summer months, but availability may be limited during periods of deep snow (Alaback 1982). Summer forage increases to a maximum at about 20 years post logging. As conifers regain dominance within the young stands, and exclude light from the forest floor, a stem exclusion phase is established by 30-40 years after logging. During this period, forage biomass diminishes during both summer and winter, and remains very low level for at least 120 years. Natural mortality of dominant conifers within the stand may begin the process of recreating old growth characteristics, and higher forage biomass for deer, at ~150-160 years after logging.

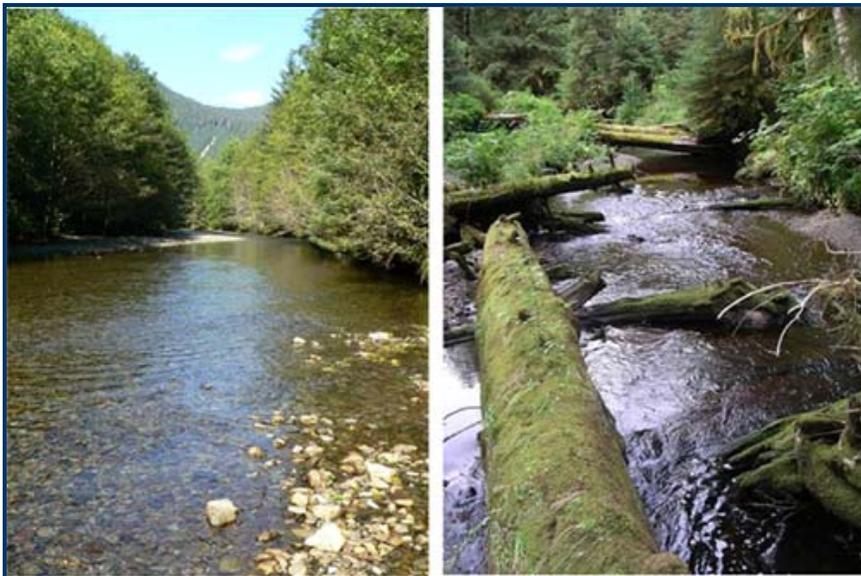
Figure 2. Large-woody debris creates complex stream habitat structure, which plays a major role in providing high quality habitat for salmonids (right). Historical practices, including logged riparian forests and removal of LWD (left) led to impaired stream functions.

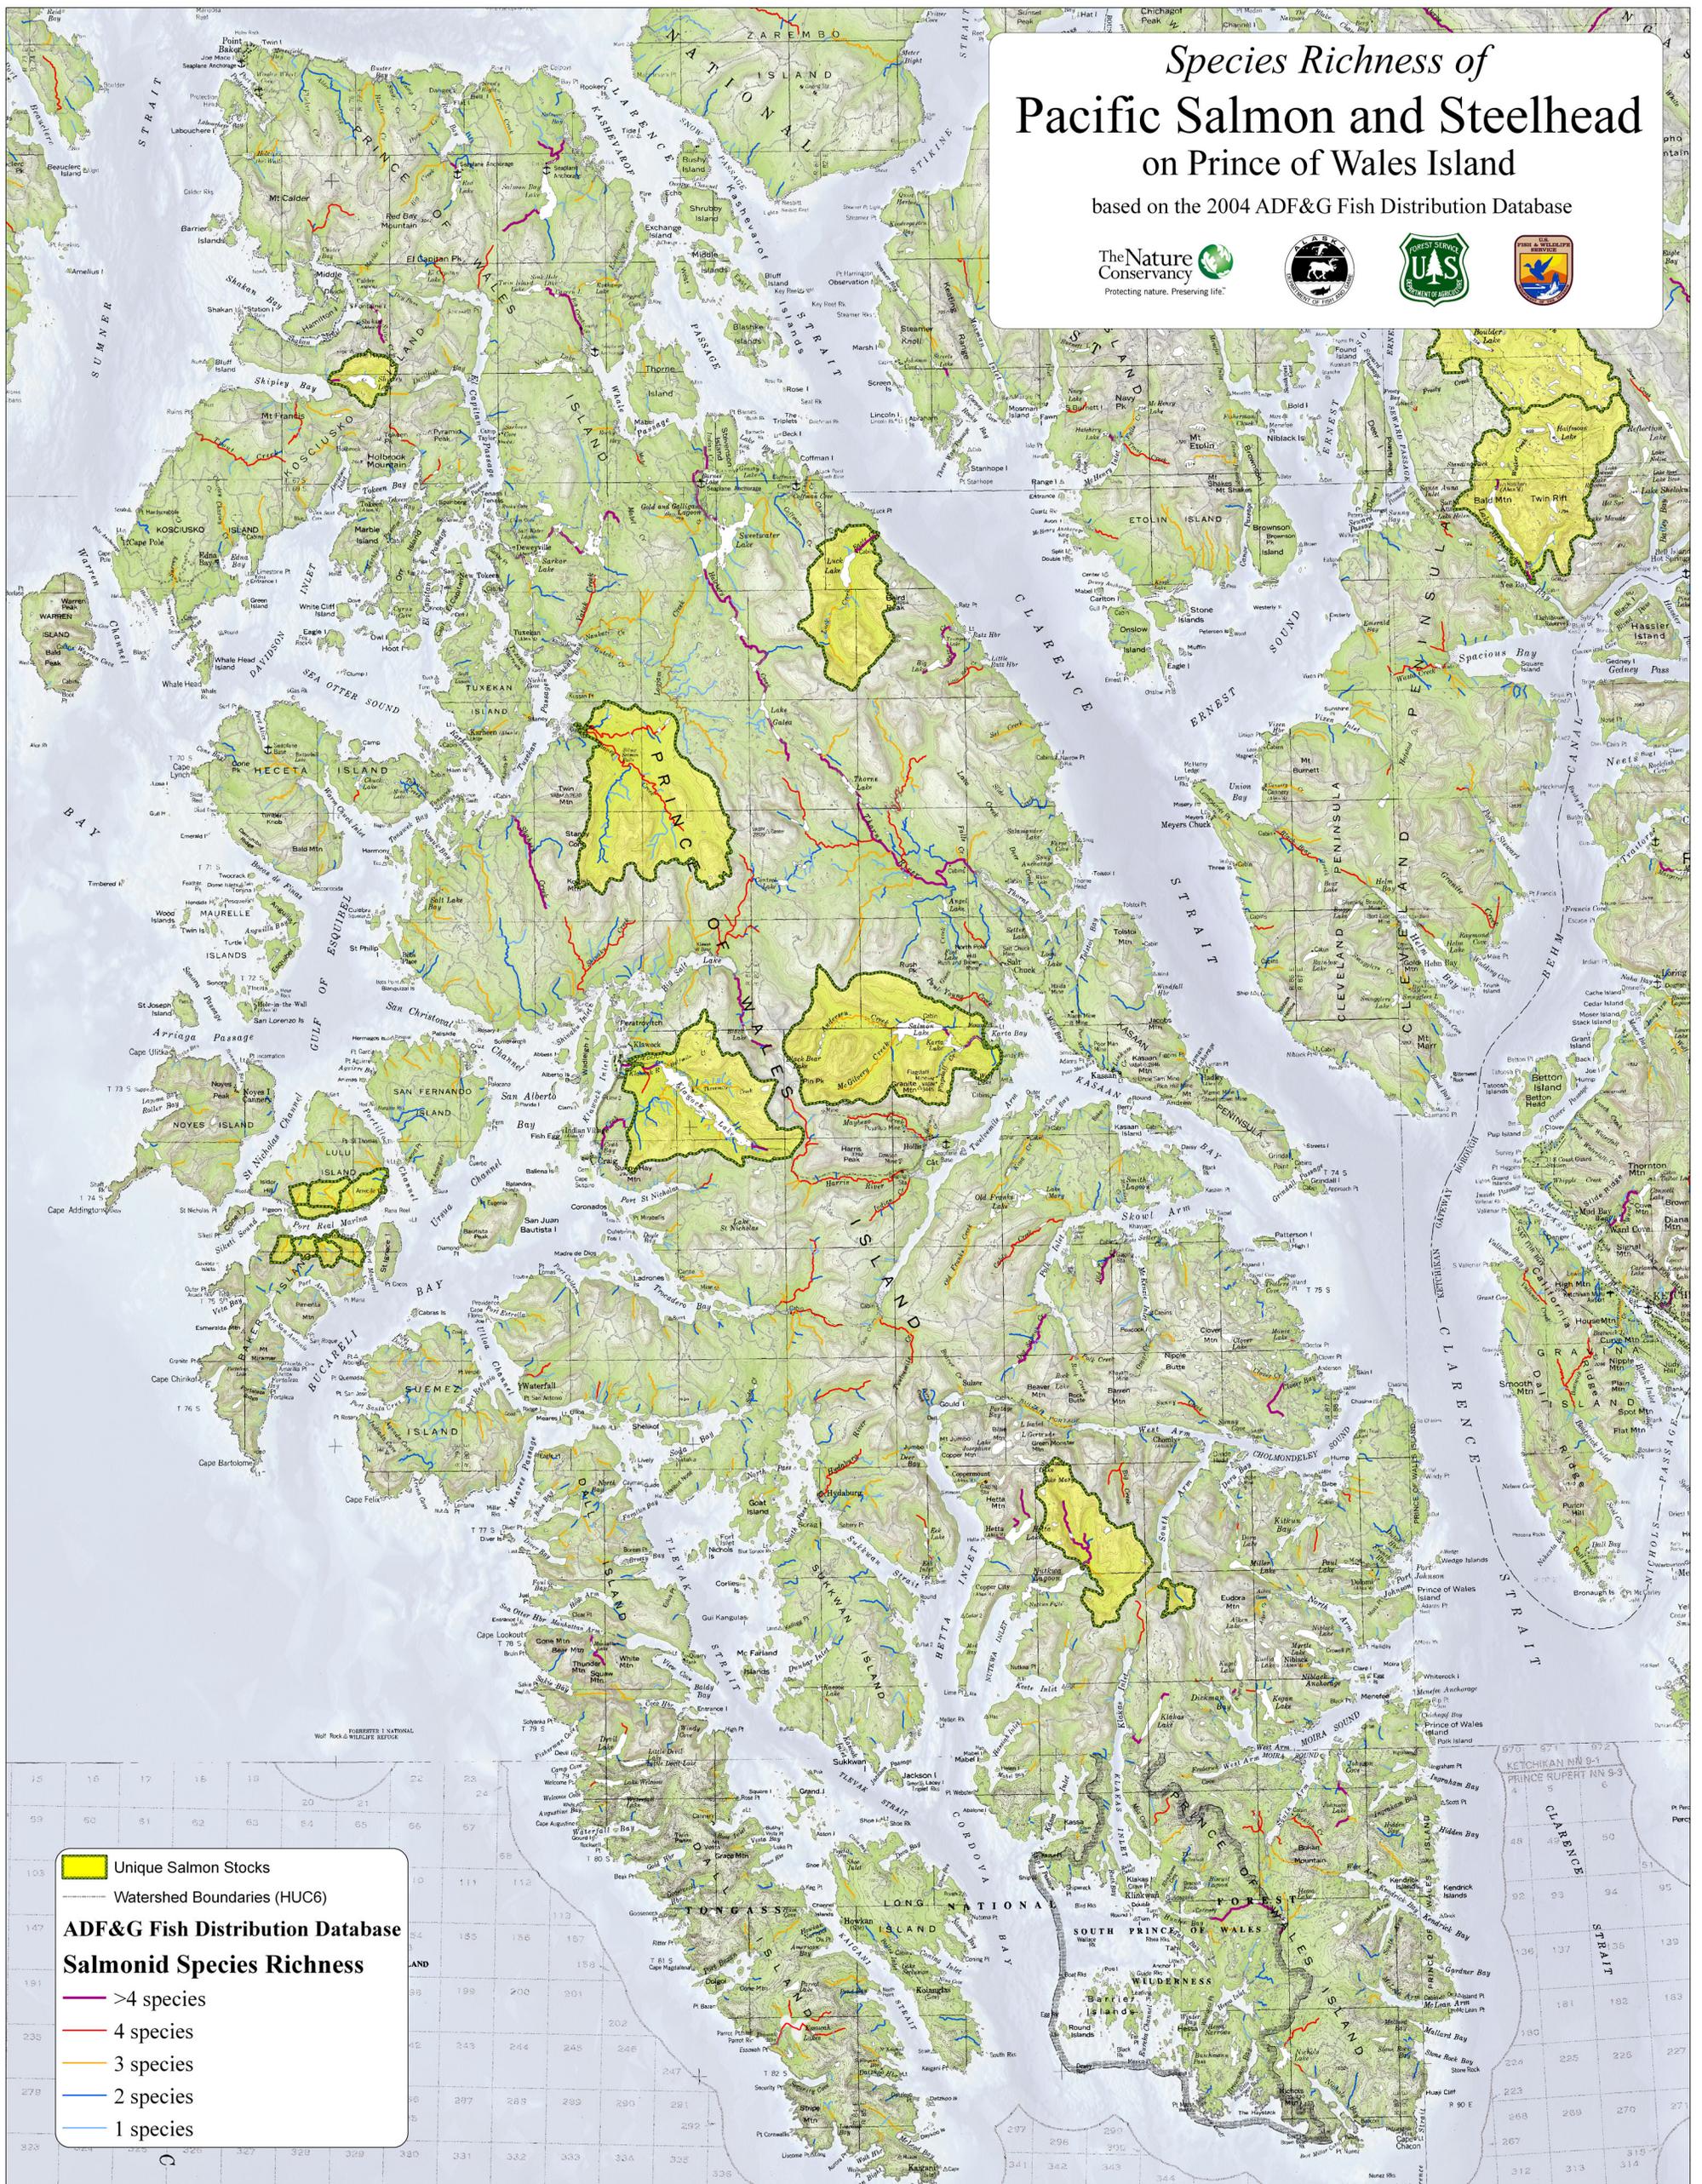
Figure 3. Species richness of Pacific salmon and steelhead among watersheds on Prince of Wales Island, and stocks with unique genetic characteristics.

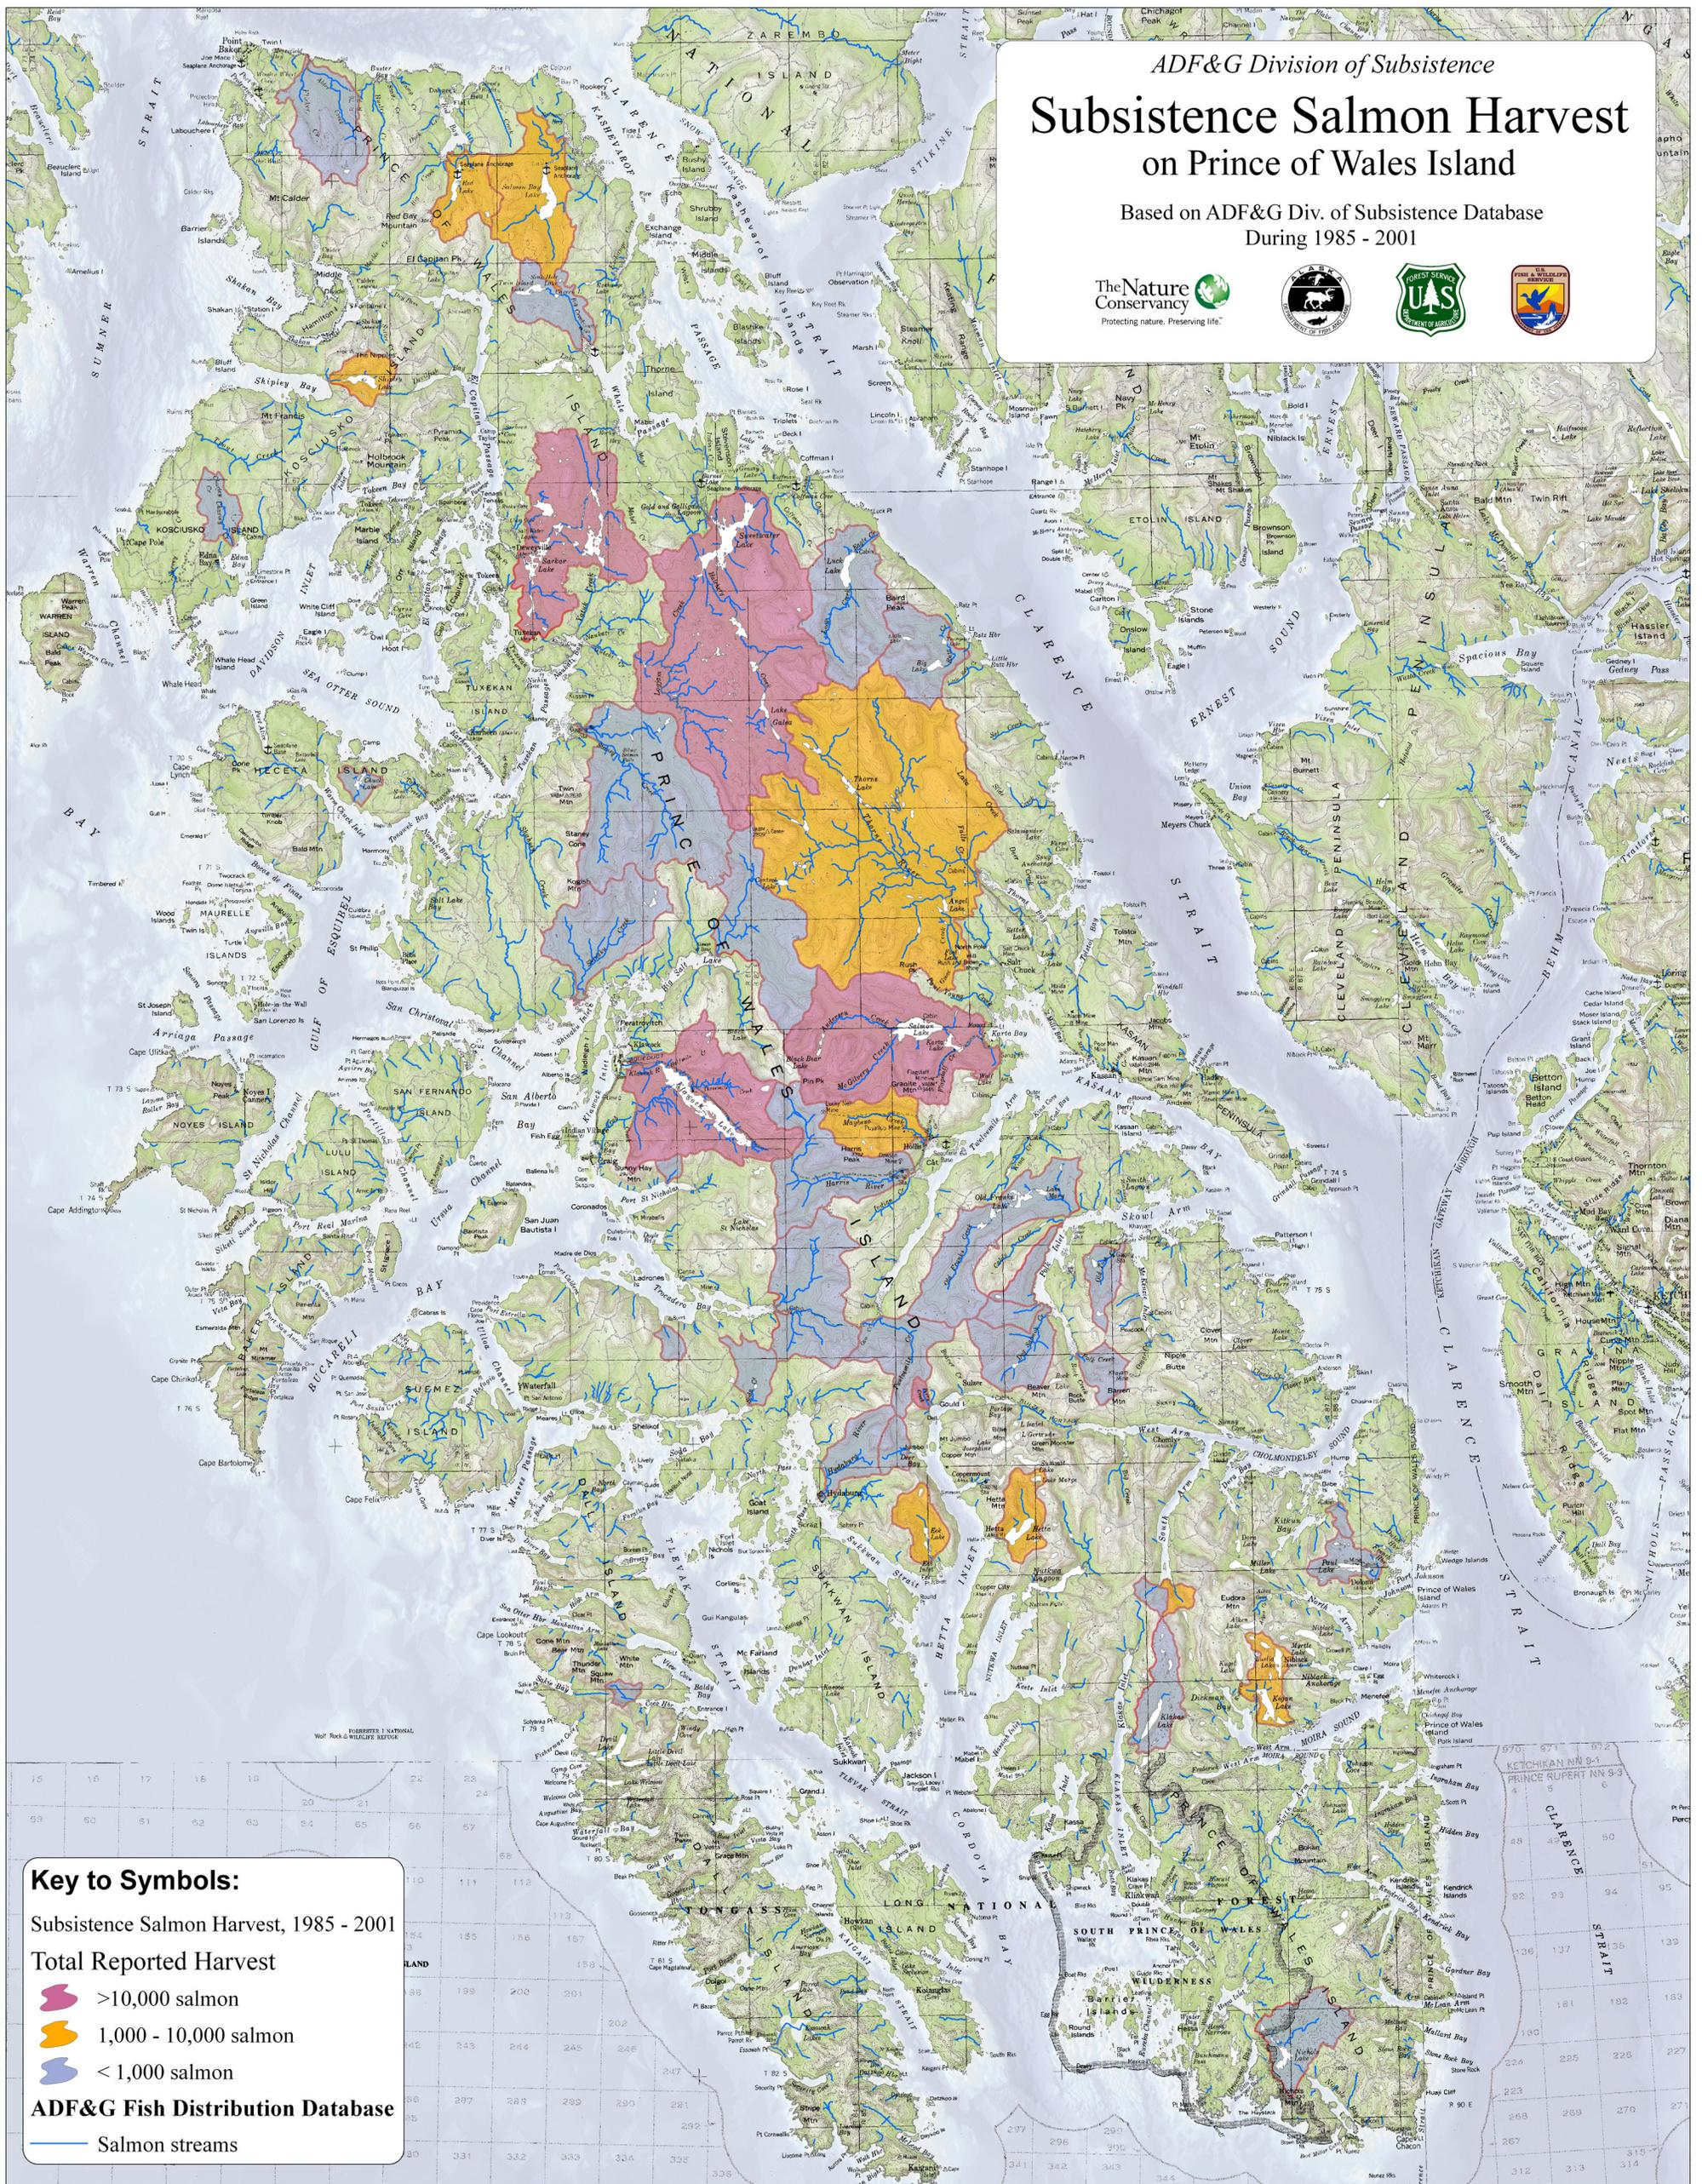
Figure 4. Estimated harvest of salmon by subsistence users on Prince of Wales Island during 1985 - 2001

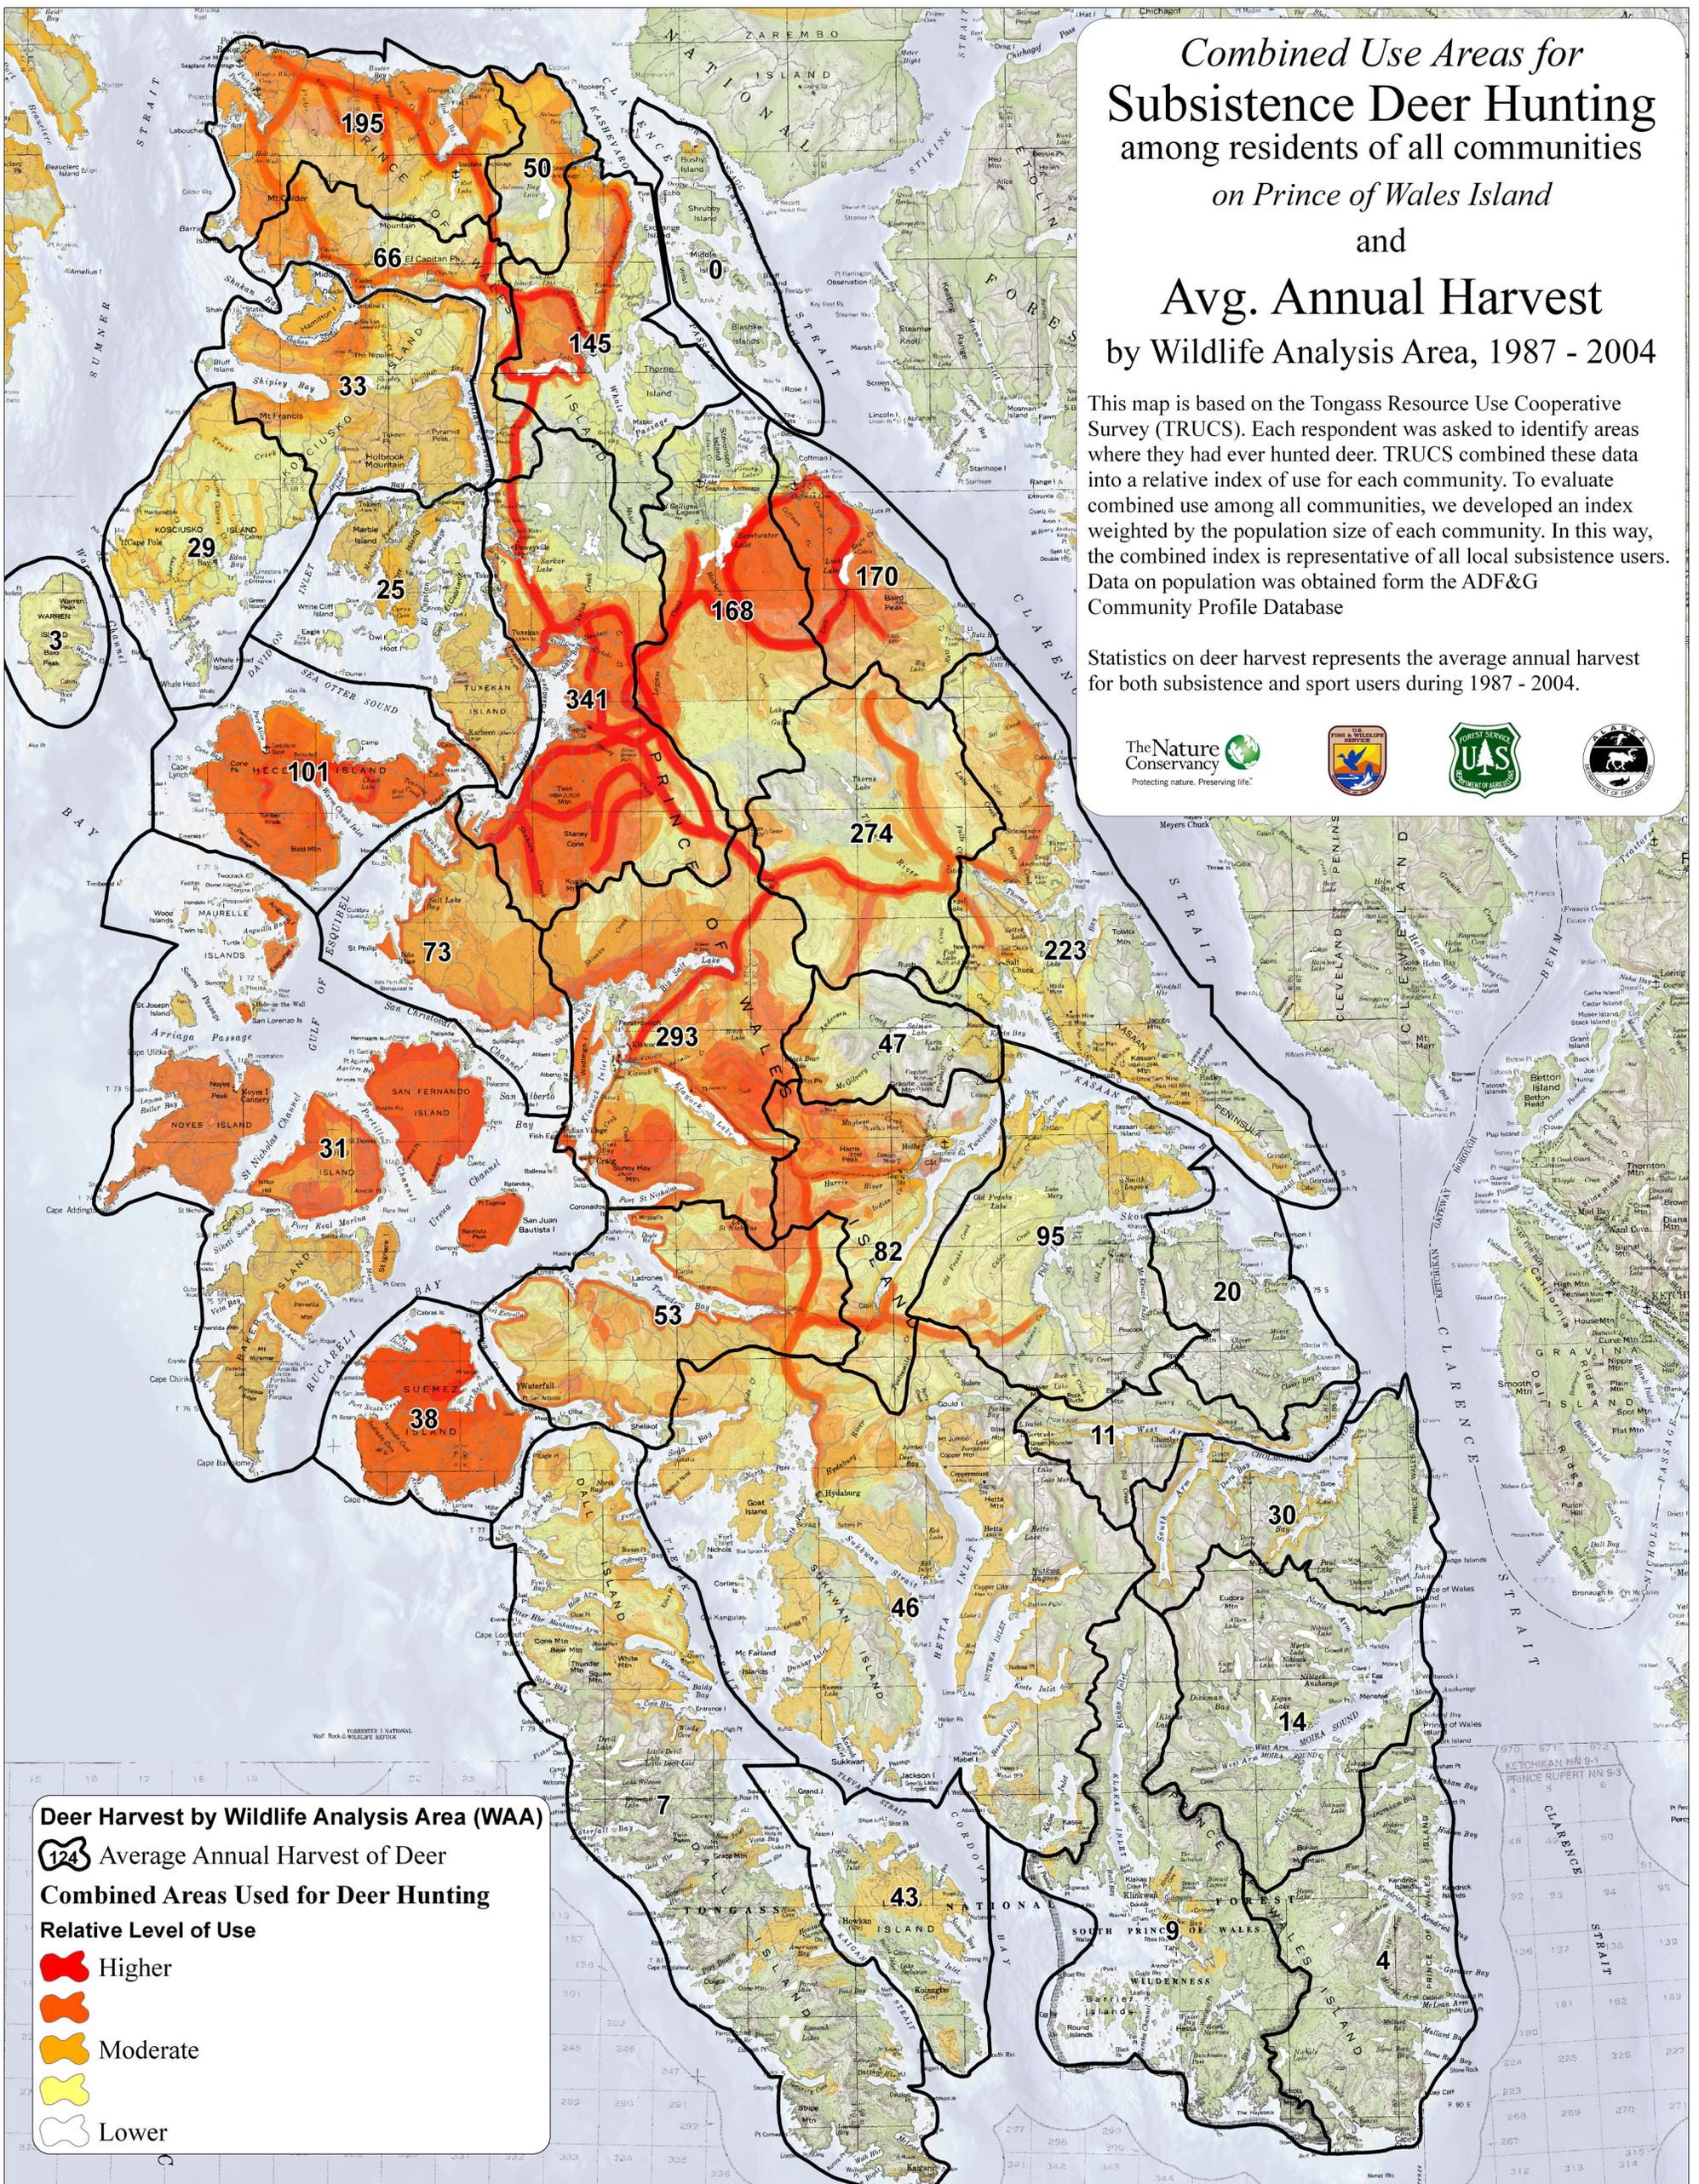
This map is based on the Tongass Resource Use Cooperative Survey (TRUCS). Each respondent was asked to identify areas where they had ever hunted deer. TRUCS combined these data into a relative index of use for each community. To evaluate combined use among all communities, we developed an index weighted by the population size of each community. In this way, the combined index is representative of all local subsistence users. Data on population was obtained from the ADF&G Community Profile Database

Statistics on deer harvest represents the average annual harvest for both subsistence and sport users during 1987 - 2004.

Figure 5. Combined use areas for subsistence deer hunting and harvest of deer by Wildlife Analysis Area during 1987 – 2004.

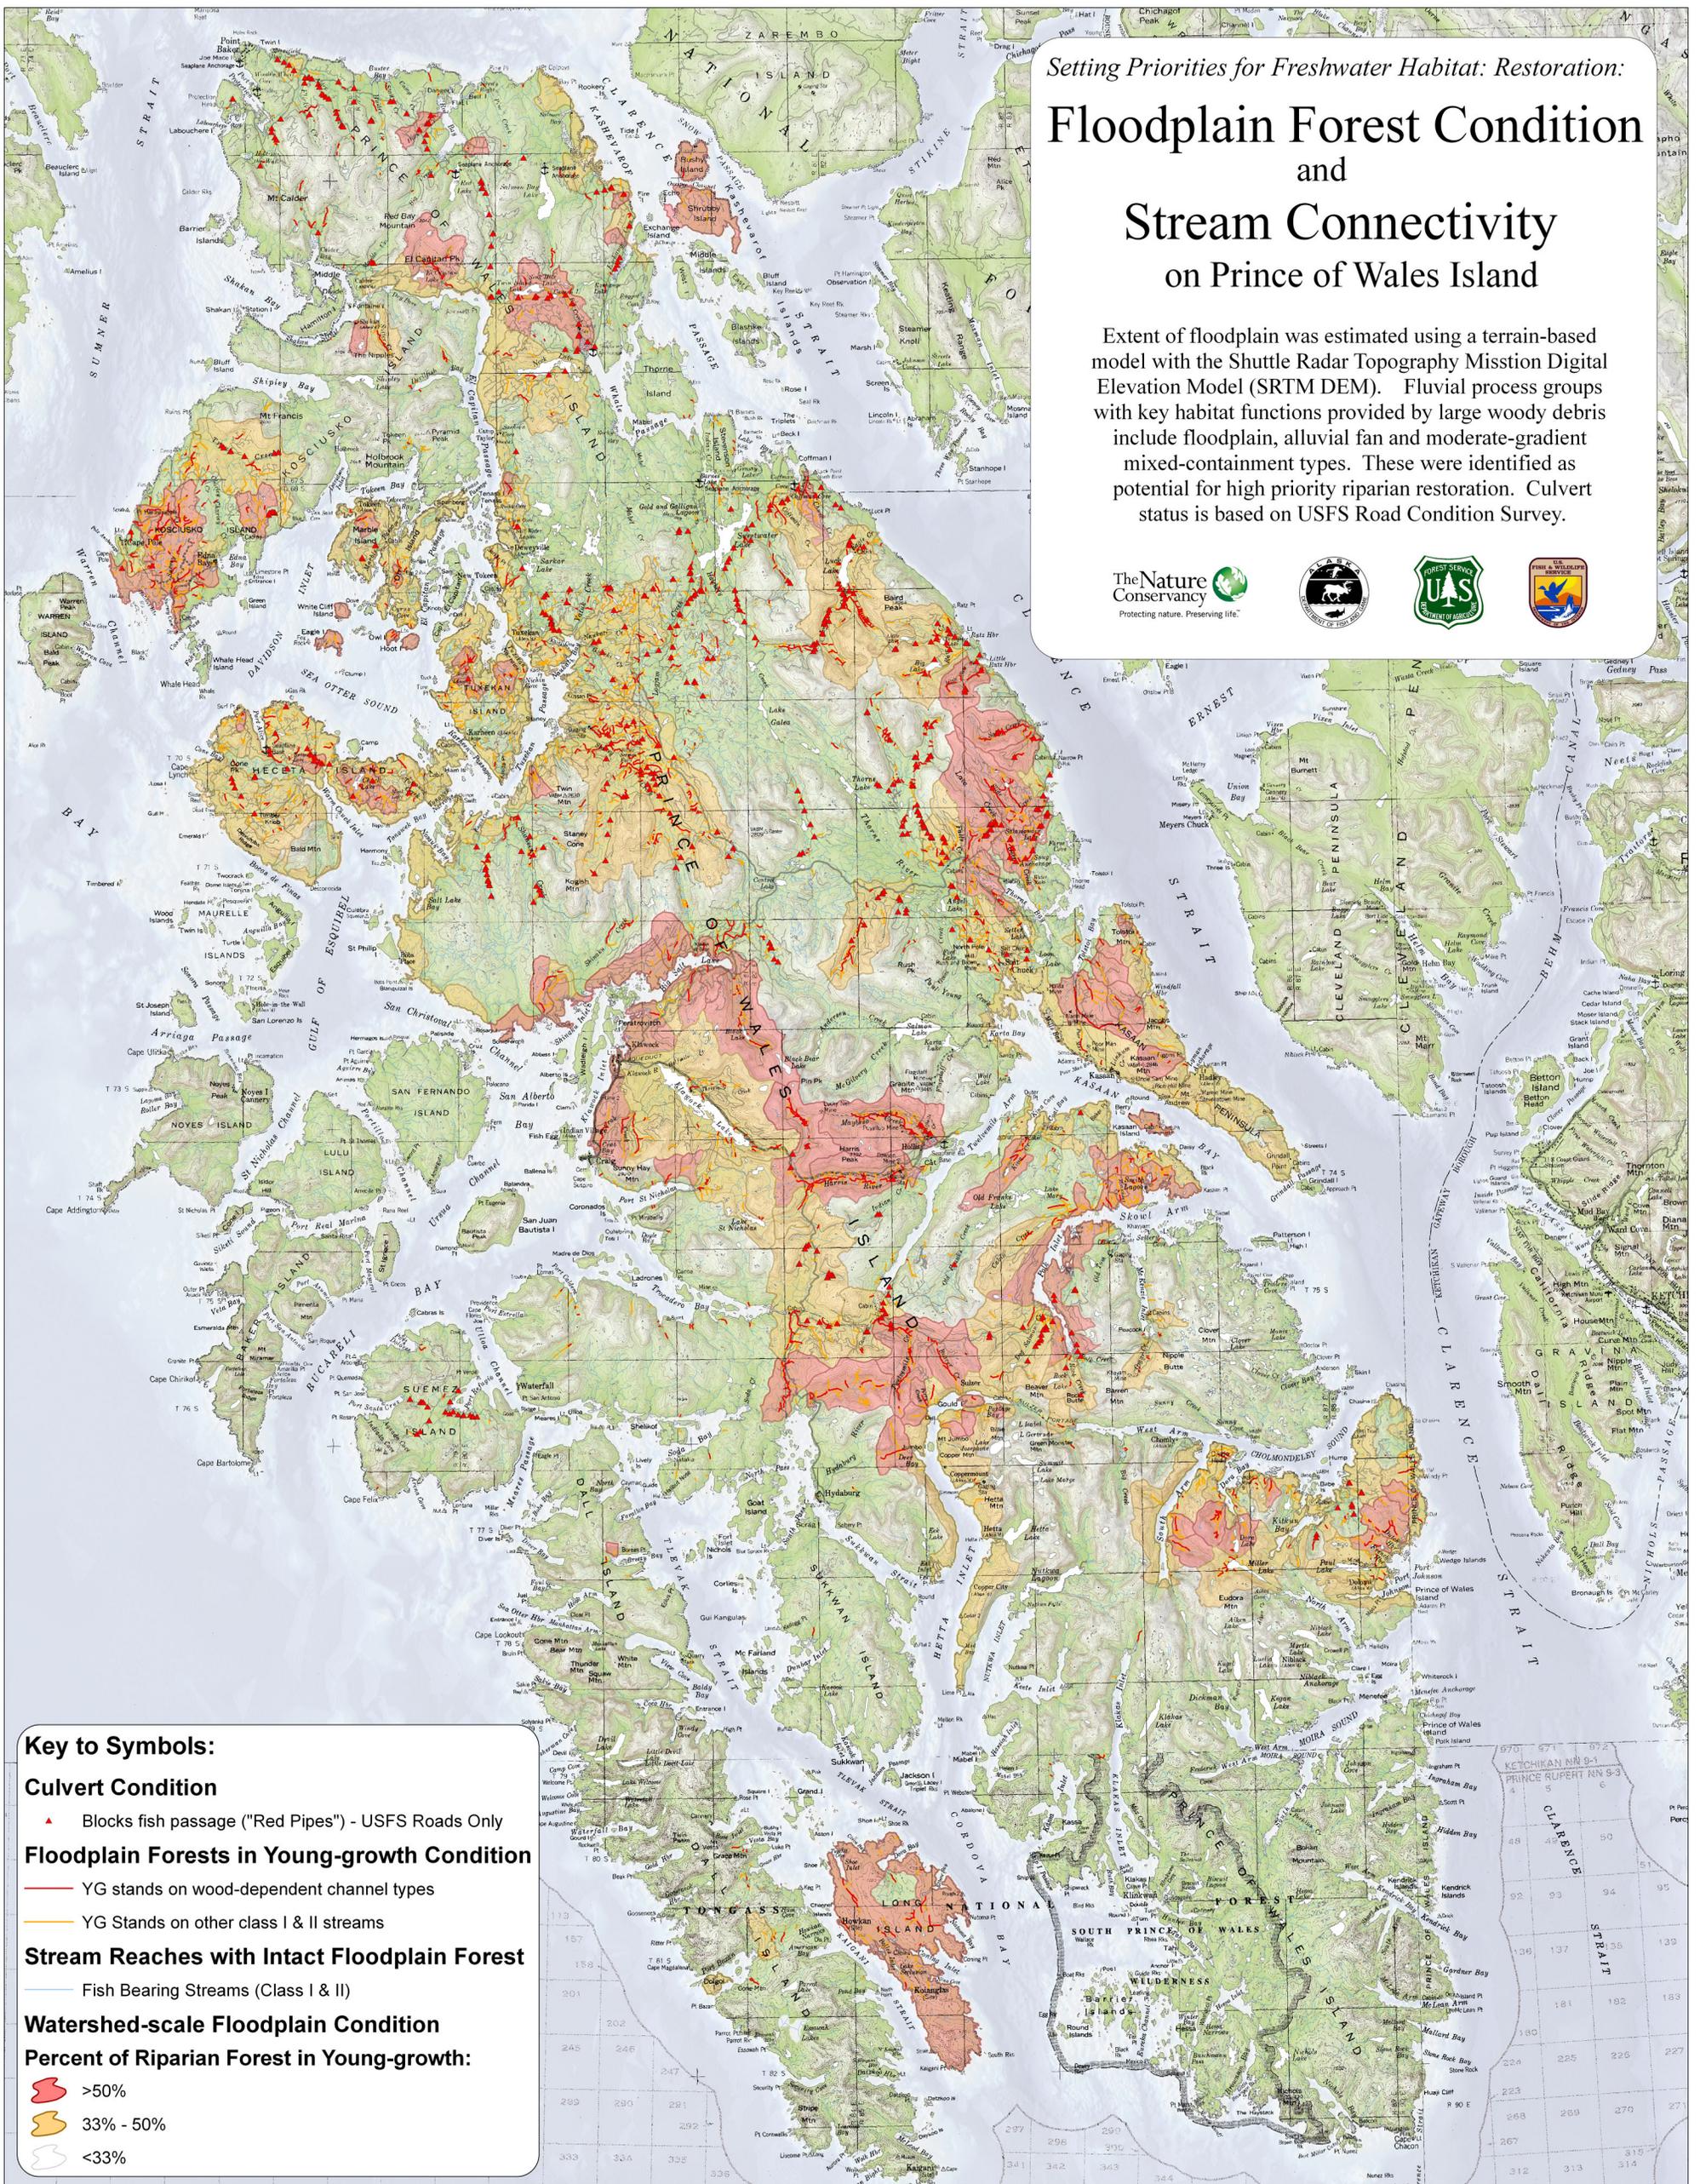
Extent of floodplain was estimated using a terrain-based model with the Shuttle Radar Topography Mission Digital Elevation Model (SRTM DEM). Fluvial process groups with key habitat functions provided by large woody debris include floodplain, alluvial fan and moderate-gradient mixed-containment types. These were identified as potential for high priority riparian restoration. Culvert status is based on USFS Road Condition Survey.

Figure 7. Floodplain forest condition and stream connectivity on Prince of Wales Island.

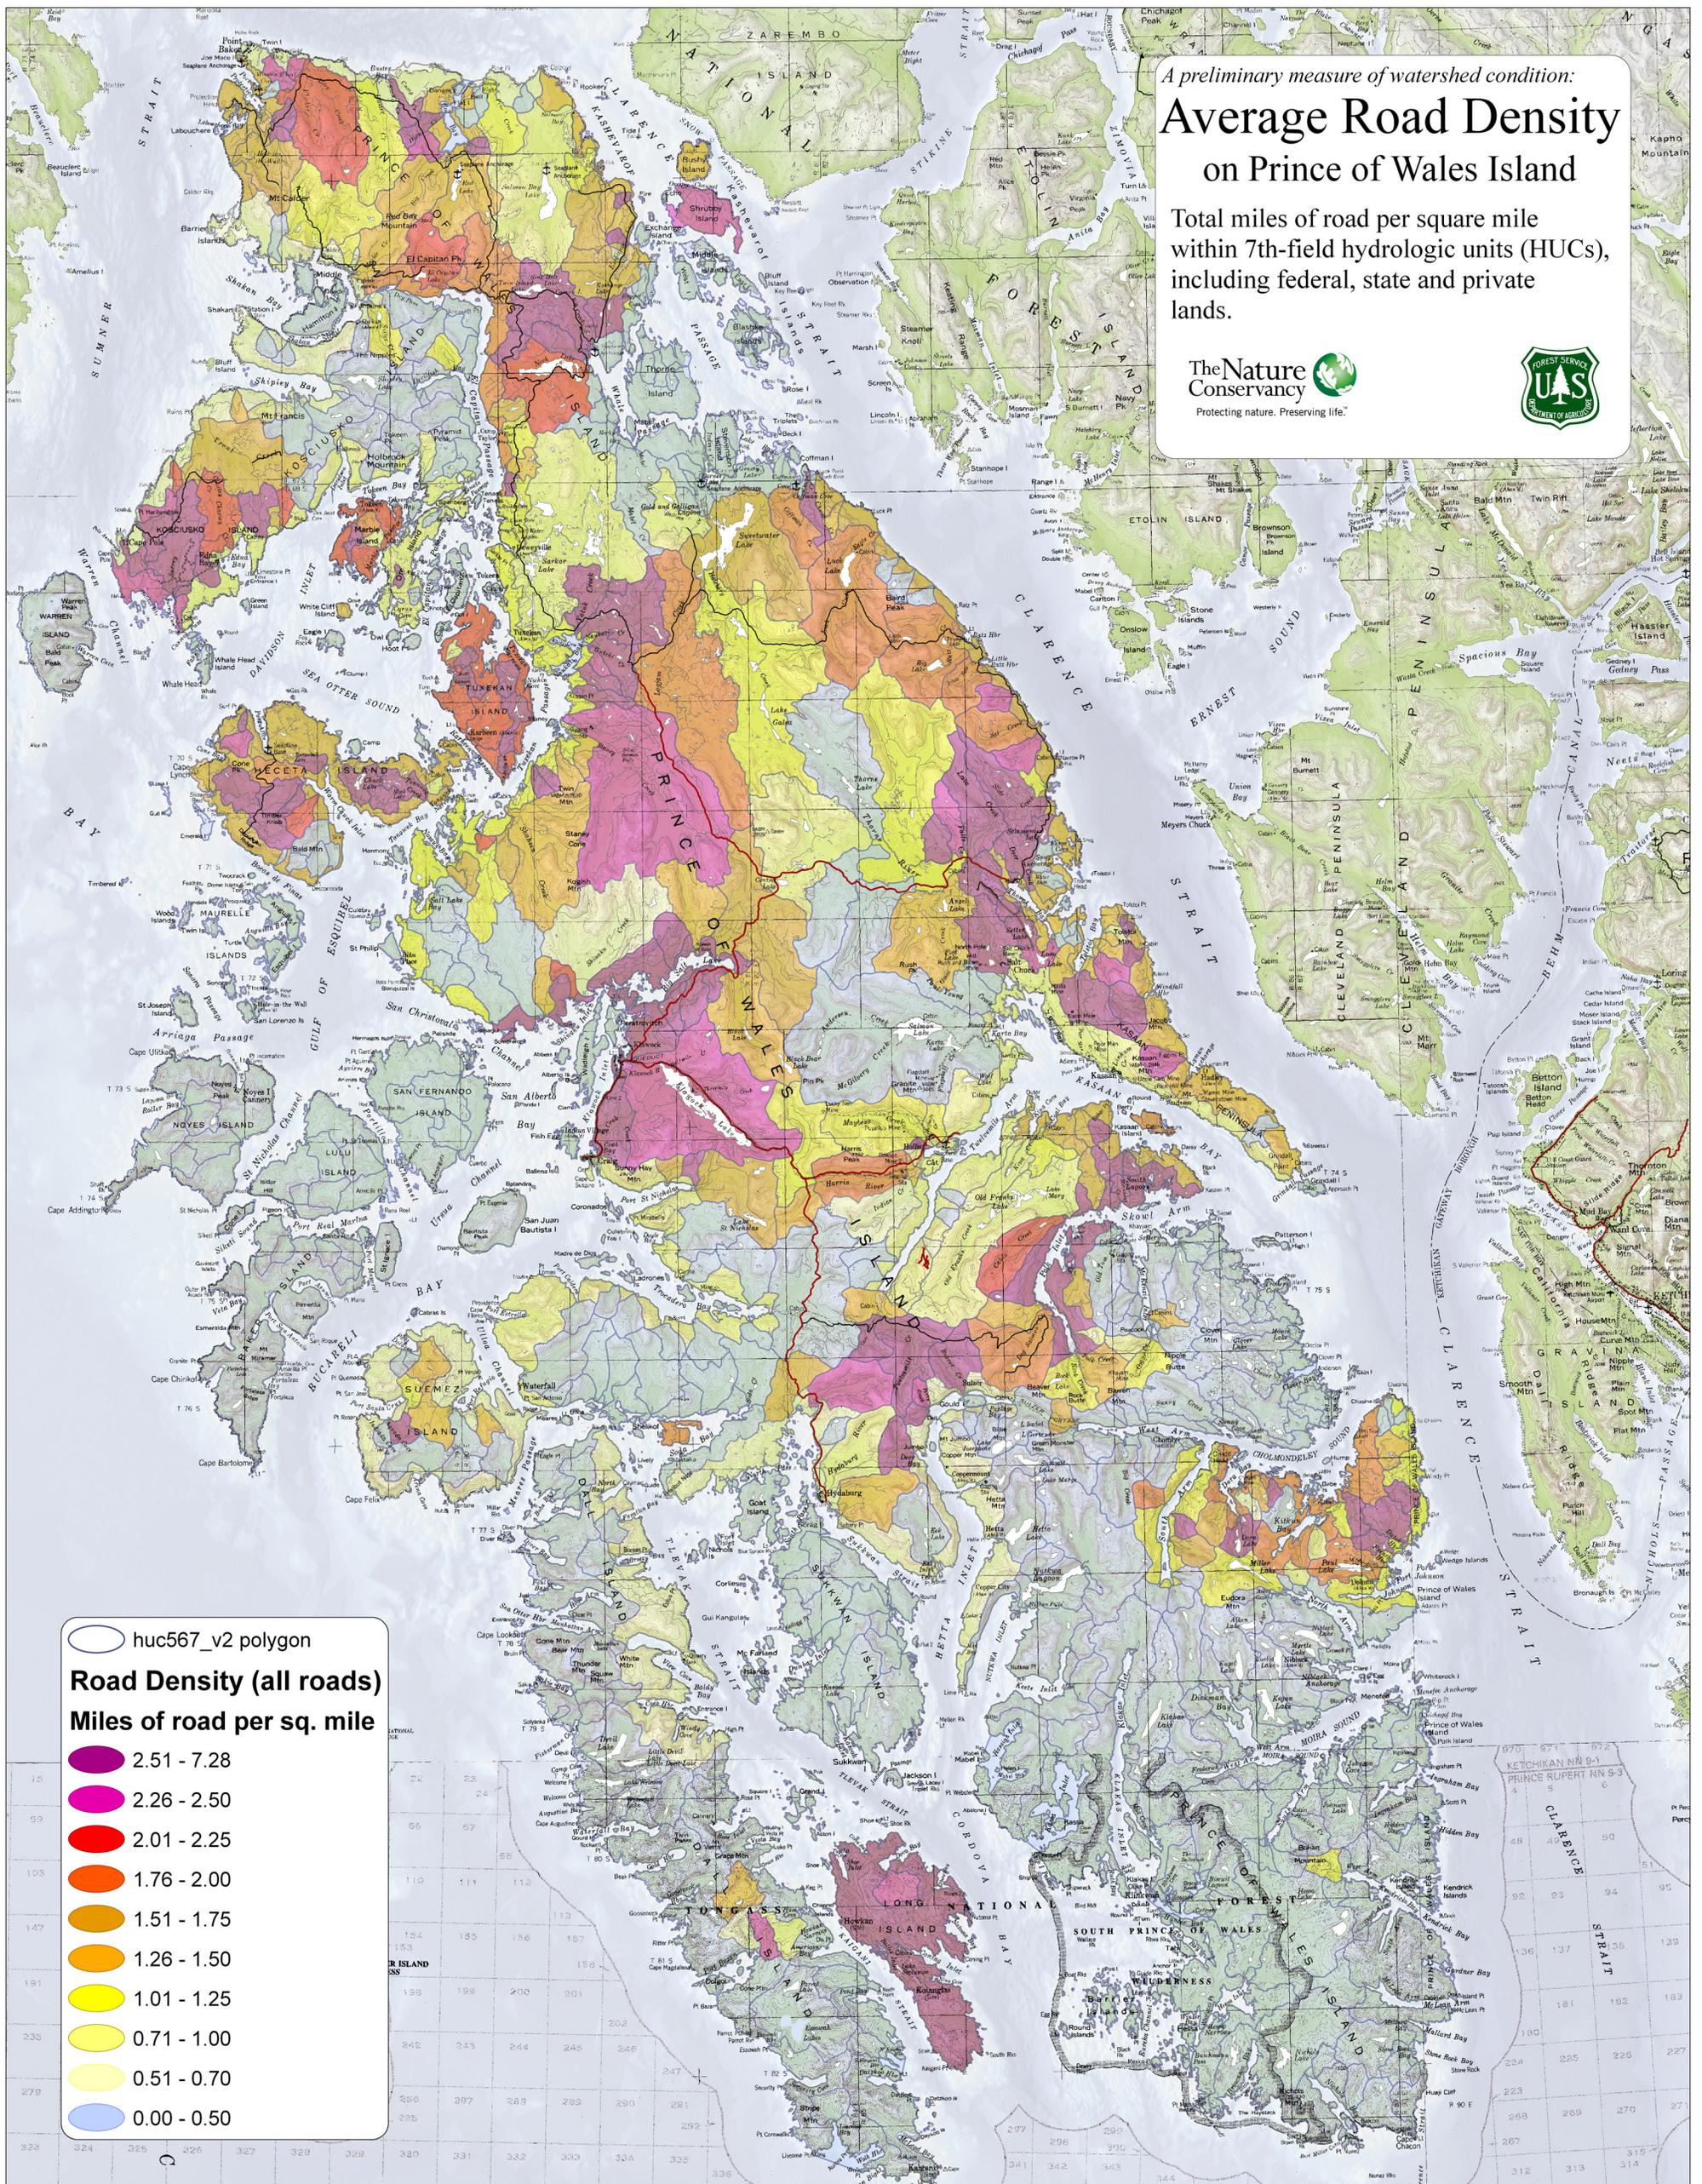
Figure 8. Road density on Prince of Wales Island and neighboring islands.

Habitat functions related to freshwater ecosystems that may be useful in evaluating restoration priorities include riparian functions; stream connectivity, water quality and water quantity (Table 5). Potential indicators for the condition of these functions for which data are available at a landscape scale include: percent of entire watershed or percent of riparian forest in young-growth; number of non-functioning (“red pipe”) culverts; number of road miles and total road density within a watershed (Fig. 8).
