A Framework for Setting Watershed-scale Priorities for
Forest and Freshwater Restoration
on Prince of Wales Island

September 30, 2008

**The Nature Conservancy
Alaska Field Office
Juneau, Alaska**

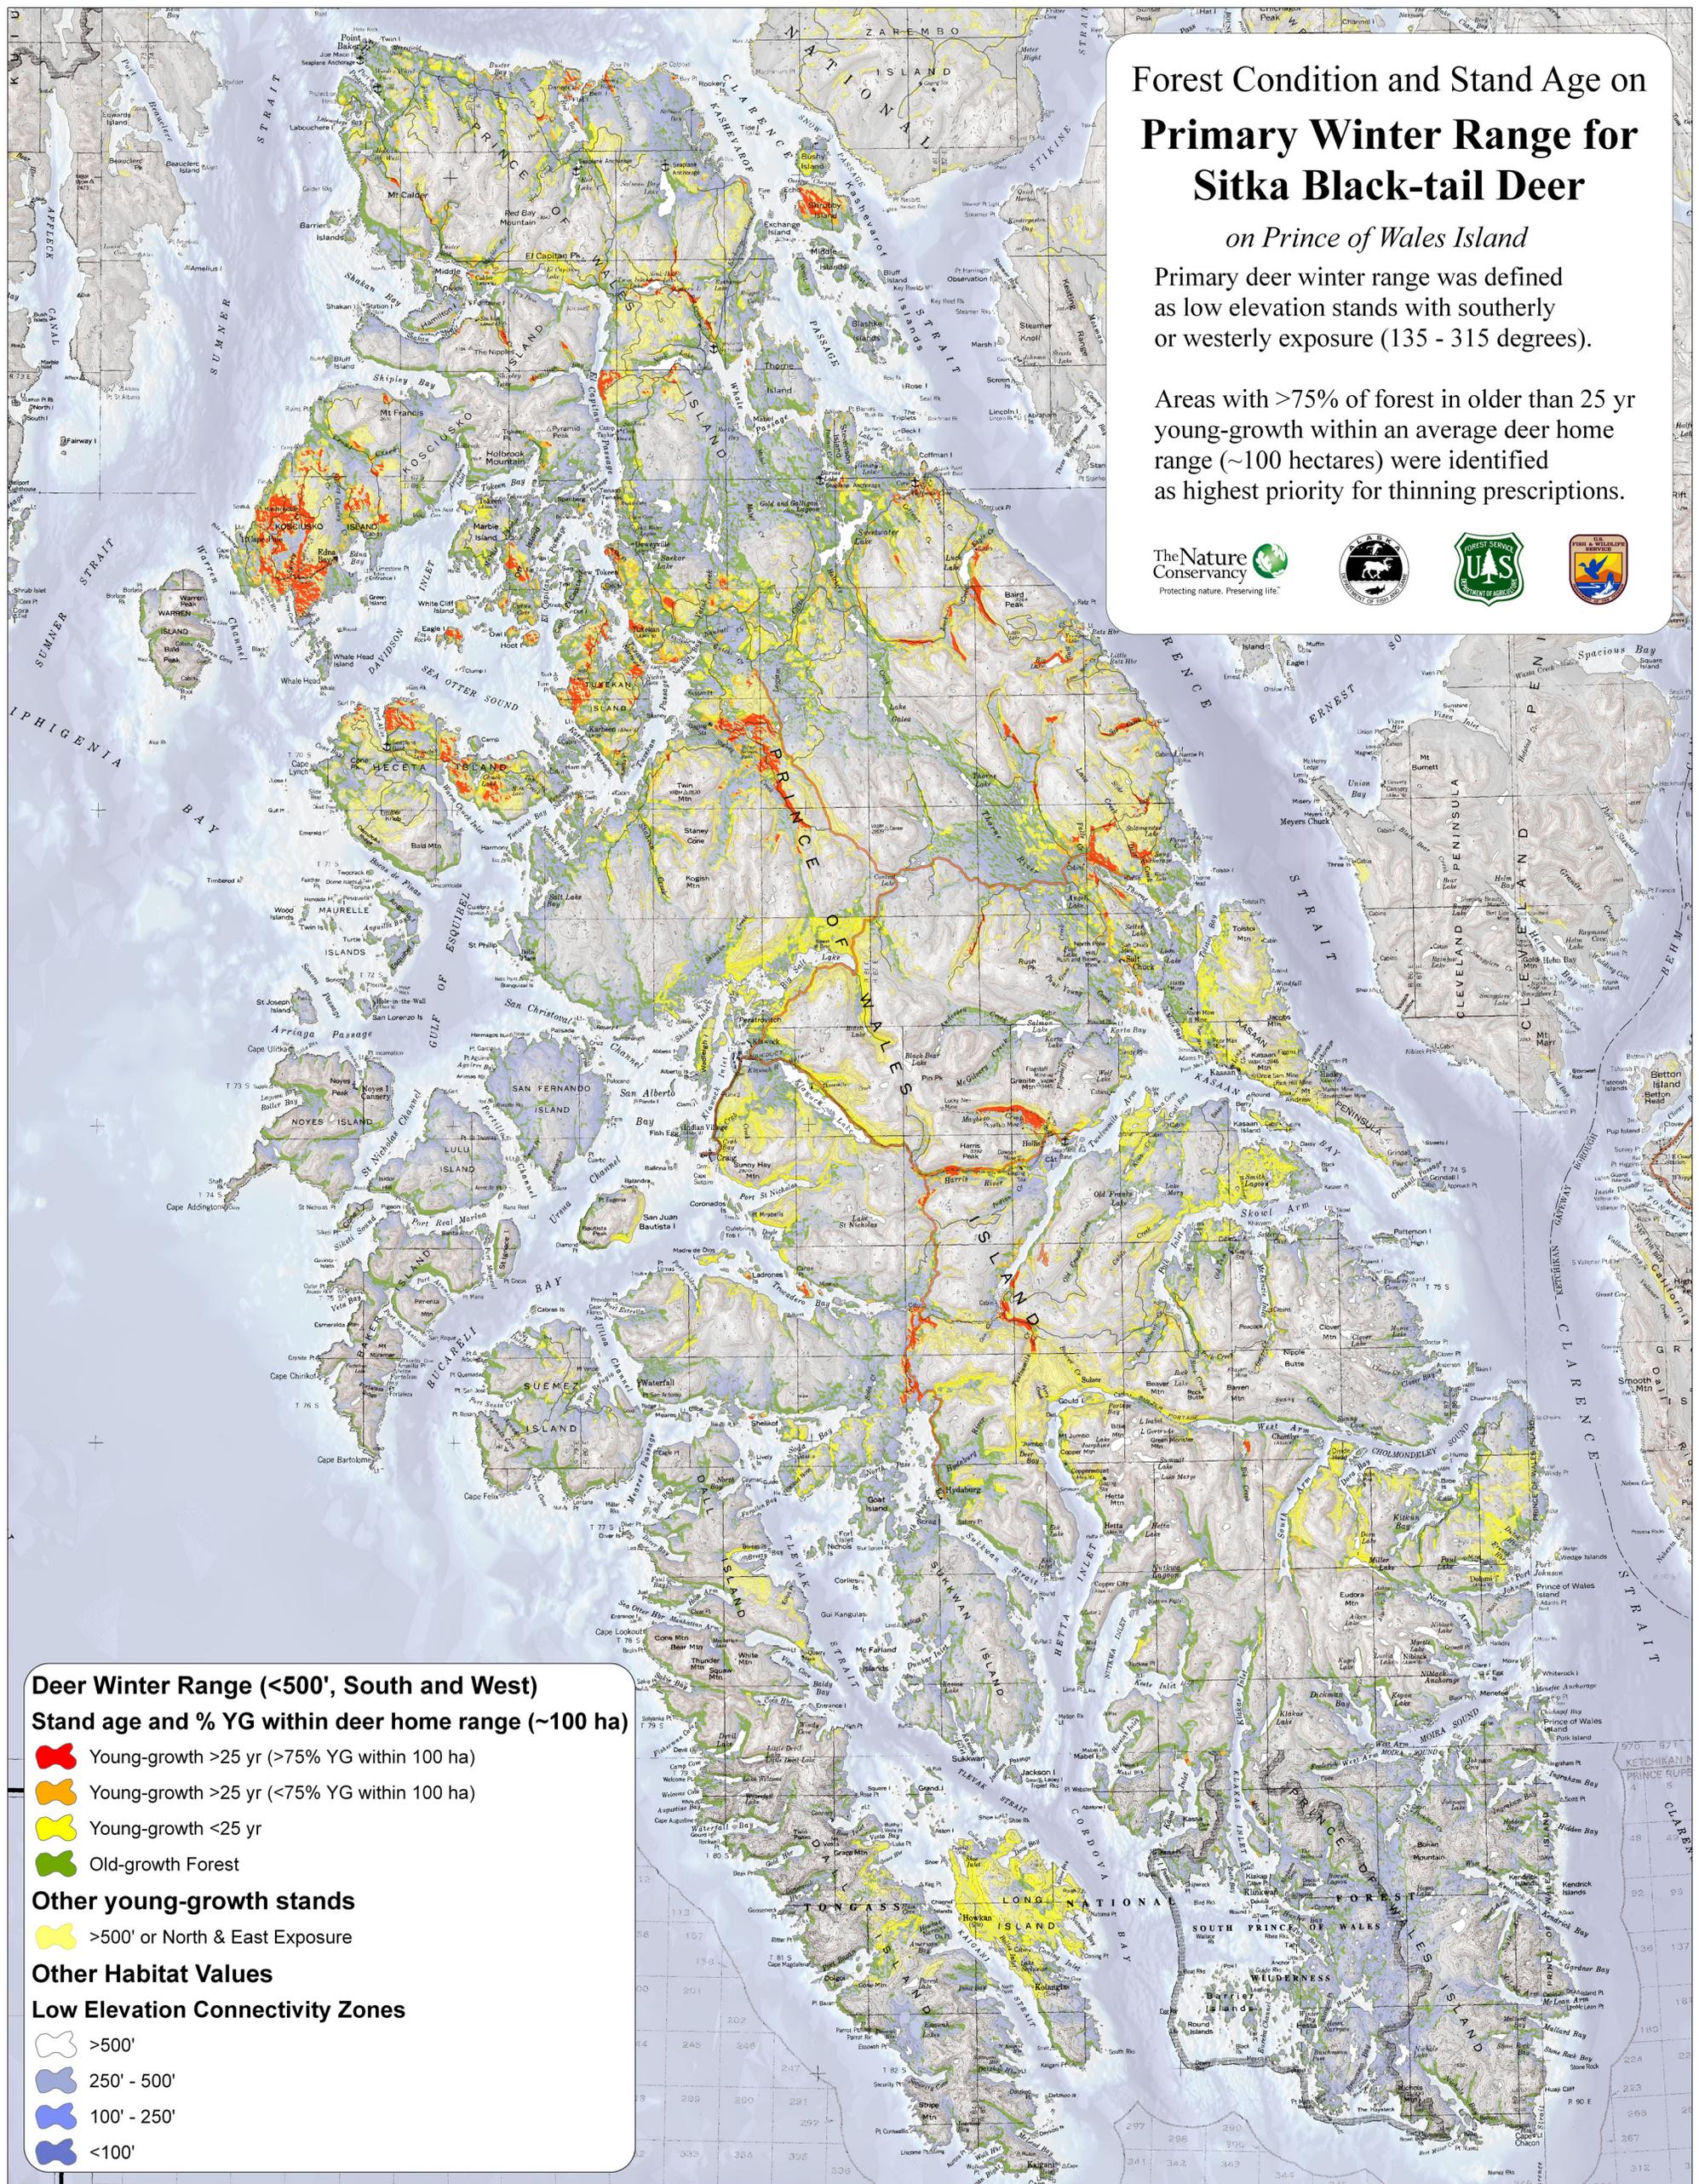
Figure 9. A landscape-scale assessment of the condition of winter range for Sitka black tailed deer on Prince of Wales Island

For the purpose of this analysis, we characterized high-value winter range as all productive forest lands that occur at elevations less than 500' with a southerly or westerly exposure (135 – 315 degrees) (Table 4). Within these lands, we defined the relative condition of deer habitat as the percent of all productive forest lands in young growth that is >25 years old (i.e., closed canopy), young growth that is <25 years old or in old growth condition. In general, we interpreted the need for restoration to be proportional to the percent of all winter range that is in closed canopy young growth within a watershed. At a landscape scale, areas where such closed-canopy young growth comprise a high percentage of all winter range within an average deer's home range (Fig. 9, shown in red) are likely places where deer populations are most in need of habitat enhancement and restoration.

Based on this analysis, we identified 373,849 acres characterized as primary winter range; 75.6% of which is currently in old-growth condition, and 24.4% of which is in young growth. Moreover, approximately 11% of all primary winter range is in young growth >25 years old (Appendix C).

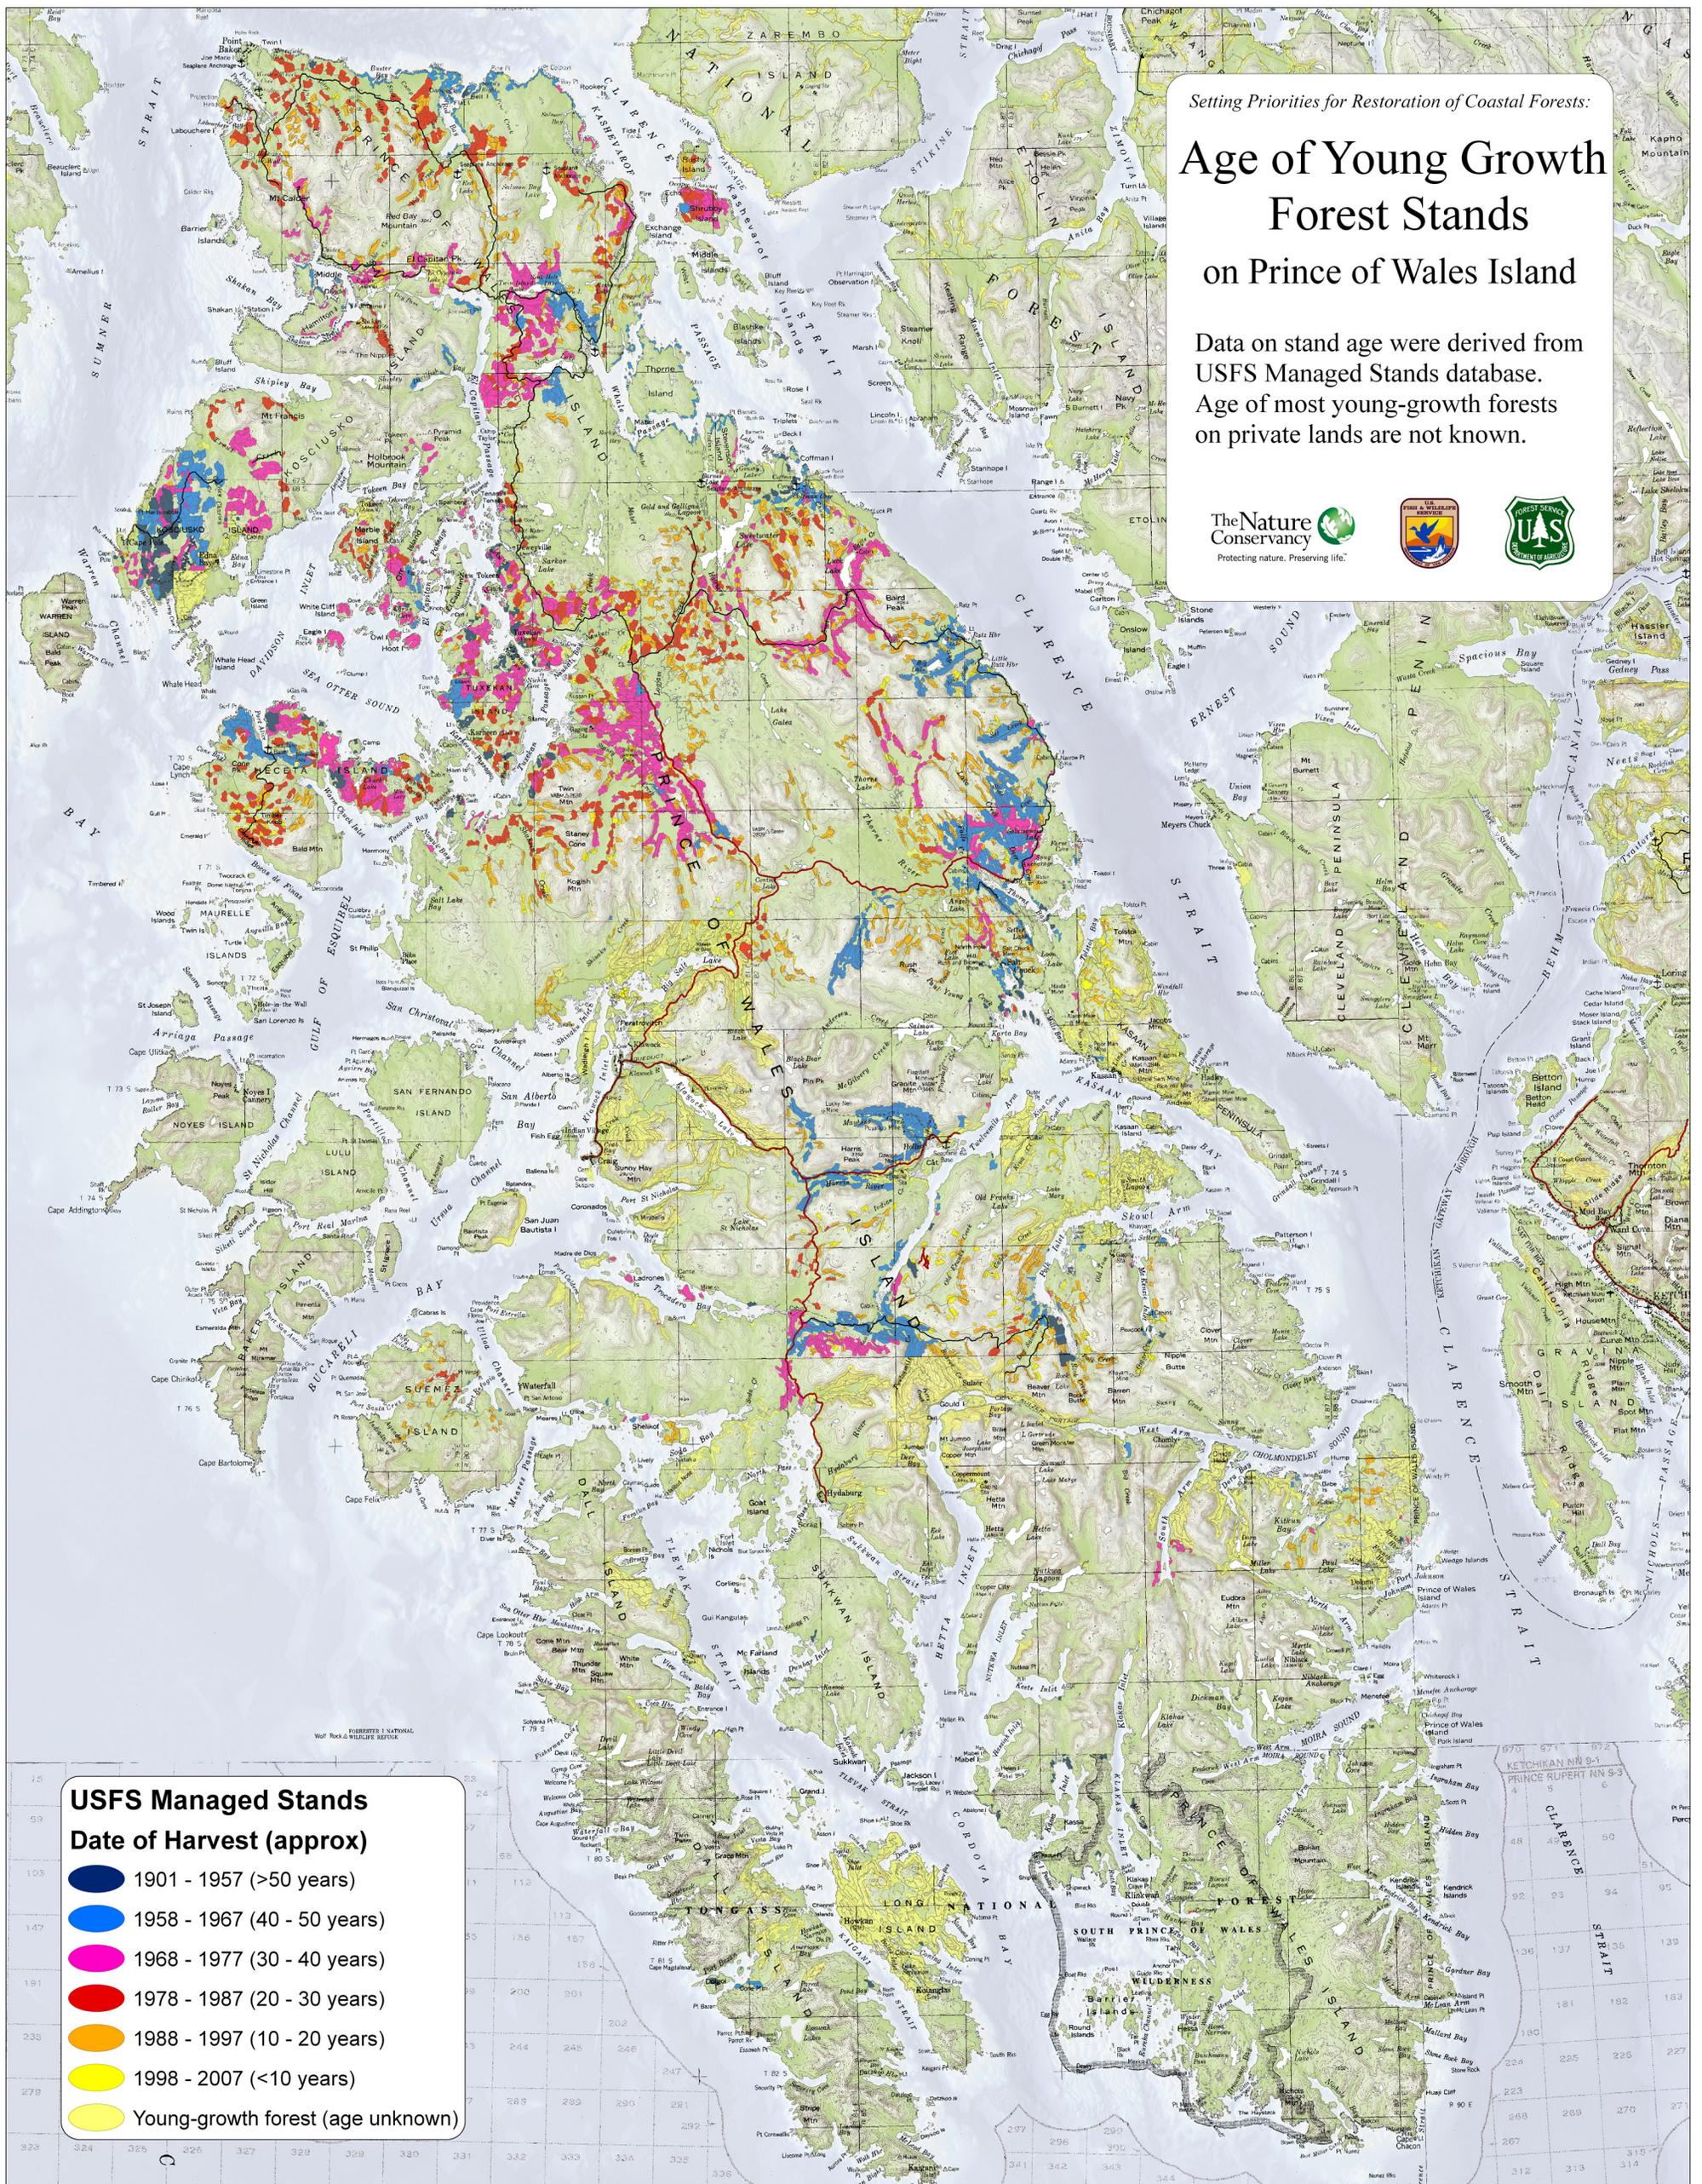
Figure 10. Age of young growth stands on Prince of Wales Island

Based on the USFS Managed Stands inventory, a total of 49,551 acres of young-growth forest exist on Prince of Wales Island that is at least 40 years old; with 41,568 ac. in 40-50 years and 7,983 ac. in > 50 year-old young growth (Appendix E). Of the acres >50 years old (representing current potential for commercial thinning); 4,535 acres (56.8%) occur within Development LUDs, 516 acres (6.4%) occur in Natural Setting; 2,065 acres (25.8%) occur within Beach Fringe and 867 acres (10.8%) occur within Riparian Buffers under the 1997 TLMP. Kosciusco Island contains a total of 3,751 acres of >50 year-old young growth, which represents 47.0% of all such stands in the Prince of Wales Island group. Other areas with high potential for commercial thinning (i.e., >50 year old young growth) include Northwest Prince of Wales Island (1,015 acres; 12.7%) including Staney Creek and POW – Sea Otter Sound, and Skowl Arm (849 acres; 10.6%) which includes the Polk Inlet – Skowl Arm Frontage. Within the Beach Fringe, largest areas of >50-year young-growth include within Northwest Prince of Wales (471 acres), Kasaan Bay (388 acres), Skowl Arm (261 acres), and Tuxekan Island (223 acres); and Southwest Prince of Wales (222 acres). The Prince of Wales Island – Sea Otter Sound “watershed” (HUC6) within the Northwest Prince of Wales area (HUC5) is the site of the Winter Harbor project to improve habitat values for deer using commercial thinning as a primary treatment.

Within the >40 year-old cohort, the distribution of young growth opportunity shifts to the Luck Point to Fores Cove (i.e., Cobble Landscape, 5,387 acres); Harris River (2,930 acres), Twelvemile Creek (2,913 acres), Maybeso Creek (2,889 acres); and Ratz Creek (2,364 acres). Collectively, Kosciusco Island (6,428 acres) and Thorne River (5,070 acres) also contain a significant area of young growth in the 40-50 year old cohort.

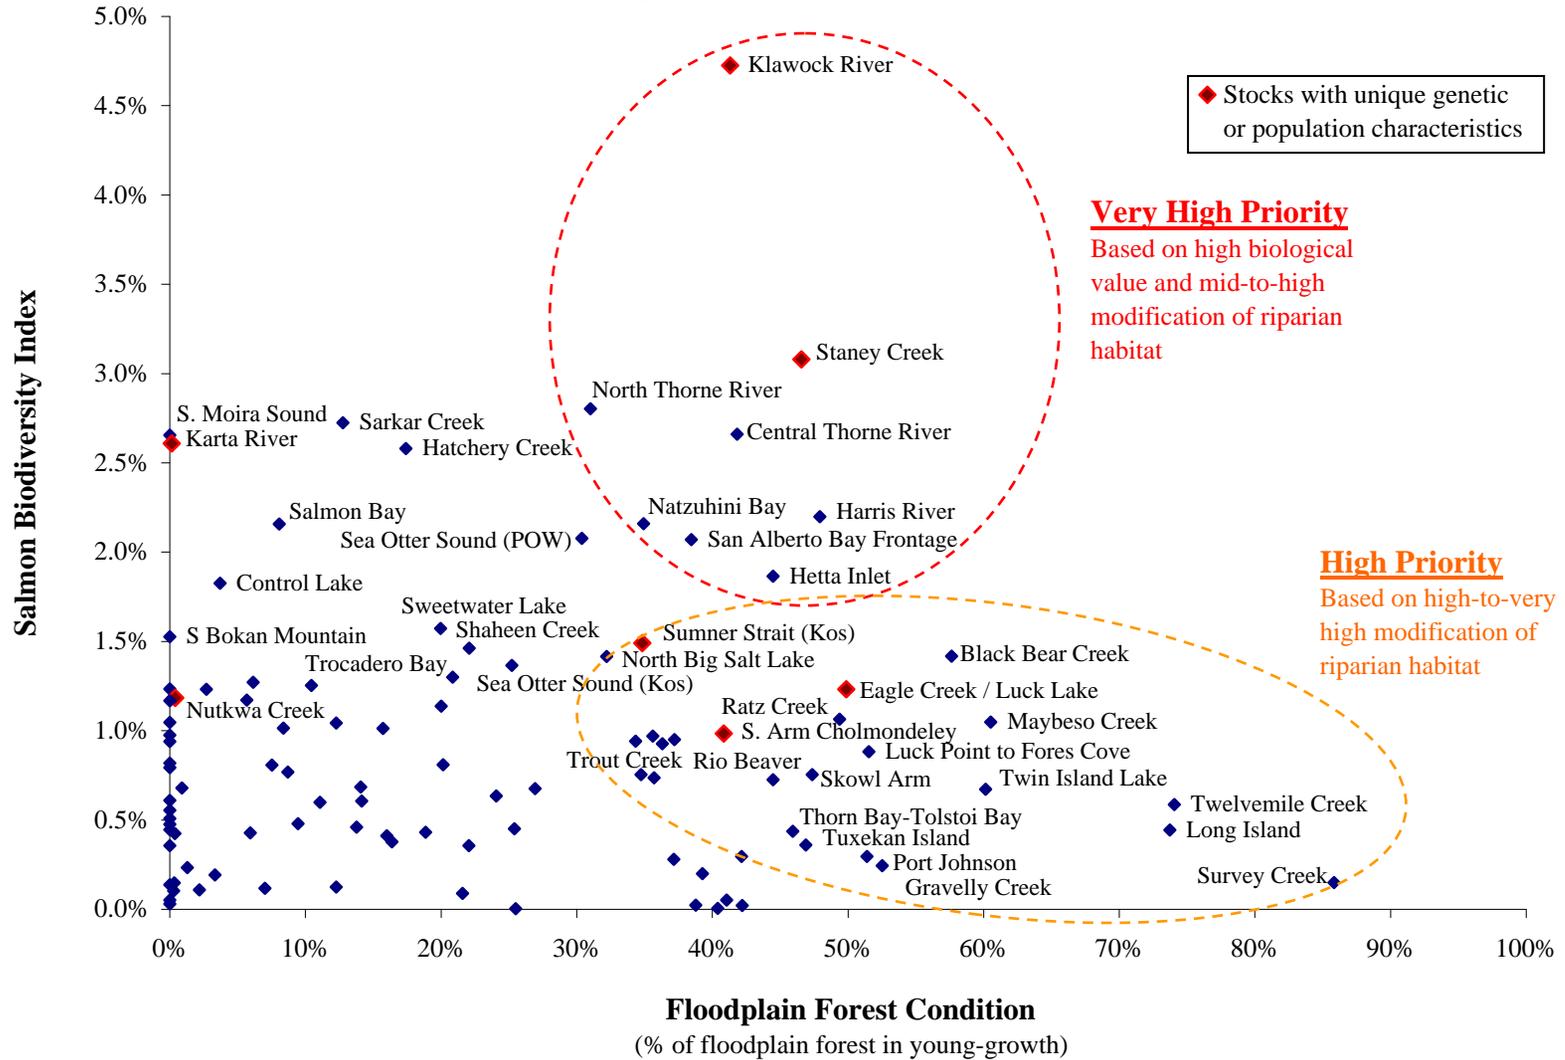
Figure 11. A framework for setting restoration priorities based on freshwater salmon distribution and floodplain forest condition among watersheds on Prince of Wales Island.

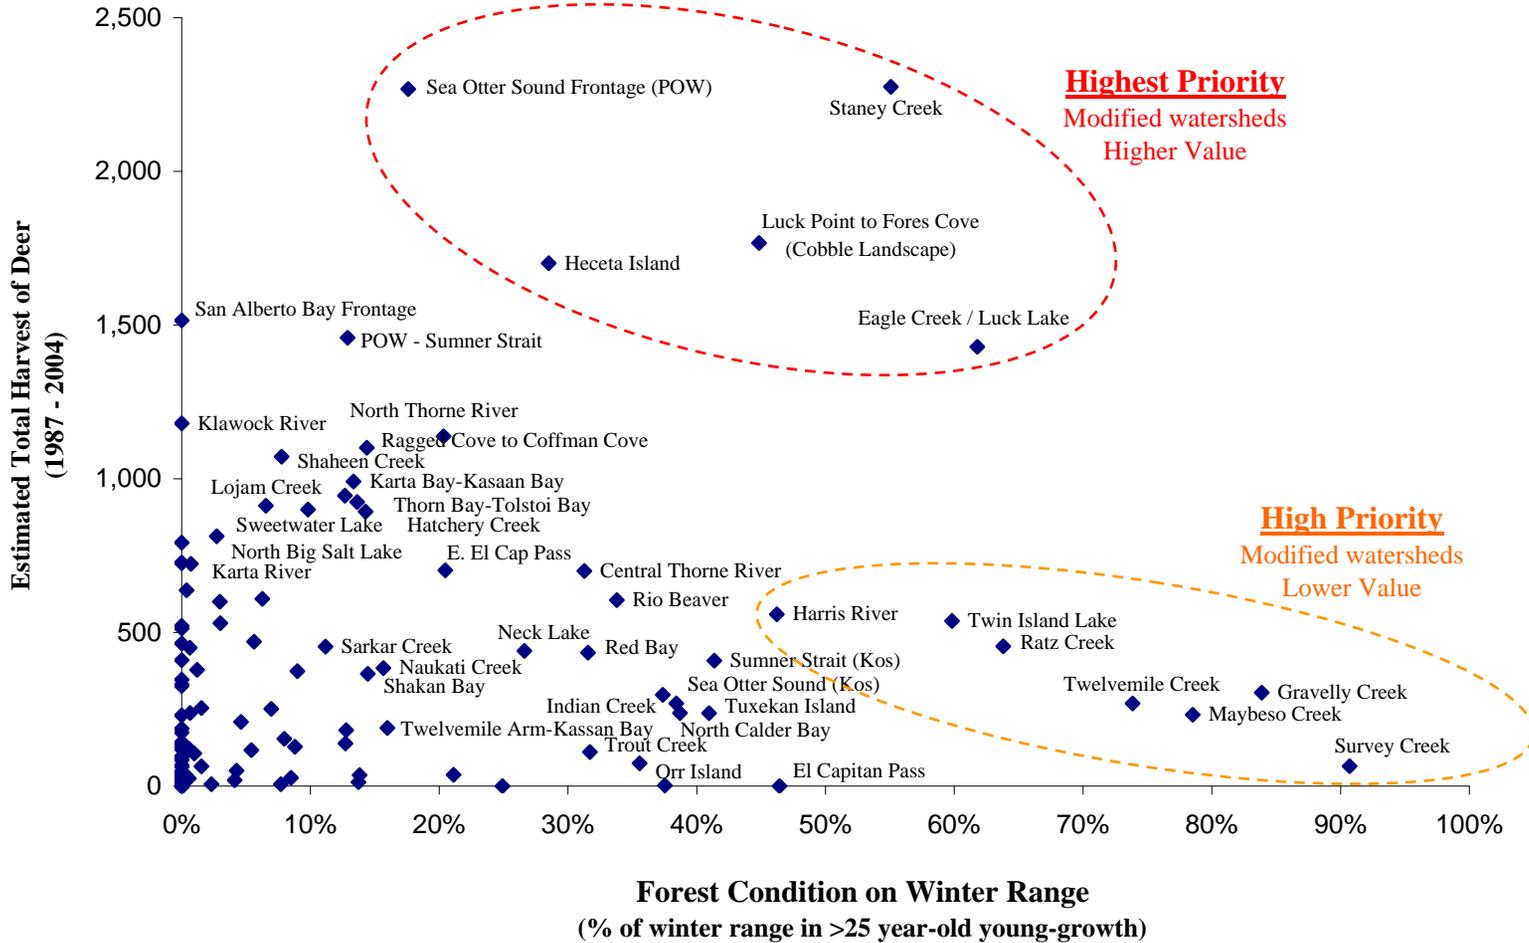
Figure 12. A framework for setting restoration priorities based on deer harvest and forest condition on winter range among watersheds on Prince of Wales Island.

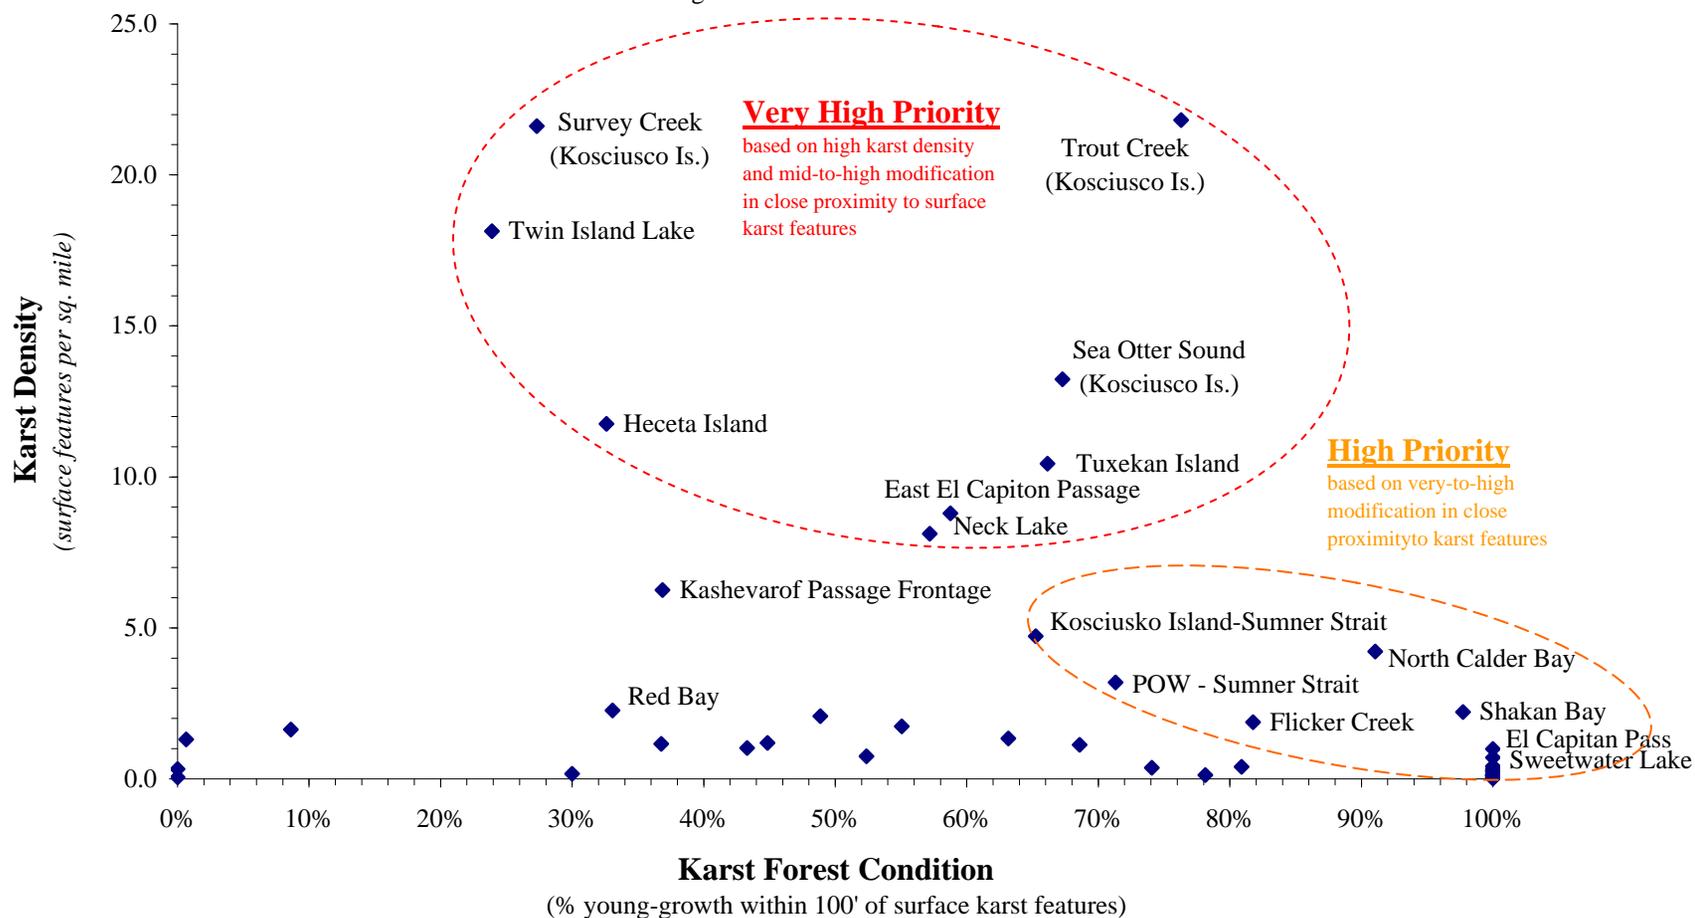
Figure 13. A framework for setting restoration priorities based karst density and forest condition among watersheds on Prince of Wales Island.

We describe watersheds in three situations that can be considered high priority for restoration. The first set includes watersheds with very high biological and / or social values that contain mid-to-high levels of modification of important ecological systems and functions. Based on the biological or social values, these watersheds are considered to be "very high priority" for restoration. In the freshwater environment, these watersheds include Klawock River, Stoney Creek, North and Central Thorne River, Harris River, Natzuhini Bay, San Alberto Bay Frontage and Hetta Inlet (Fig 11). In the terrestrial environment, these include Stoney Creek, POW - Sea Otter Sound Frontage, Luck Point to Forest Cove, Heceta Island and Eagle Creek / Luck Lake (Fig 12). Priorities based on surface karst features include Survey Creek, Trout Creek, and Sea Otter Sound – all located on Kosciusko Island, Twin Island Lake, Tuxekan Island, East El Capitan Passage, and Neck Lake (Fig 13).

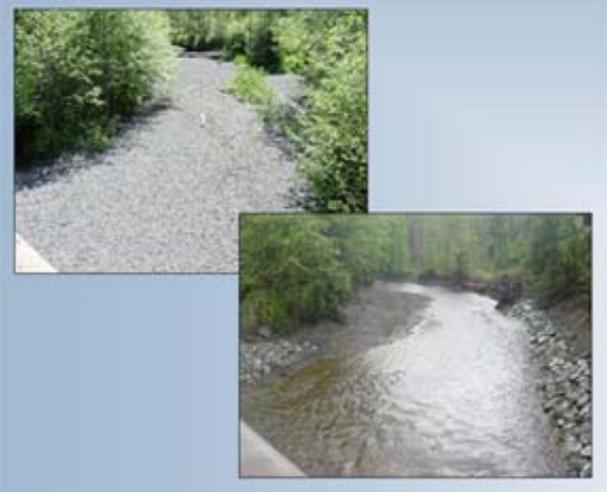
<p>Figure 14. Restoration of historic stream channel (from Prussian et al., 2006)</p>
<p>Pre-project Condition</p> <ul style="list-style-type: none"> ❖ Excessively accumulated sediments, app. 2000 ft <ul style="list-style-type: none"> • reduced channel slope and decreased ability to transport sediment • buried large wood and other channel forming materials • raised the channel to the elevation of the floodplain ❖ Inadequate fish passage and loss of fish habitat <ul style="list-style-type: none"> • Existing condition of culverts did not provide fish passage at all required flow conditions • Fish (adult and juvenile) use original channel during high flows and become trapped during storm recession ❖ Road Maintenance Concerns <ul style="list-style-type: none"> • Existing culverts used to accommodate flow inhibit fish passage • Large wood transported during high flow commonly blocks culverts inhibiting flow

<p>Restoration Included:</p> <ul style="list-style-type: none"> ❖ Reconstruction of 2400 ft of channel - 2006 <ul style="list-style-type: none"> • 5 log jams engineered for hydraulic and ecological functions • 2 log drop structures at existing culvert inlets to maintain flood elevation • pool and riffle sequences • enhancement of floodplain to restore flood processes ❖ Removed drainage structures and closed 1.2 miles of road- 2004 ❖ Collected large wood material (200 logs) for use in channel reconstruction - 2004 and 2006 ❖ Total project cost including assessment, design and implementation: \$500,000 ❖ Over 600 salmon spawning in the targeted section of Fubar Creek within 2 weeks of project completion (Prussian et al., 2006)

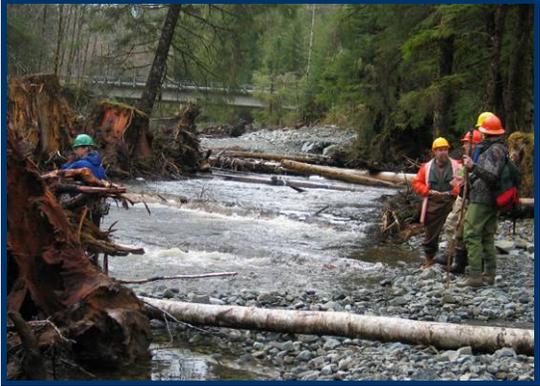
<p><i>(Photo by K Koski)</i></p> <p>Figure 15. Fubar Creek restoration work addressed sedimentation concerns, enhanced fisheries habitat, and re-established fish passage across the road. Notice the large woody debris placed in stream and water flowing in the historic channel.</p>

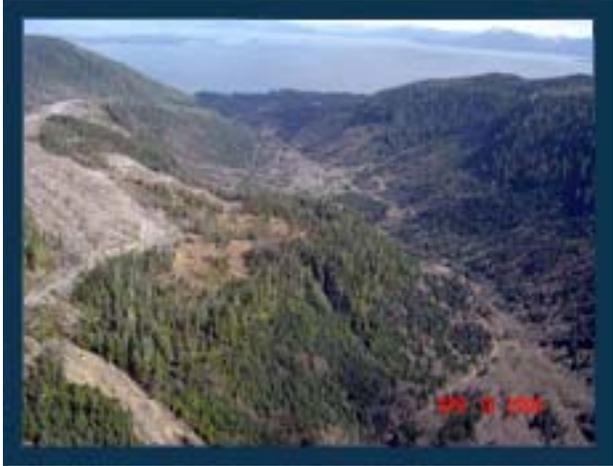
<p>Figure 16. The goal of the Sal Creek Watershed Restoration Project was to restore fisheries production and biodiversity. (Prussian & Bair, 2007) Note the extent of red alder trees (as non-green vegetation) along hillsides and the valley bottom.</p>
<p>Pre-project Condition</p> <ul style="list-style-type: none"> ❖ Sal Creek watershed shows the effects of intensive and large scale timber harvest and road construction in the form of: <ul style="list-style-type: none"> • Landslide paths • widespread red alder regeneration along streams and non-native reed canary grass propagation along waterways and ponds (reed canary grass is largely associated with poor regeneration of trees) • erosion from roads within the floodplain • culverts that block both fish passage and tributary flows • poor wildlife forage and wintering grounds ❖ Additional density of food sources led to prolific beaver activity causing: <ul style="list-style-type: none"> • Closure of the mainstem of Sal Creek causing bank erosion and instability in the remaining overflow channels • less complex spawning and rearing areas for fish • less valuable substrates for spawning, and ultimately fewer numbers and species of fish

<p>Restoration Summary (Phase I):</p> <ul style="list-style-type: none"> ❖ Reconnected 23 tributary streams blocked by 1 mile of abandoned logging road ❖ Removed 4 log culverts that blocked fisheries access to nearly 1 mile of habitat along the same road ❖ Thinning 50 acres of red alder within the riparian and floodplain area ❖ Strategically placed 85 whole trees to construct large woody debris (LWD) complexes to rehabilitate channel processes within disturbed reaches of stream 	<p>Phase II, Summer 2007</p> <ul style="list-style-type: none"> • Reconnect streams along half-mile of abandoned logging roads • Thinning 50 acres of dense alder stands to release conifers within the riparian and floodplain areas • Place additional 300 trees in the lower 3 miles of main-stem stream <p>The US Forest Service, in partnership with The Nature Conservancy and Trout Unlimited, has invested over \$360,000 in Sal Creek restoration work.</p>

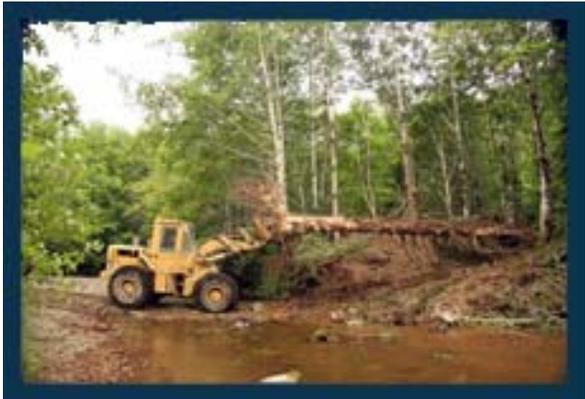
<p>Figure 17. Moving large woody debris into the stream channel to re-establish structure in a 1-mile stretch of Sal Creek</p>
