# An Environmental Streamflow Assessment for the Santiam River Basin, Oregon

Open-File Report 2012–1133

U.S. Department of the Interior  
U.S. Geological Survey

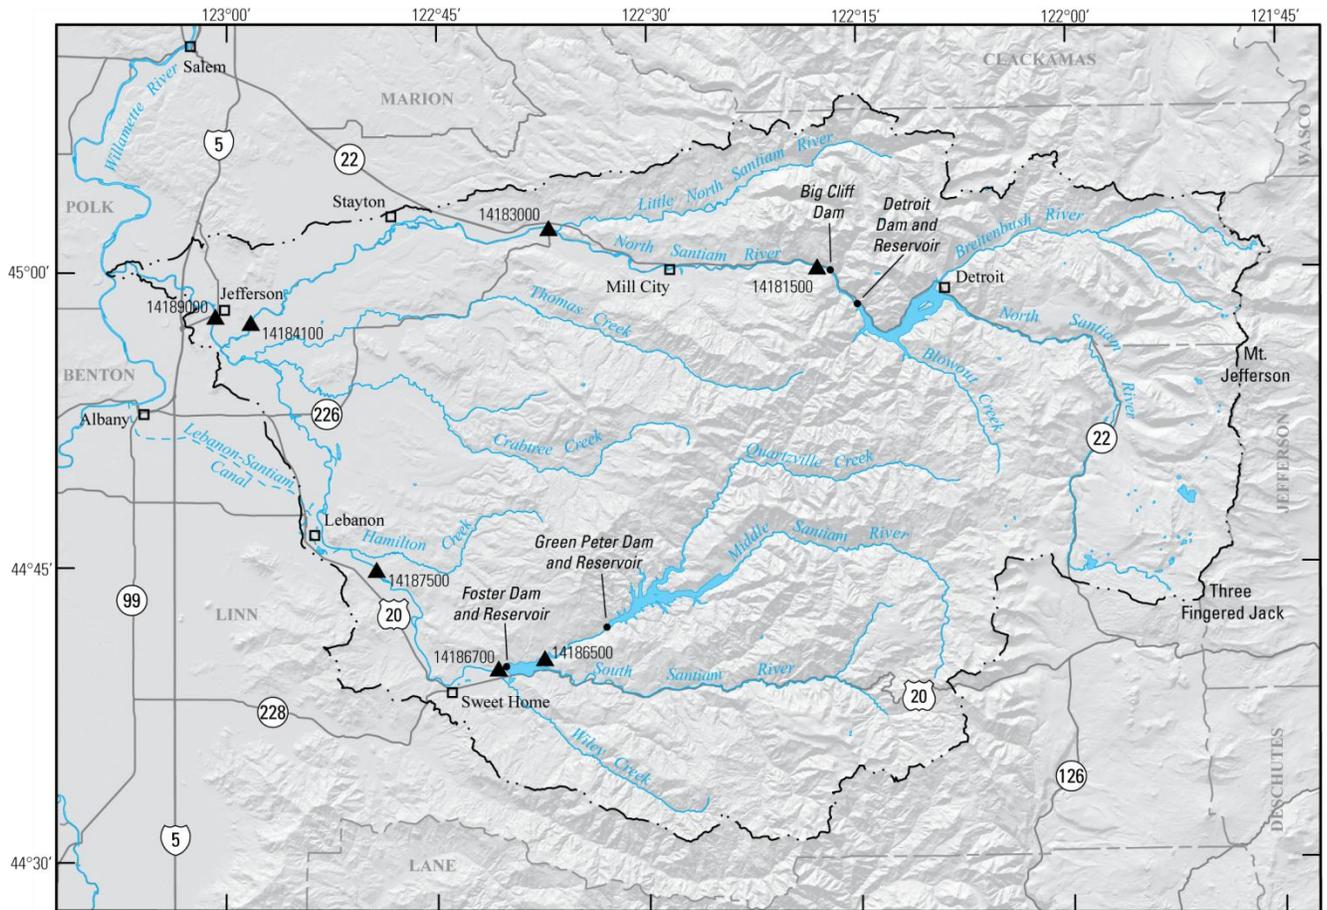
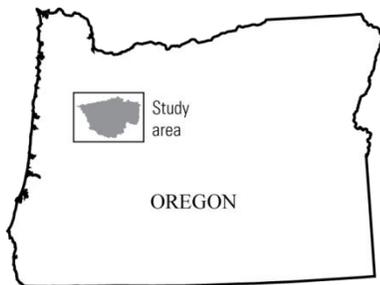
**Figure 1.** Map showing major streams and dams in the Santiam River basin, Oregon.

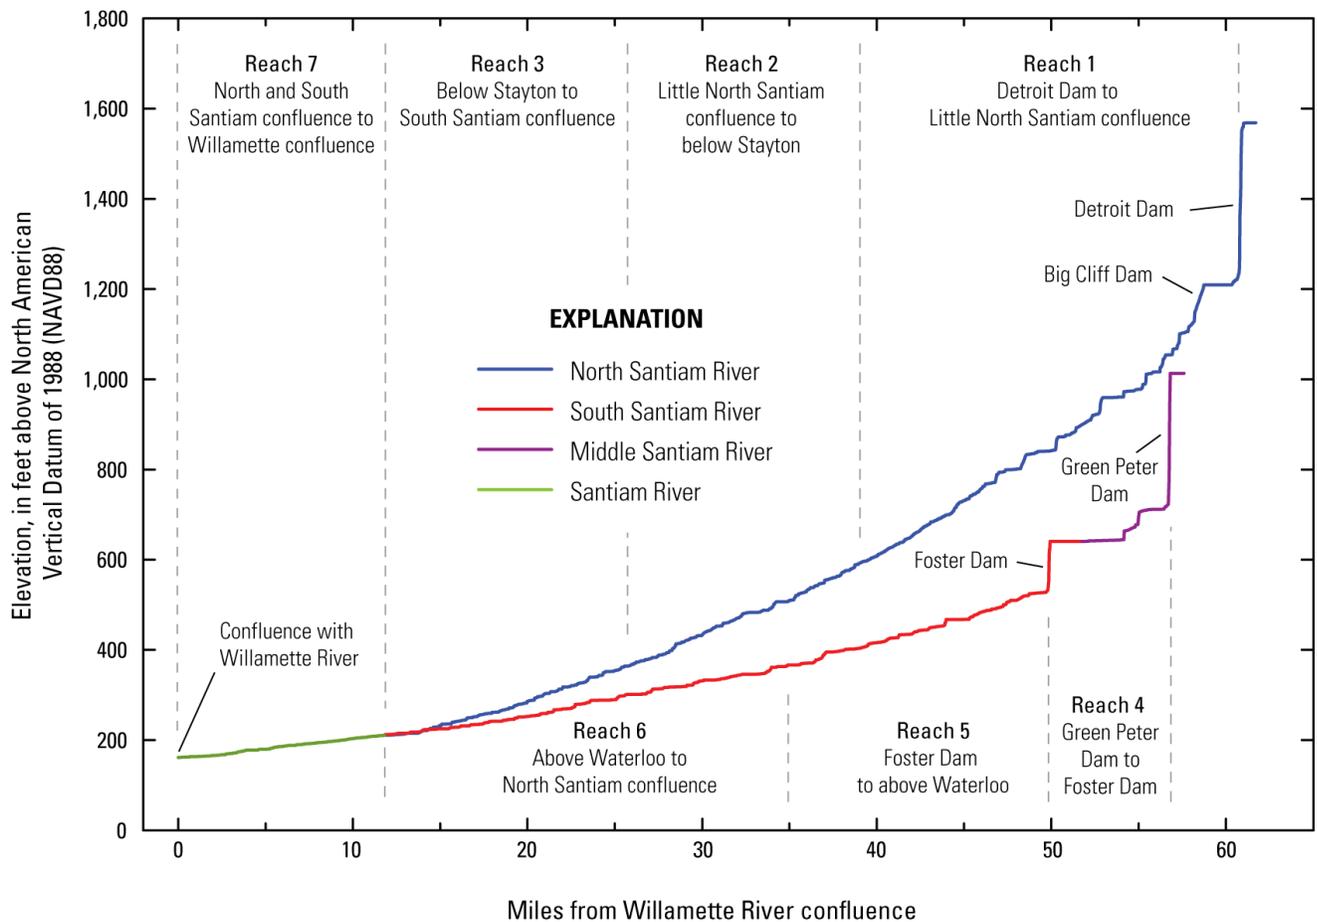
Figure 2. Diagram showing profile of the Santiam River basin, Oregon.

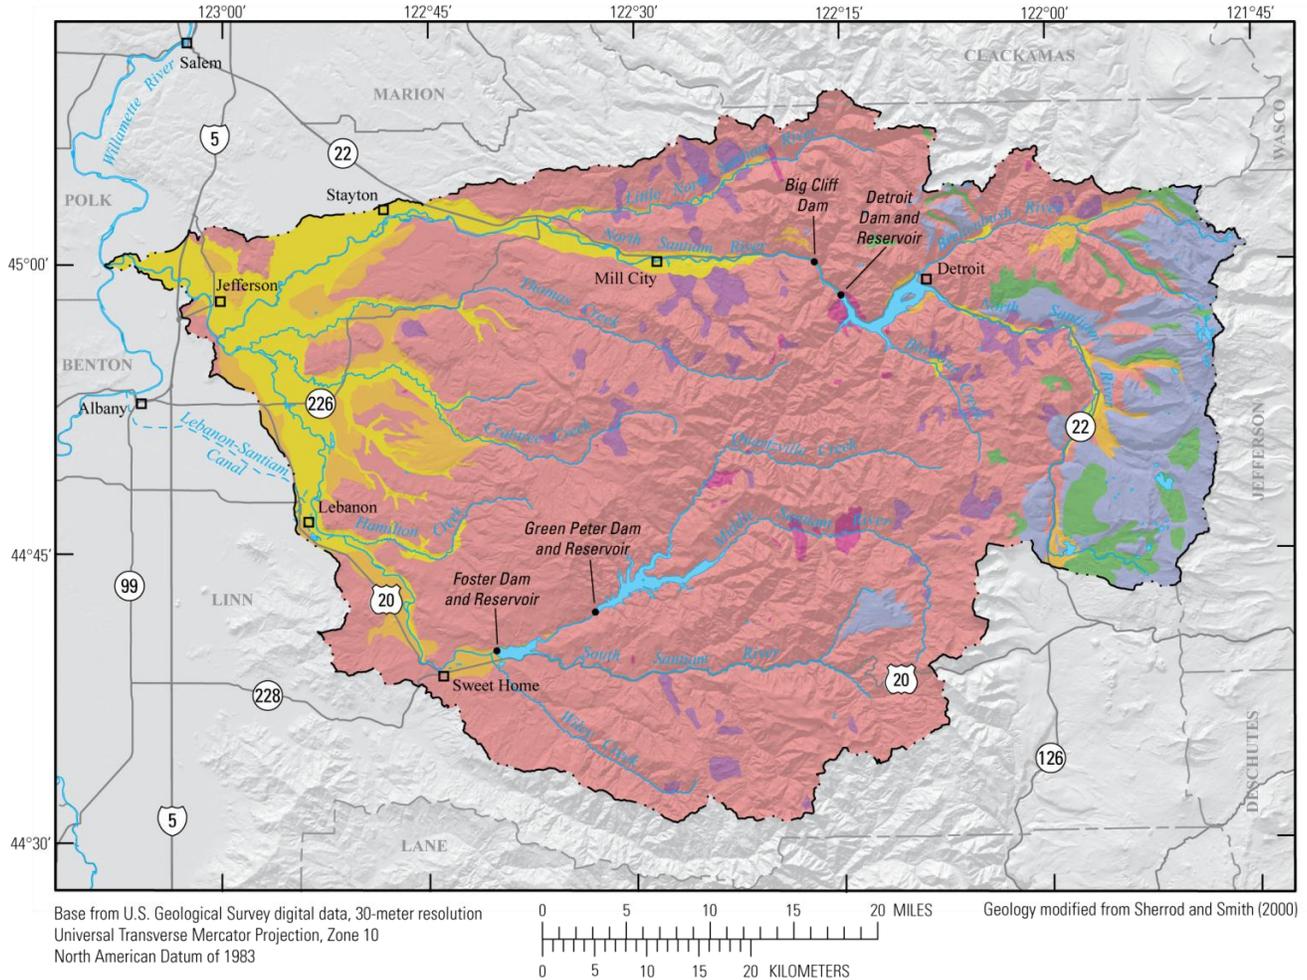
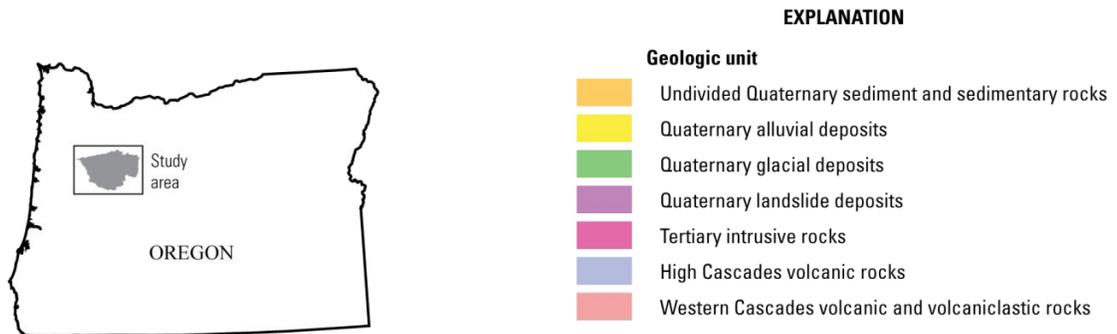
**Figure 3.** Map showing geology of the Santiam River basin, Oregon.

strained flood plain underlain by Quaternary alluvium (fig. 3). The economy of the Santiam River basin is supported by agriculture, timber harvesting, recreation, and manufacturing. Approximately 70 percent of the basin is forested. Timber is harvested on both private and Federal lands. Higher elevation areas in the basin are managed by the Willamette National Forest.

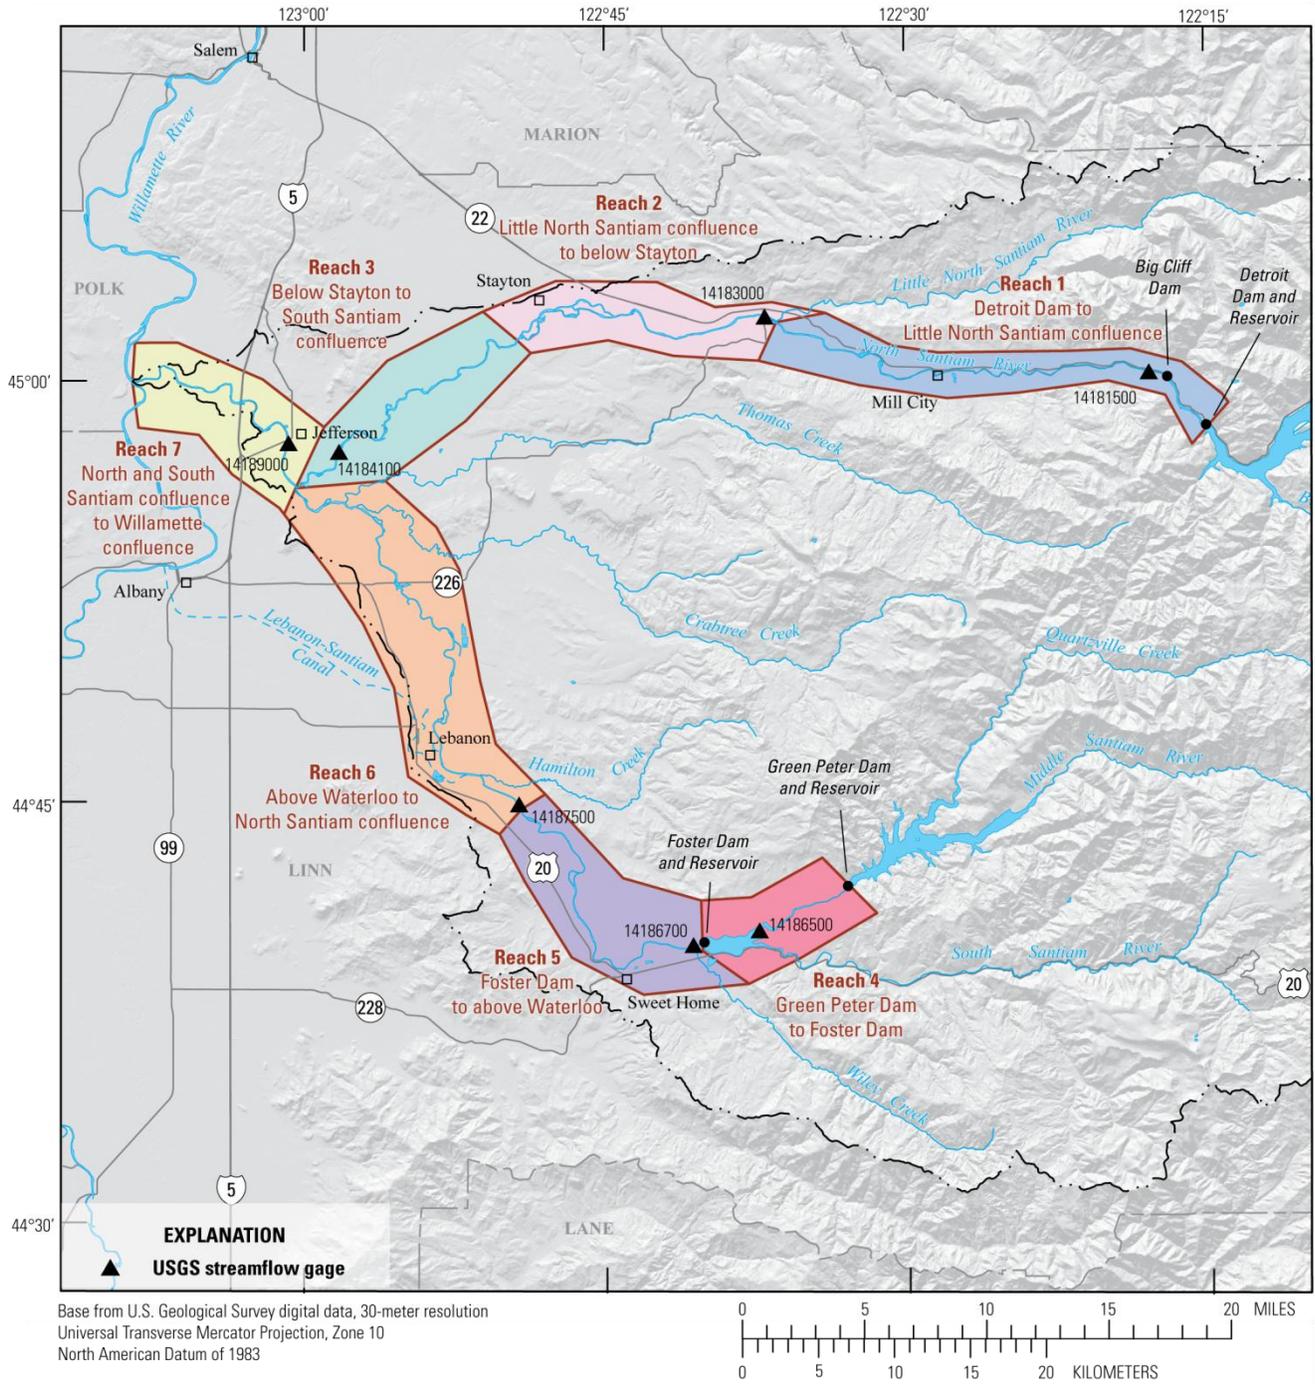
Figure 4. Map showing location of study reaches, Santiam River basin, Oregon.

The Santiam River system in the study area was divided into seven reaches, each having distinct streamflow, geomorphic, and ecological conditions (fig. 4, table 1). The North Santiam River portion of the study area was divided into three reaches. Reach 1 extends from Detroit Dam to the confluence of the Little North Santiam River. Reach 2 continues downstream to river mile (RM) 26 near Stayton. Reach 3 continues downstream to the South Santiam River confluence. The South Santiam River basin was also divided into three reaches. Reach 4 is along the Middle Santiam River, a tributary of the South Santiam River, between Green Peter Dam and Foster Lake reservoir. Reaches 5 and 6 extend

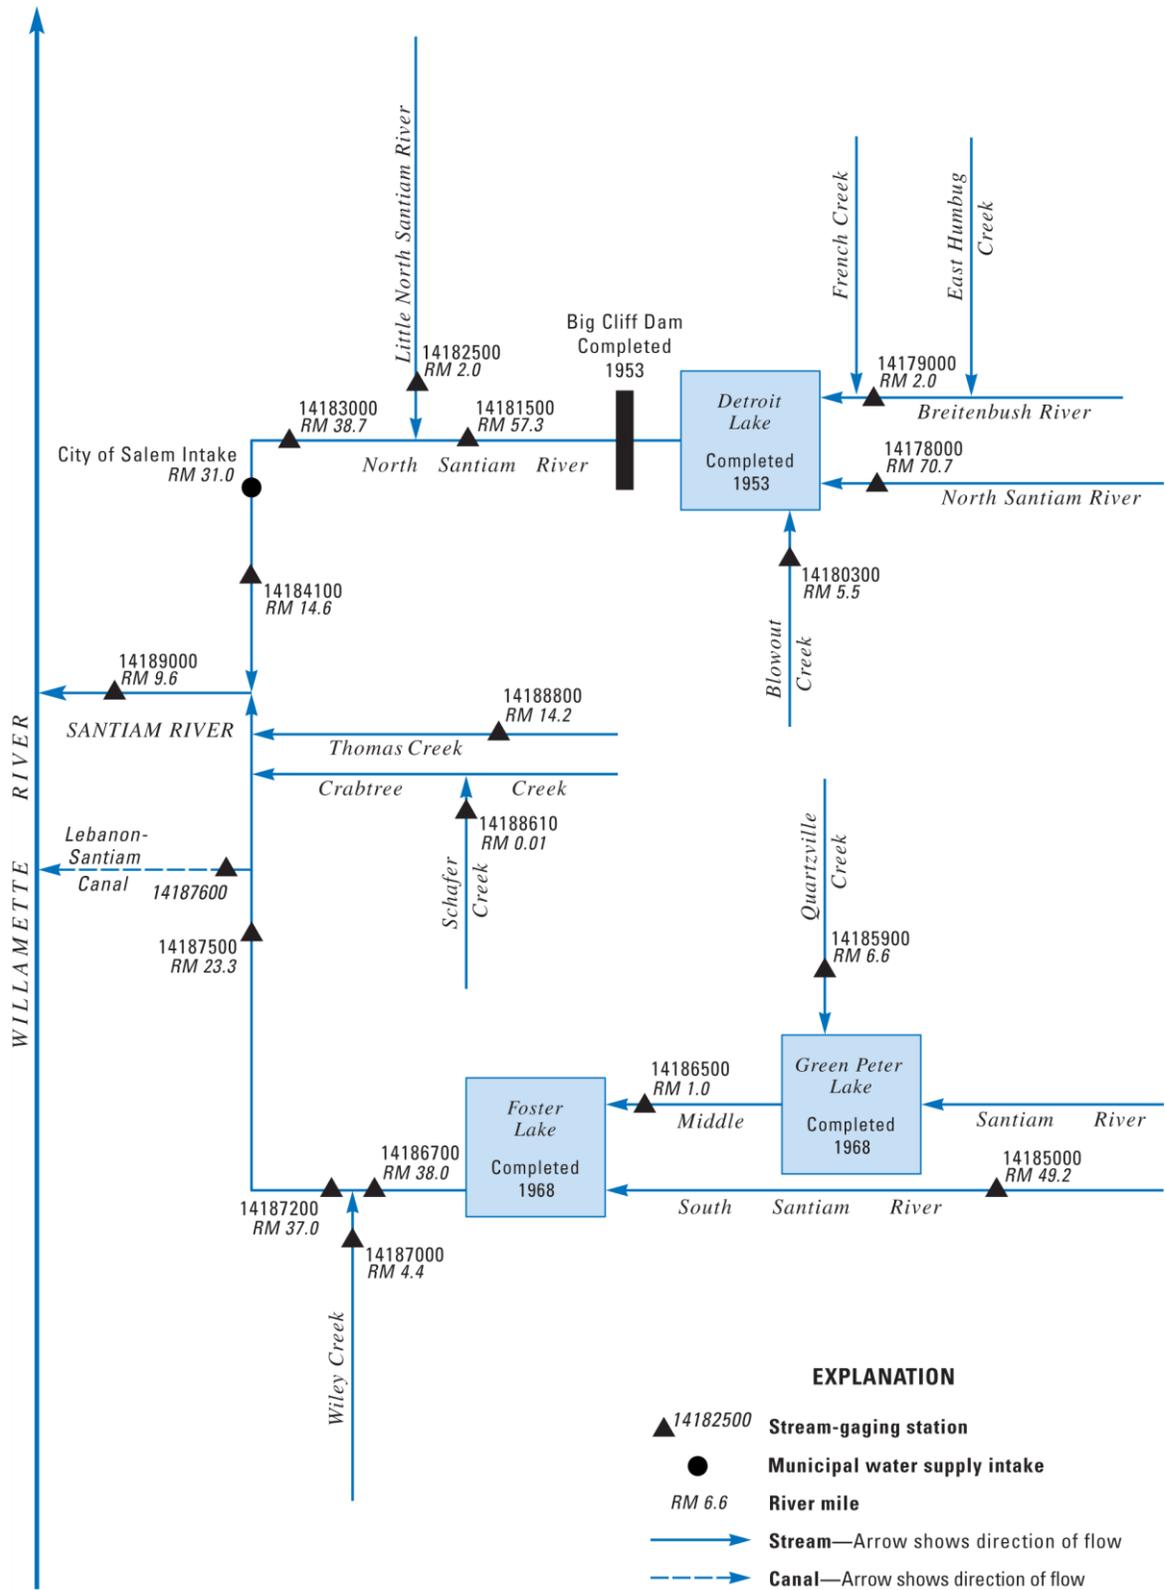
Figure 5. Diagram showing dams and selected streamflow gaging stations in the Santiam River basin, Oregon.

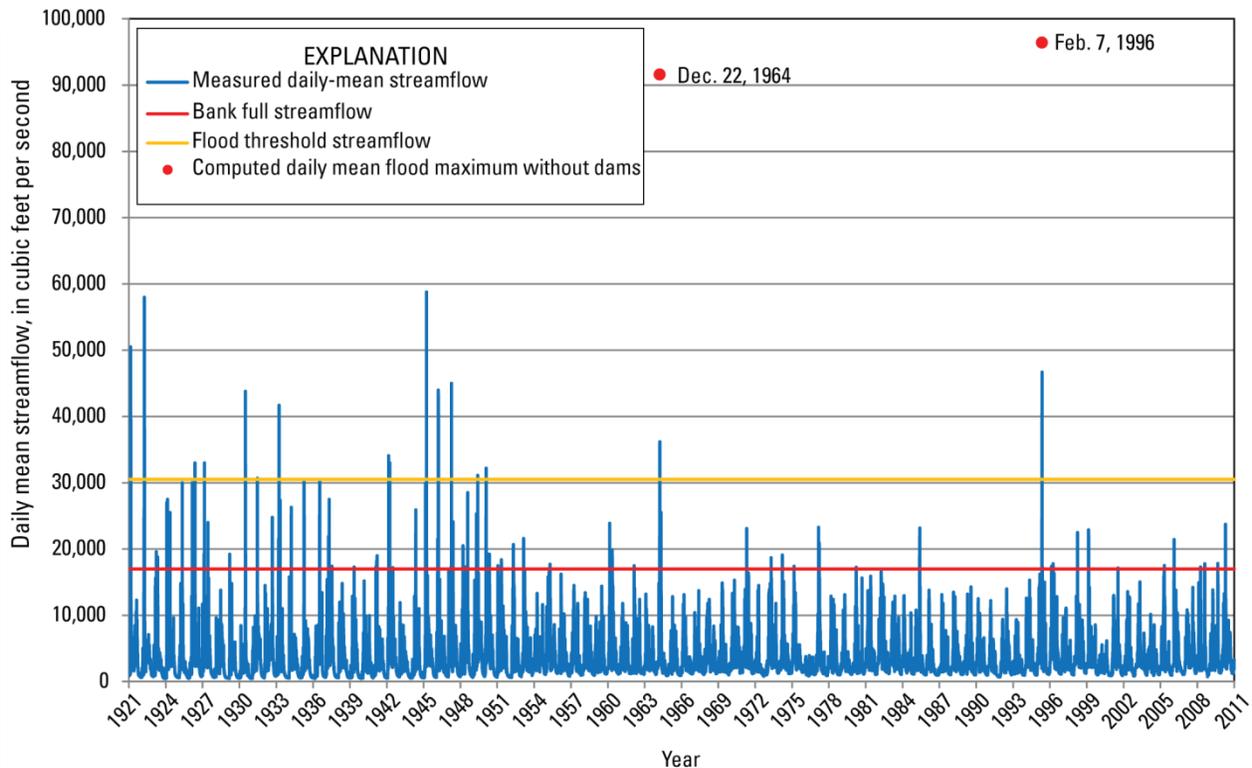
**Figure 6.** Graph showing daily mean streamflow in Reach 2 at North Santiam River at Mehama, Oregon (14183000), water years 1922–2011.

flood threshold was exceeded in the post-dam period were December 22, 1964, at 36,200 ft<sup>3</sup>/s and February 7, 1996, at 46,700 ft<sup>3</sup>/s, respectively. The USACE estimated that these two events would have been 91,600 and 96,400 ft<sup>3</sup>/s, respectively, had the dams not been constructed (fig. 6) (Alan Donner, U.S. Army Corps of Engineers, written commun., 2011).

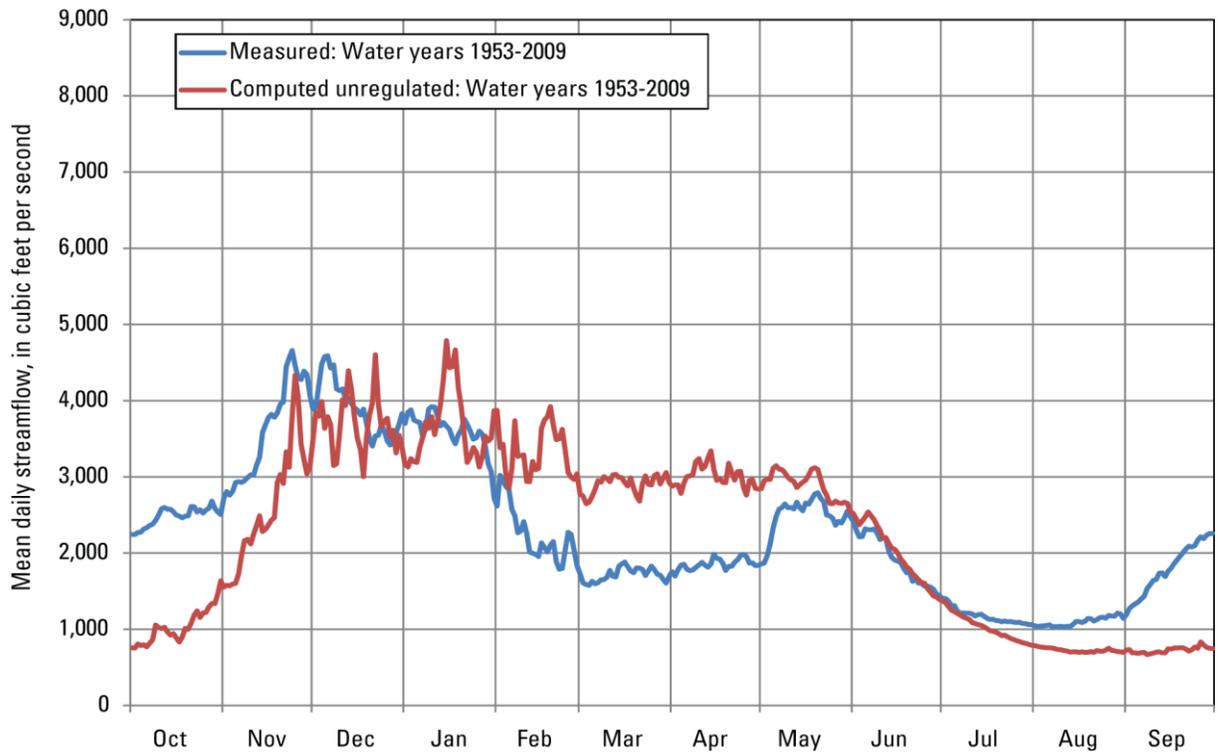
**Figure 7.** Graph showing mean daily streamflow in Reach 1 at North Santiam River at Niagara, Oregon (14181500), water years 1953–2009.

A comparison of measured and computed unregulated mean daily streamflows (water years 1953–2009) at North Santiam River gages in Reaches 1–3 at Niagara (14181500), Mehama (14183000), and Green’s Bridge (14184100) showed that February–April streamflows decreased and August–November streamflows increased under regulated streamflow conditions

(figs. 7–9), respectively. These streamflow alterations are typical of locations downstream from reservoirs used for hydropower production and flood control. Flows are decreased in the spring when the reservoirs are filling up. The increased fall flows are the result of reservoir drawdown each year prior to the annual flood season.

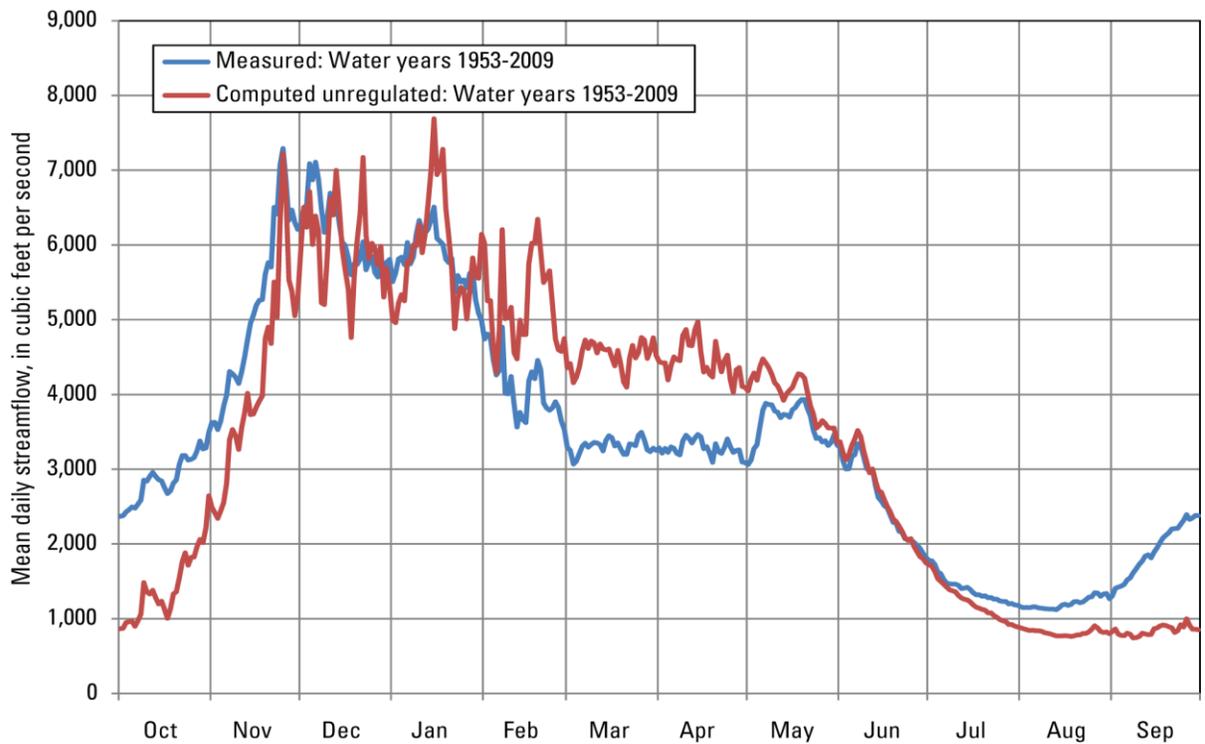
**Figure 8.** Graph showing mean daily streamflow in Reach 2 at North Santiam River at Mehama, Oregon (14183000), water years 1953–2009.

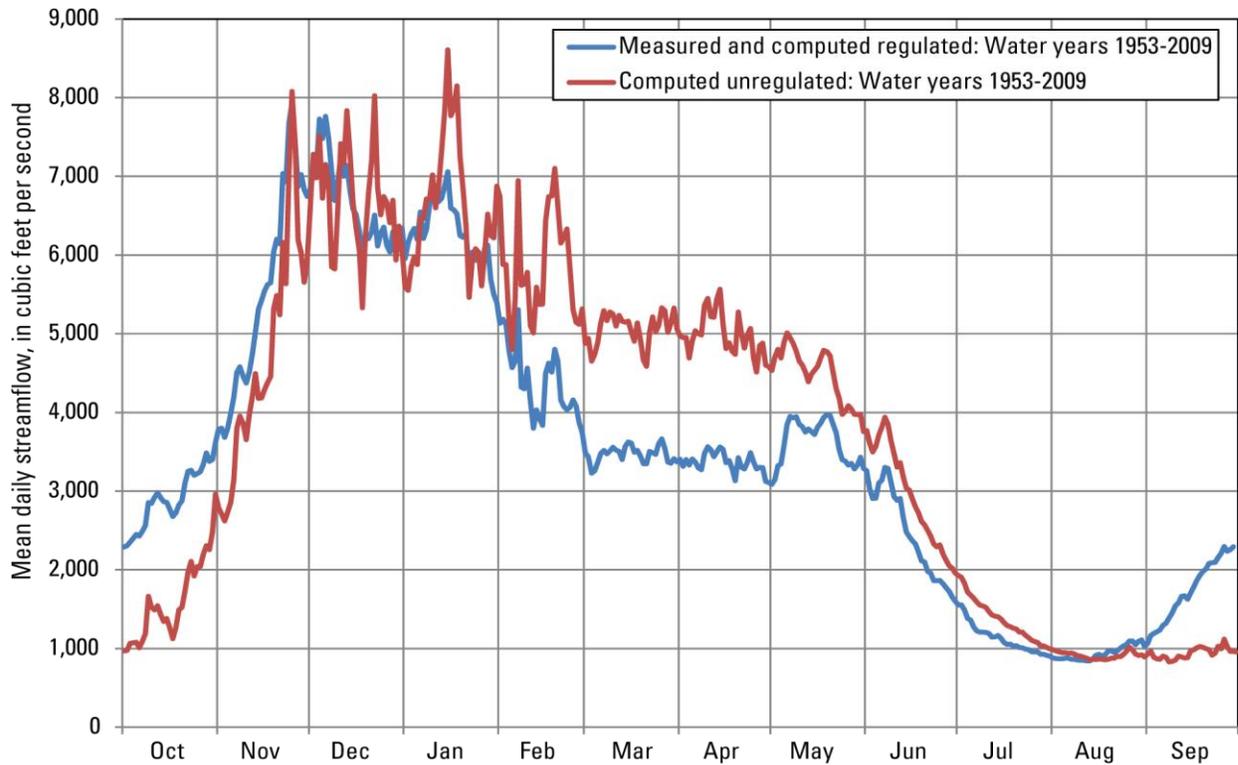
**Figure 9.** Graph showing mean daily streamflow in Reach 3 at North Santiam River at Green's Bridge near Jefferson, Oregon (14184100), water years 1953–2009.

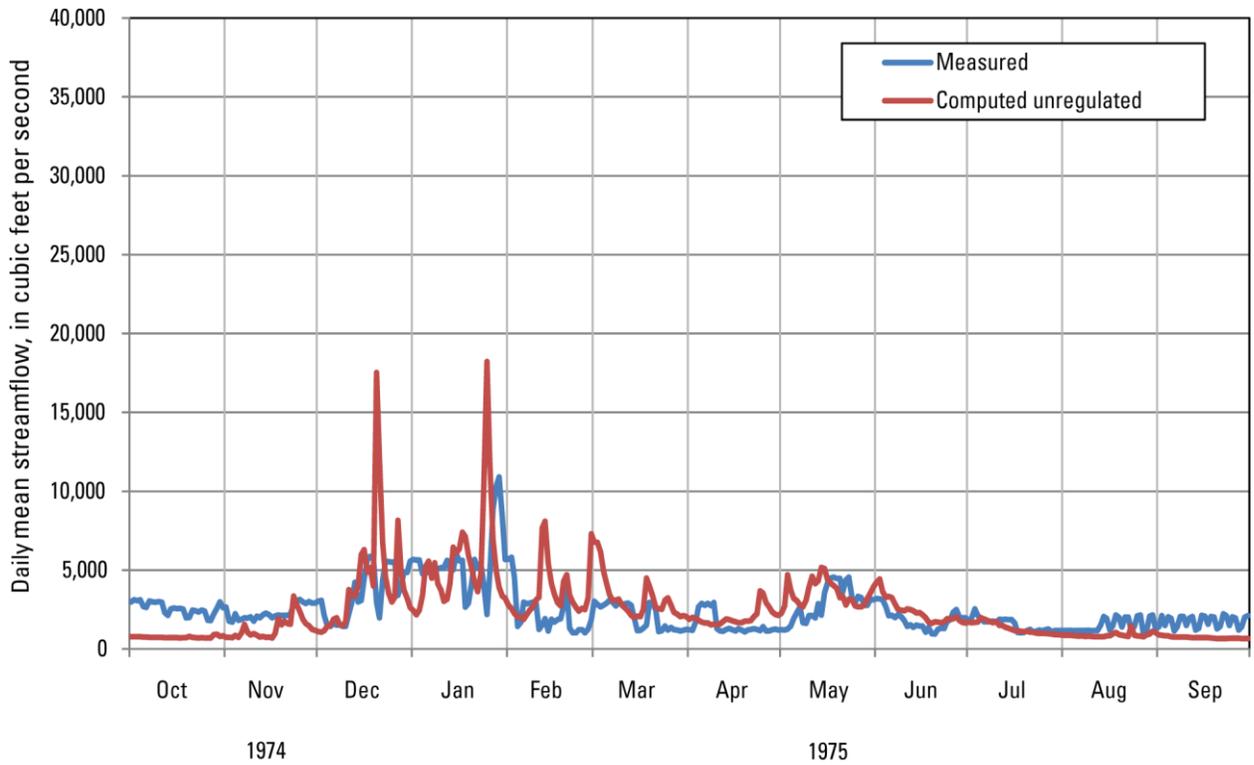
**Figure 10.** Graph showing daily mean streamflow in Reach 1 at North Santiam River at Niagara, Oregon (14181500), water year 1975.

Changes in seasonal streamflow patterns caused by the dams is also evident in a comparison of measured regulated and computed unregulated daily mean streamflows at these three gages during a single average hydrologic year (1975). Although the timing of high-flow events remained constant, the magnitude of these events decreased. The dam operation and its effect on streamflow can be seen at Niagara (14181500) (fig. 10), particularly in March and April and again in August and September. The effect of dam operation on streamflow becomes dampened at the two downstream gages (figs. 11–12).

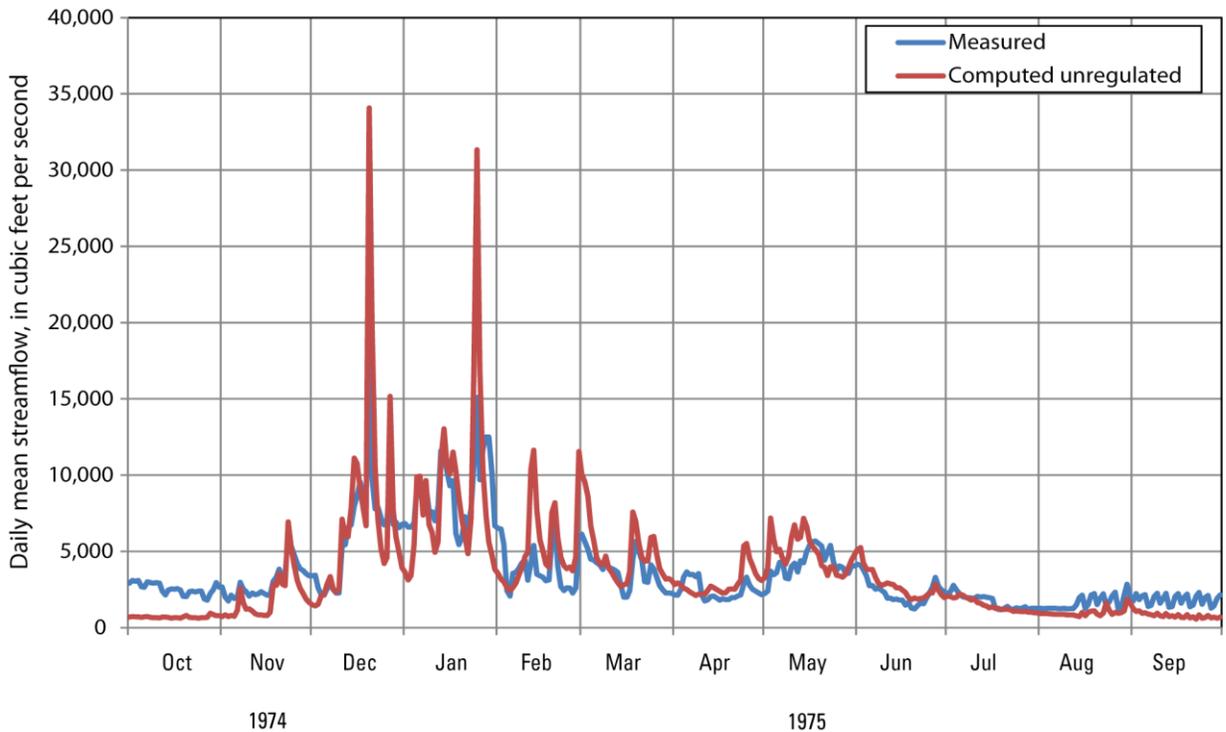
**Figure 11.** Graph showing daily mean streamflow in Reach 2 at North Santiam River at Mehama, Oregon (14183000), water year 1975.

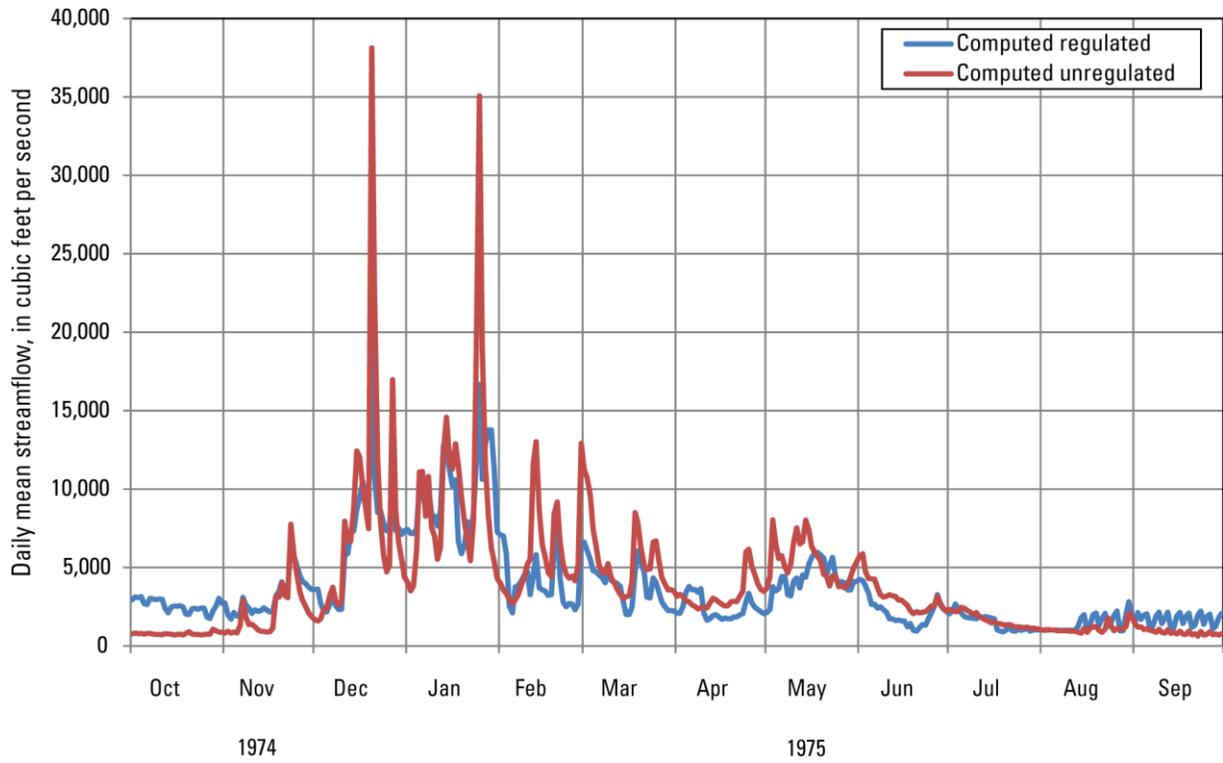
**Figure 12.** Graph showing daily mean streamflow in Reach 3 at North Santiam River at Green's Bridge near Jefferson, Oregon (14184100), water year 1975.

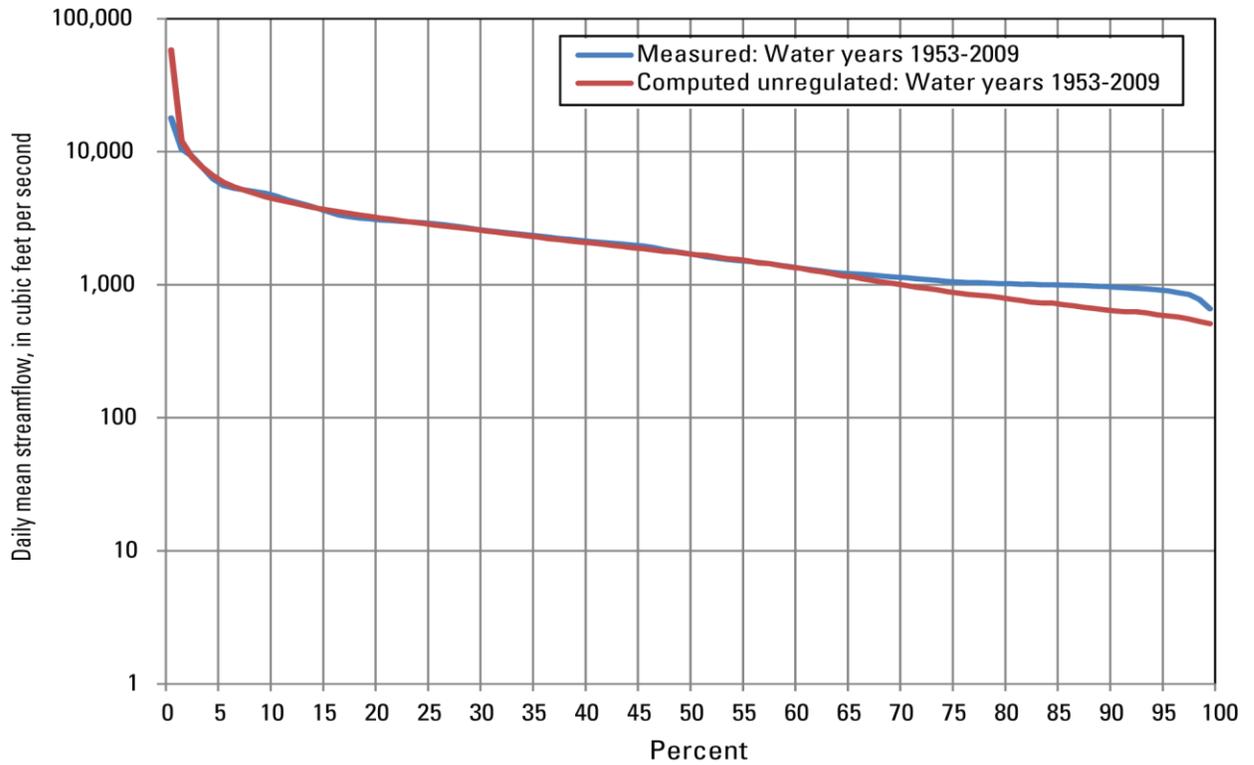
**Figure 13.** Graph showing percent of daily mean streamflows equaled or exceeded in Reach 1 at North Santiam River at Niagara, Oregon (14181500), water years 1953–2009.

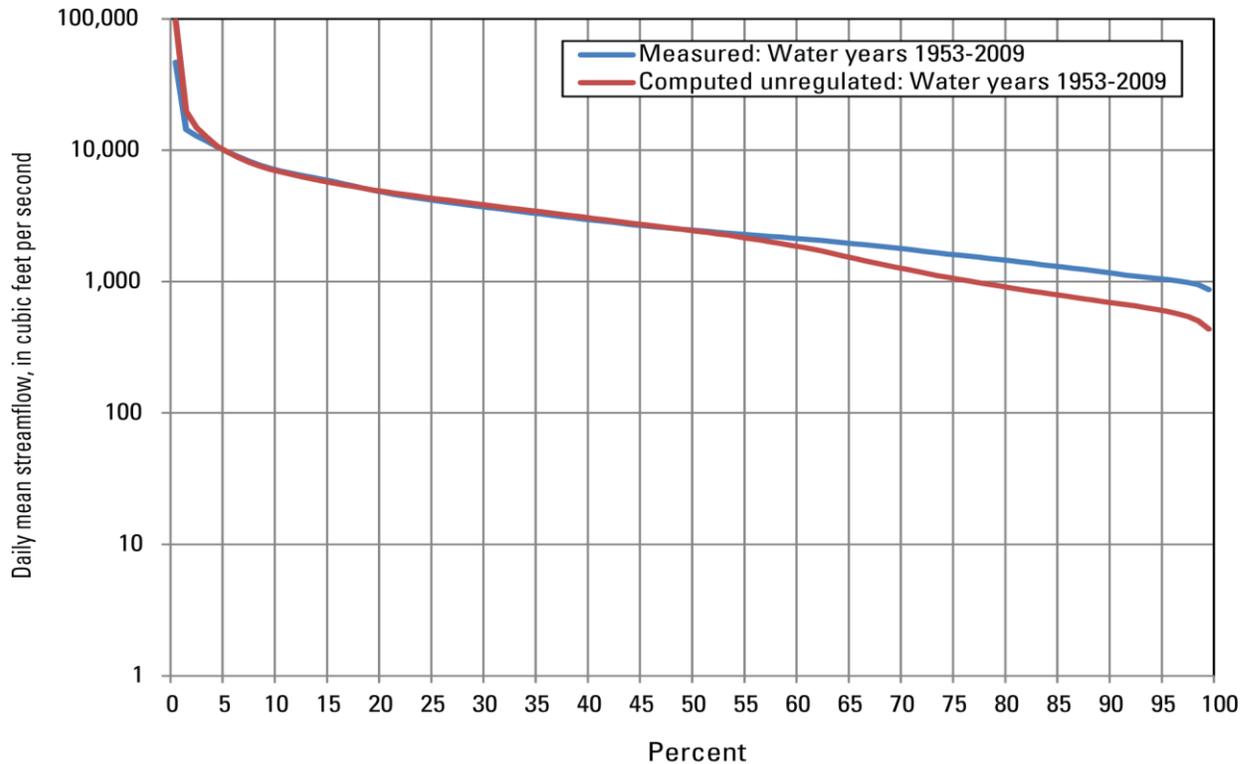
**Figure 14.** Graph showing percent of daily mean streamflows equaled or exceeded in Reach 2 at North Santiam River at Mehama, Oregon (14183000), water years 1953–2009.

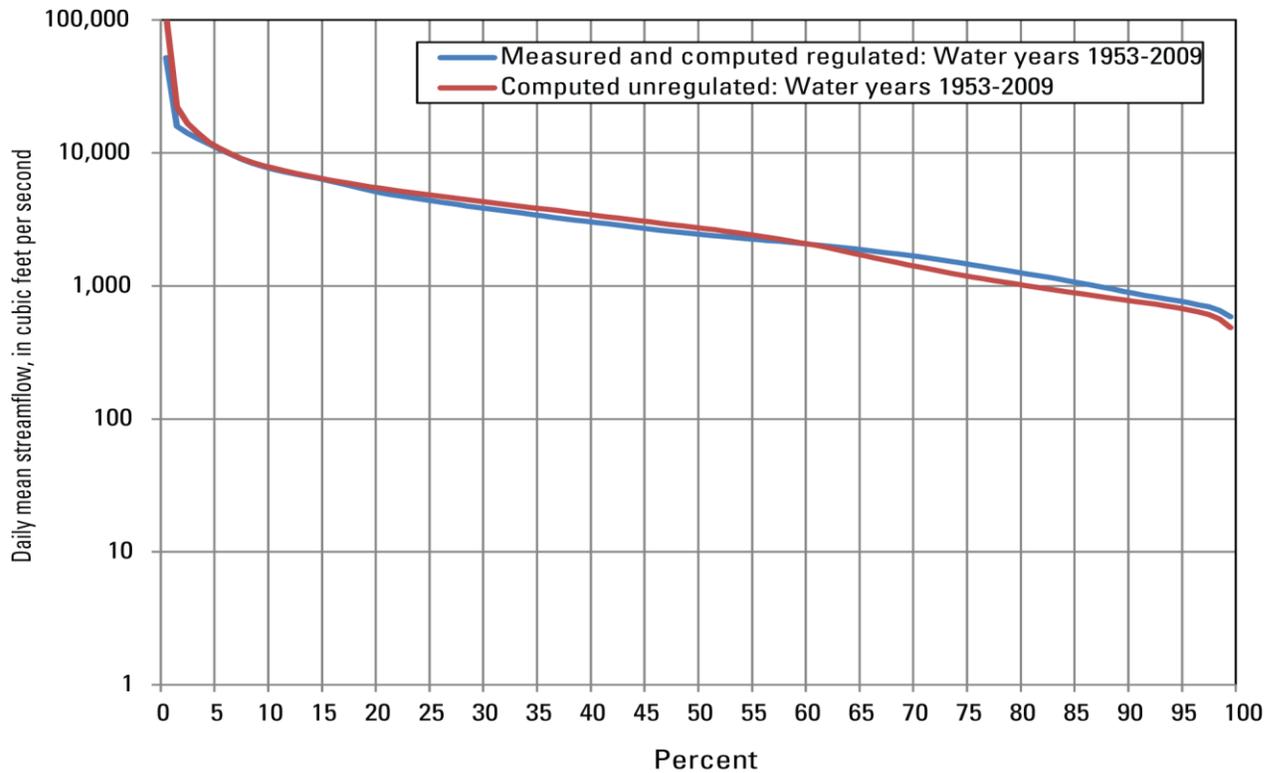
**Figure 15.** Graph showing percent of daily mean streamflows equaled or exceeded in Reach 3 at North Santiam River at Green's Bridge near Jefferson, Oregon (14184100), water years 1953–2009.

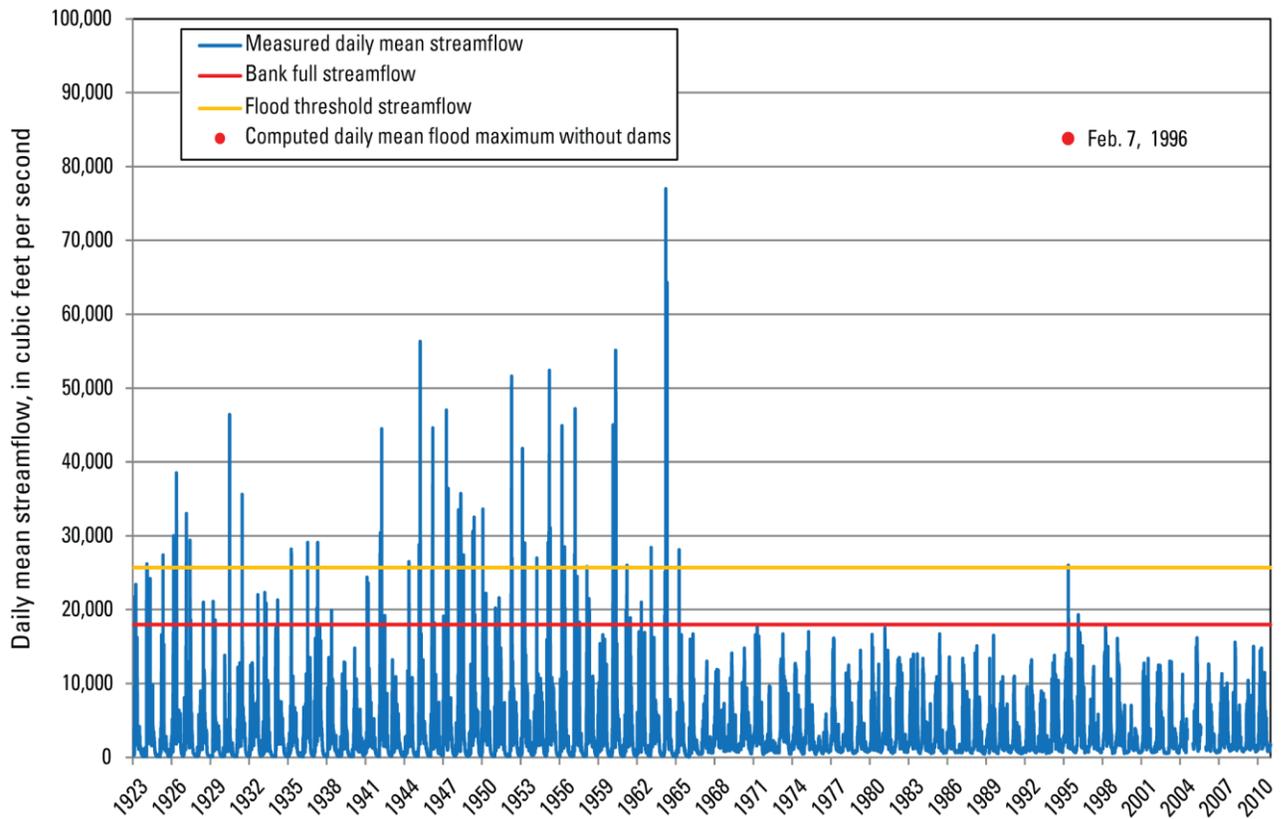
**Figure 16.** Graph showing daily mean streamflow in Reach 6 at South Santiam River at Waterloo, Oregon (14187500), water years 1924–2011.

Using annual peak flows, which have been measured at the Waterloo (14187500) gage since 1906, flood frequencies were separately computed for the pre-dam (1906–1966) and post-dam (1967–2010) periods. As a result of dam regulation, the 1.5-, 10-, 50-, 100-, and 500-year peak flows decreased by 55 to 77 percent (table 8).

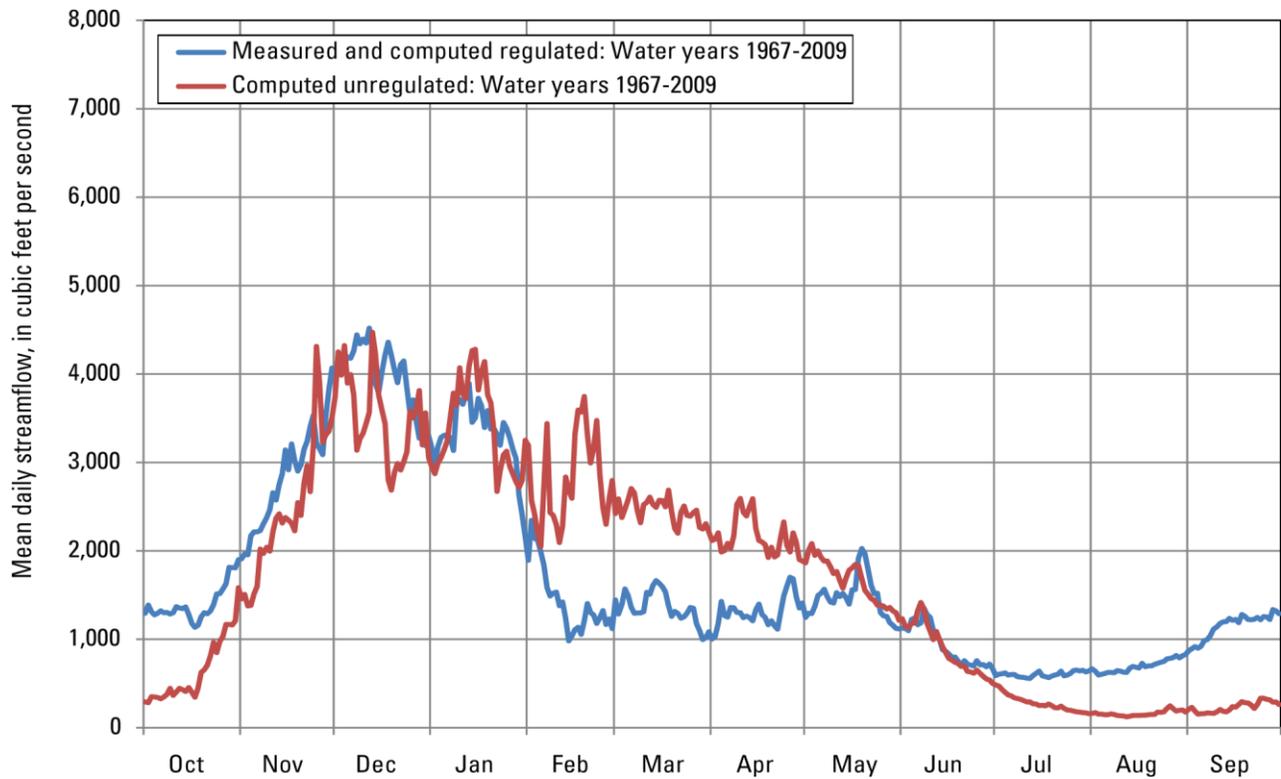
**Figure 17.** Graph showing mean daily streamflow in Reach 4 at Middle Santiam River at mouth near Foster, Oregon (14186500), water years 1967–2009.

Following a similar pattern as the North Santiam gages, a comparison of measured and computed unregulated mean daily streamflows (water years 1967–2009) at the three South Santiam River basin gages (Reaches 4–6) showed that February–May streamflows decreased and July–November streamflows increased under regulated streamflow conditions (figs. 17–19). The Middle Santiam River at mouth near Foster (14186500)

gage (Reach 4) shows the effects of regulation from Green Peter Dam. The Reach 5 gage is on the South Santiam River at Foster (14186700) just below Foster Dam. Farther downstream, in Reach 6, the streamflow record for Waterloo (14187500) at RM 23.3 shows the effects of Foster Dam streamflow regulation combined with unregulated inflow from Wiley, Ames, and McDowell Creeks.

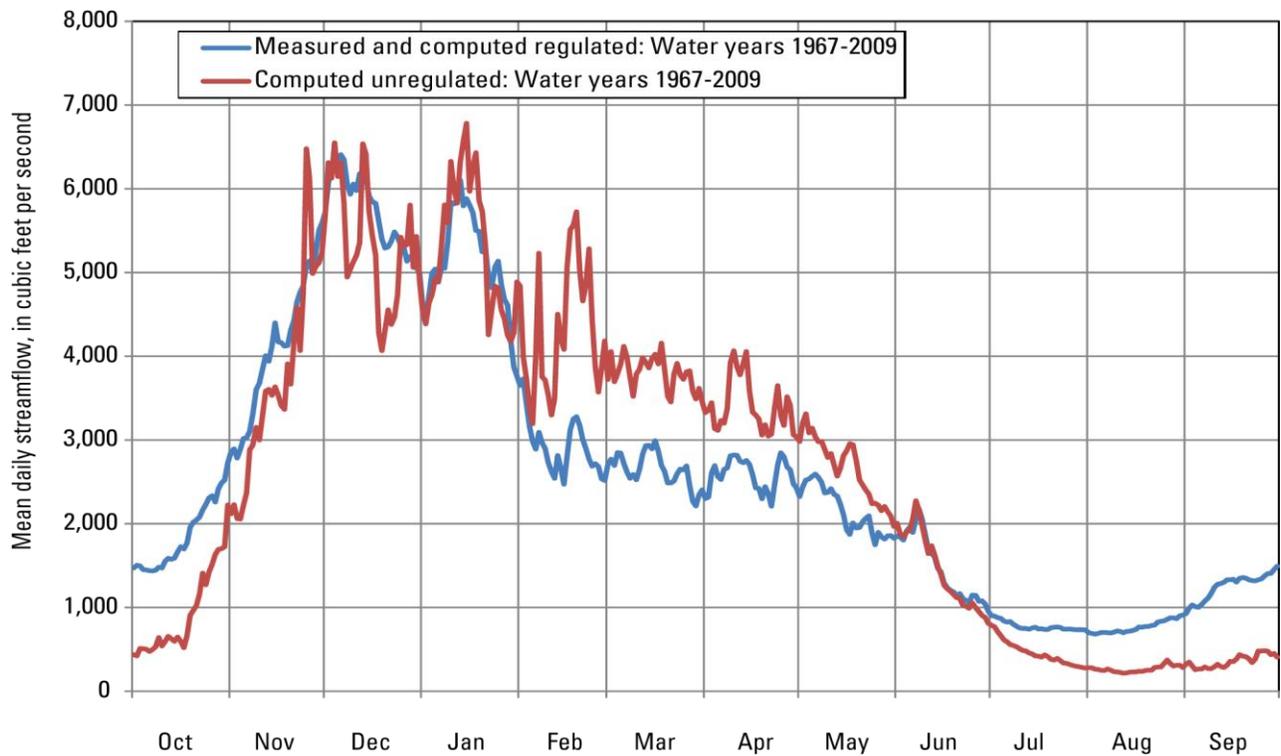
**Figure 18.** Graph showing mean daily streamflow in Reach 5 at South Santiam River at Foster, Oregon (14186700), water years 1967–2009.
