# An Environmental Streamflow Assessment for the Santiam River Basin, Oregon

Open-File Report 2012–1133

U.S. Department of the Interior  
U.S. Geological Survey

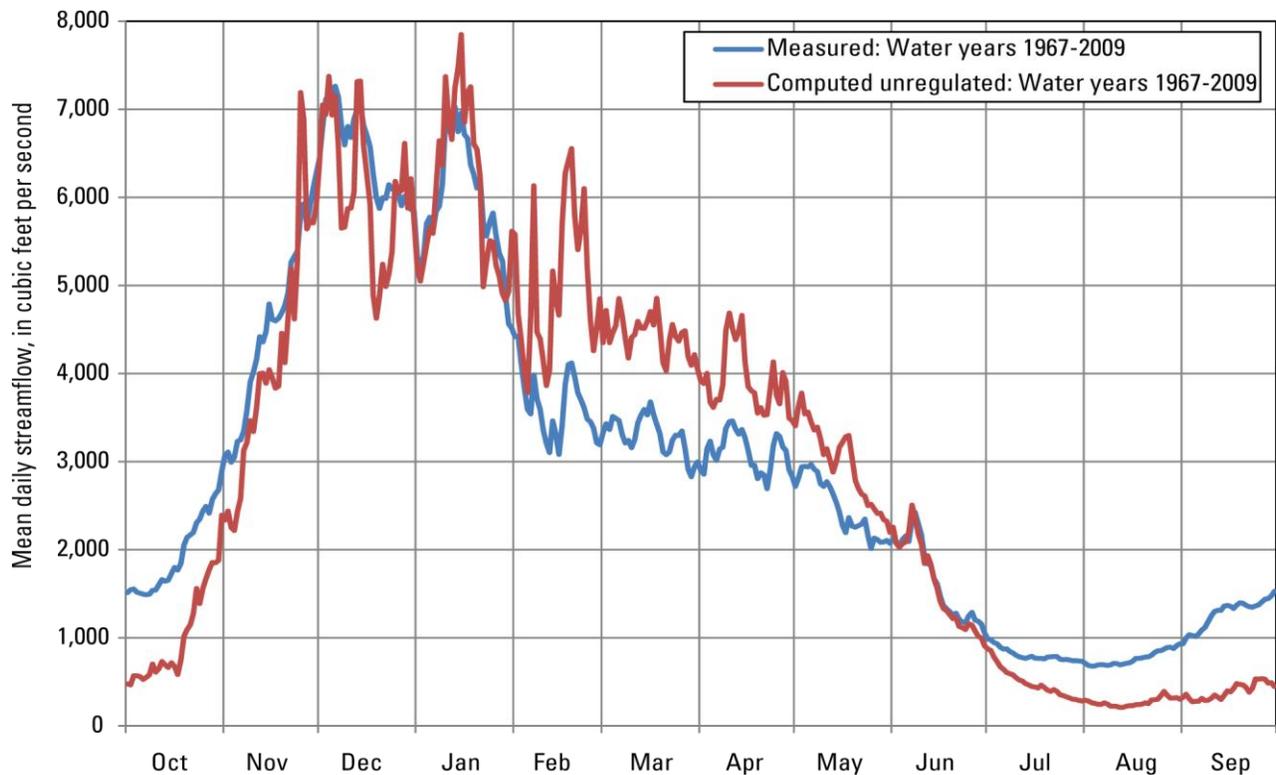
**Figure 19.** Graph showing mean daily streamflow in Reach 6 at South Santiam River at Waterloo, Oregon (14187500), water years 1967–2009.

Following a similar pattern as the North Santiam gages, a comparison of measured and computed unregulated mean daily streamflows (water years 1967–2009) at the three South Santiam River basin gages (Reaches 4–6) showed that February–May streamflows decreased and July–November streamflows increased under regulated streamflow conditions (figs. 17–19). The Middle Santiam River at mouth near Foster (14186500)

gage (Reach 4) shows the effects of regulation from Green Peter Dam. The Reach 5 gage is on the South Santiam River at Foster (14186700) just below Foster Dam. Farther downstream, in Reach 6, the streamflow record for Waterloo (14187500) at RM 23.3 shows the effects of Foster Dam streamflow regulation combined with unregulated inflow from Wiley, Ames, and McDowell Creeks.

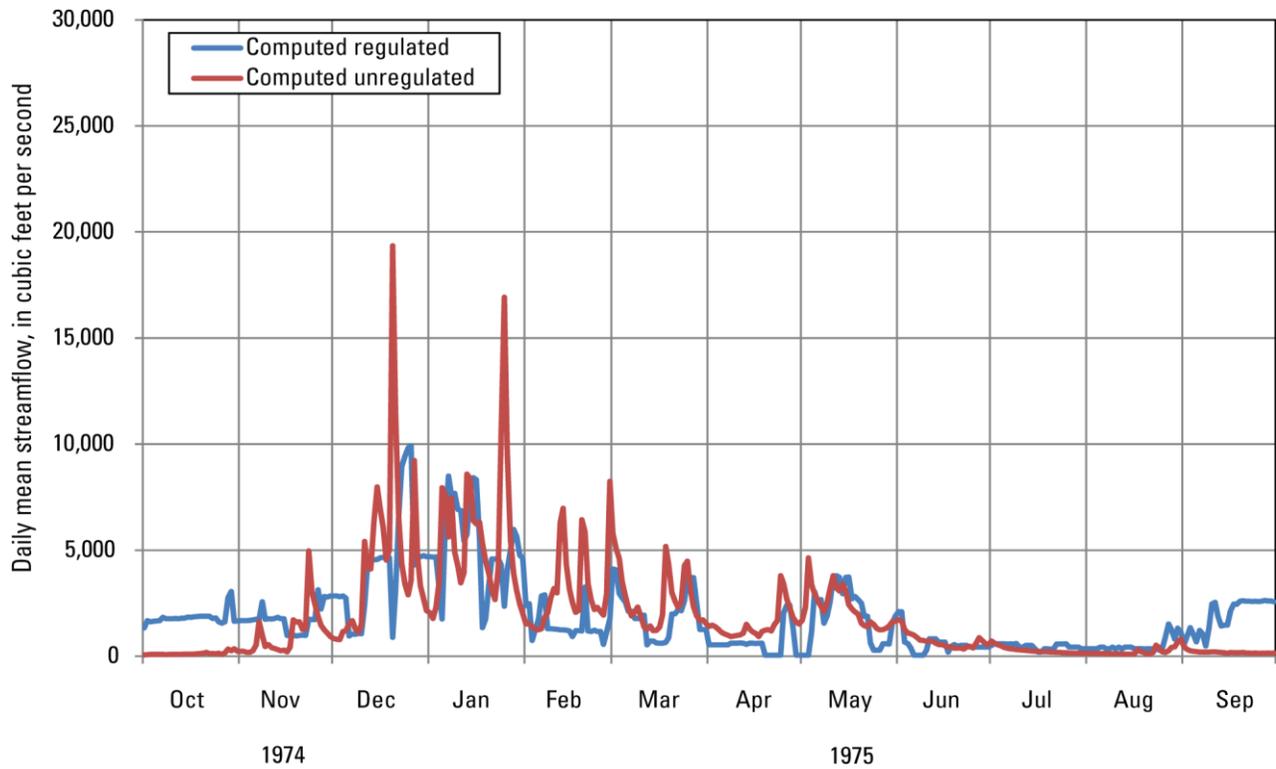
**Figure 20.** Graph showing daily mean streamflow in Reach 4 at Middle Santiam River at mouth near Foster, Oregon (14186500), water year 1975.

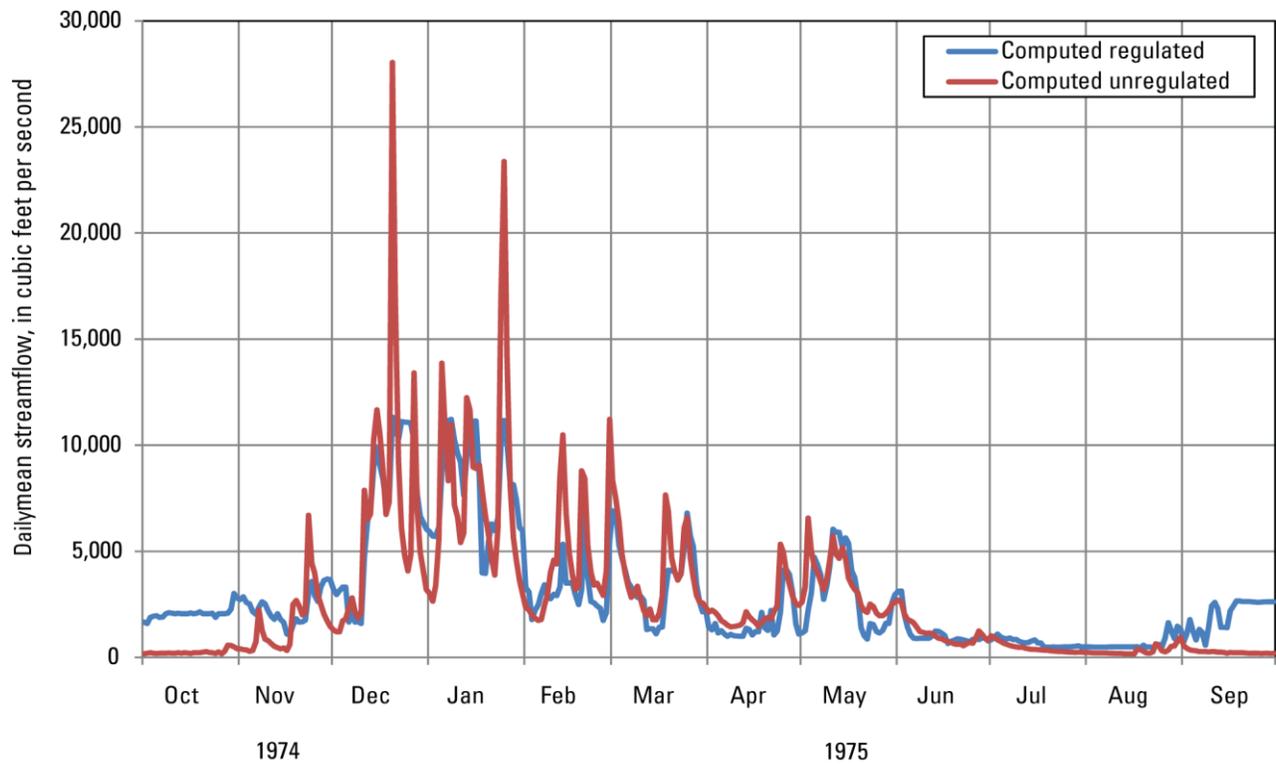
**Figure 21.** Graph showing daily mean streamflow in Reach 5 at South Santiam River at Foster, Oregon (14186700), water year 1975.

the measured streamflow at the Reach 5 gage (14186700) (fig. 21), which is below Foster Dam. Because one of the objectives of Foster Dam is re-regulating Green Peter Dam discharge, measured streamflow below Foster Dam appears more natural and less regulated than streamflow from Green Peter Dam.

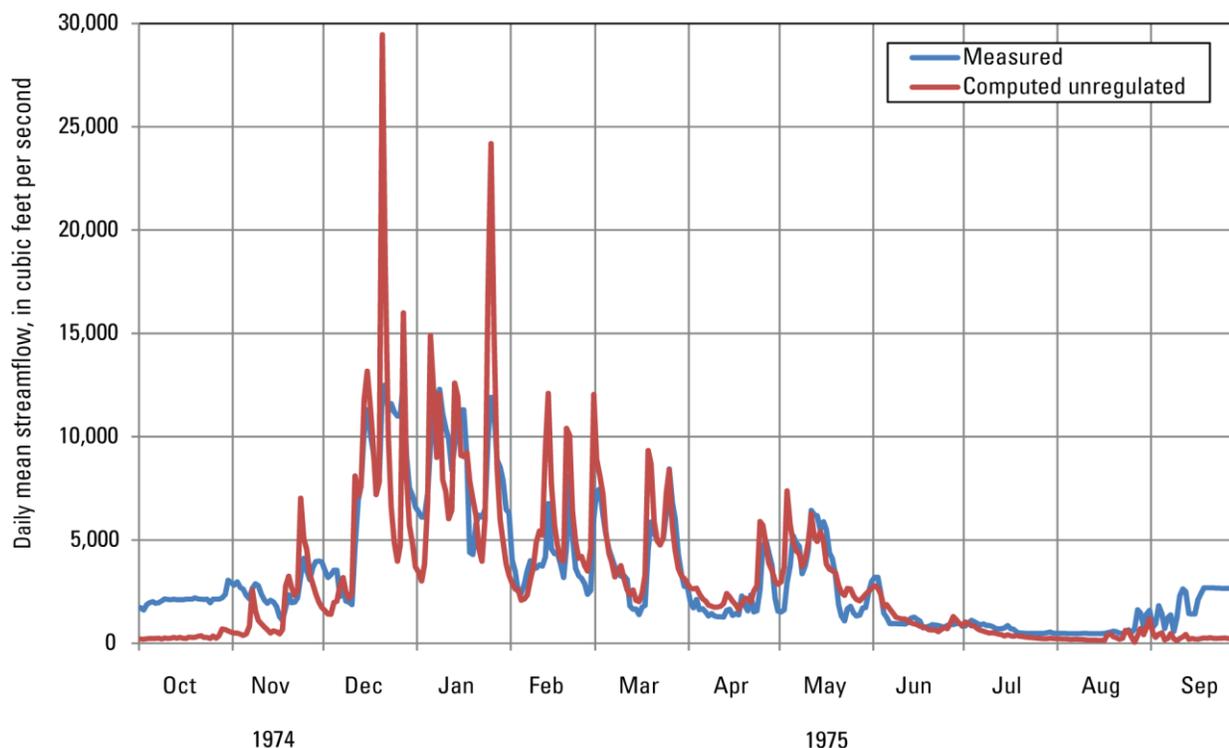
**Figure 22.** Graph showing daily mean streamflow in Reach 6 at South Santiam River at Waterloo, Oregon (14187500), water year 1975.

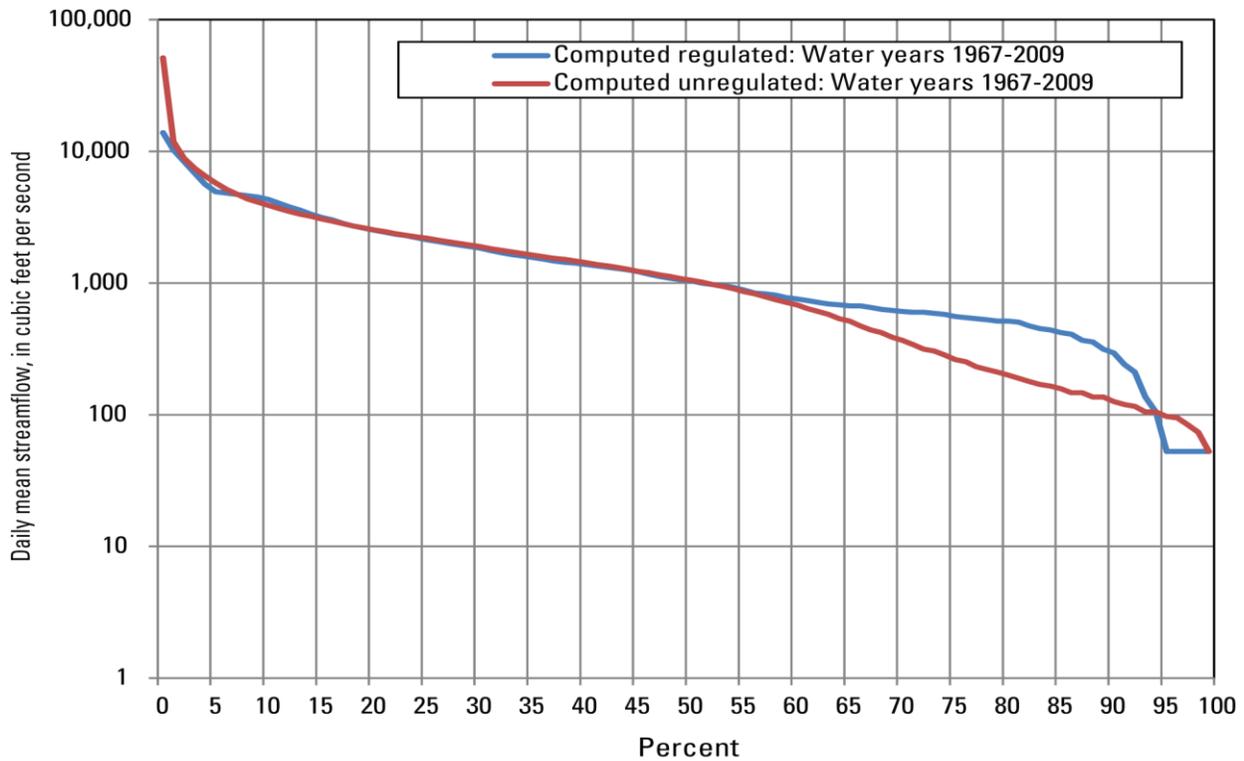
**Figure 23.** Graph showing percent of daily mean streamflows equaled or exceeded in Reach 4 at Middle Santiam River at mouth near Foster, Oregon (14186500), water years 1967–2009.

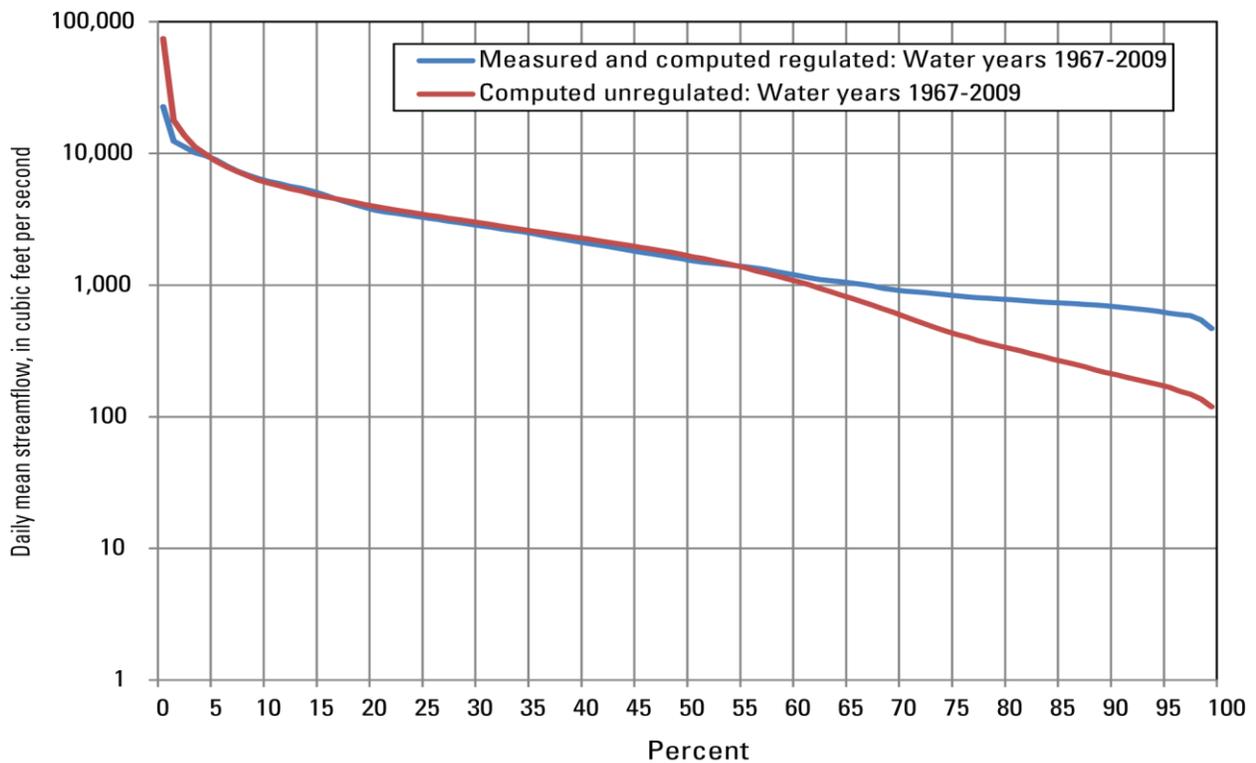
**Figure 24.** Graph showing percent of daily mean streamflows equaled or exceeded in Reach 5 at South Santiam River at Foster, Oregon (14186700), water years 1967–2009.

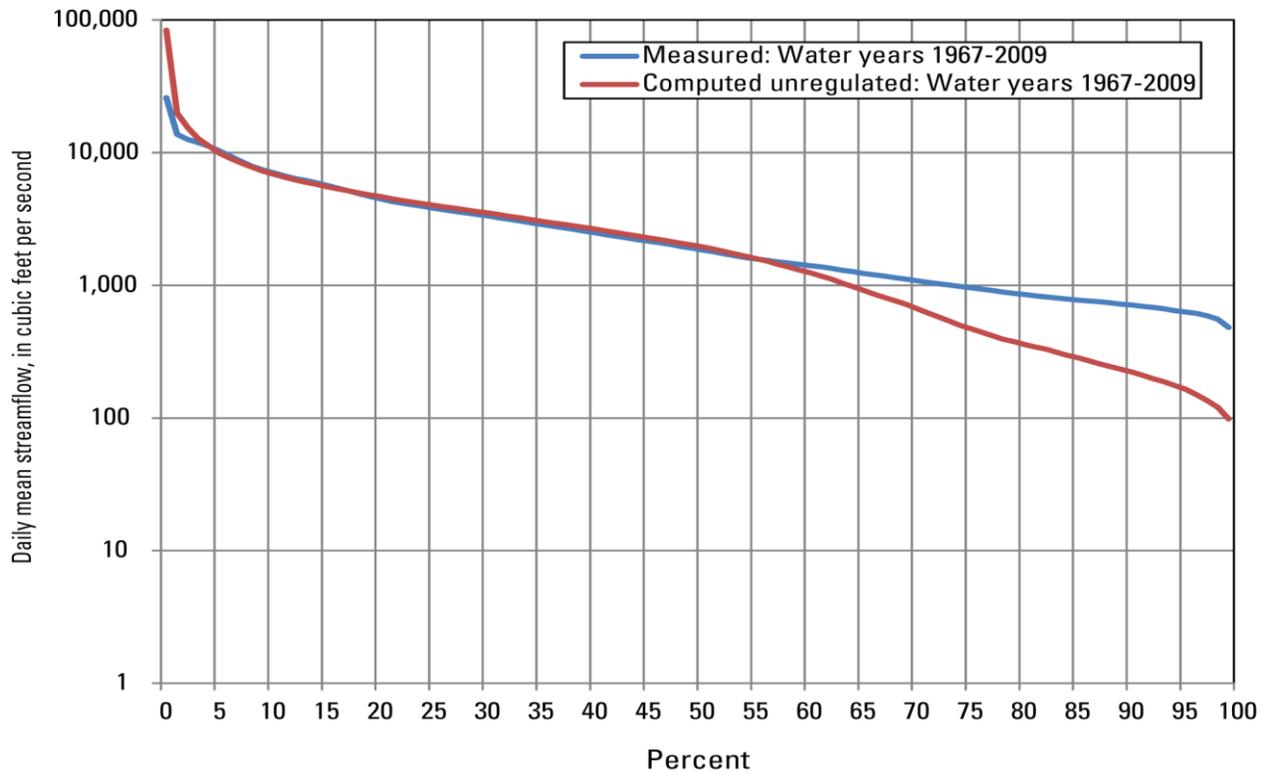
**Figure 25.** Graph showing percent of daily mean streamflows equaled or exceeded in Reach 6 at South Santiam River at Waterloo, Oregon (14187500), water years 1967–2009.

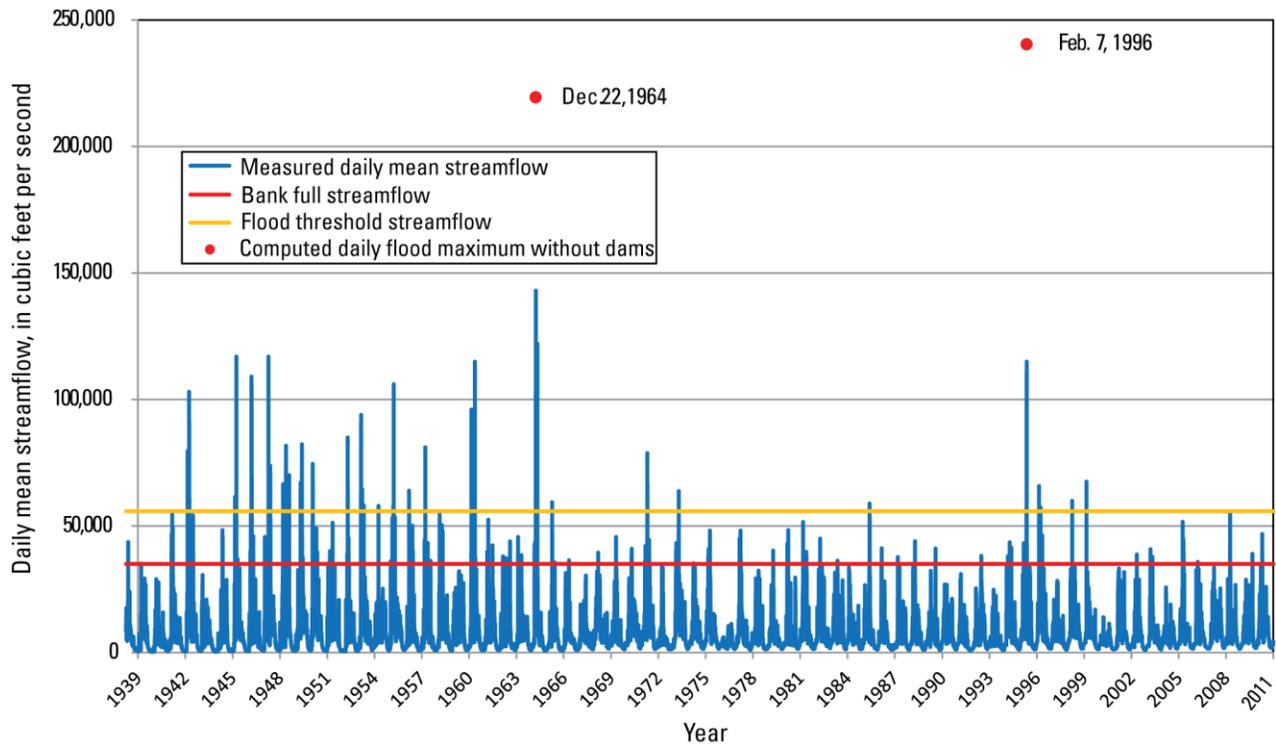
**Figure 26.** Graph showing daily mean streamflow in Reach 7 at Santiam River at Jefferson, Oregon (14189000), water years 1940–2011.

the North and South Santiam River basins because those gages are closer to the dams. In addition to the greater travel time, the effect of the dams is also decreased at the Jefferson (14189000) gage because of substantial natural inflow between the dams and the station.

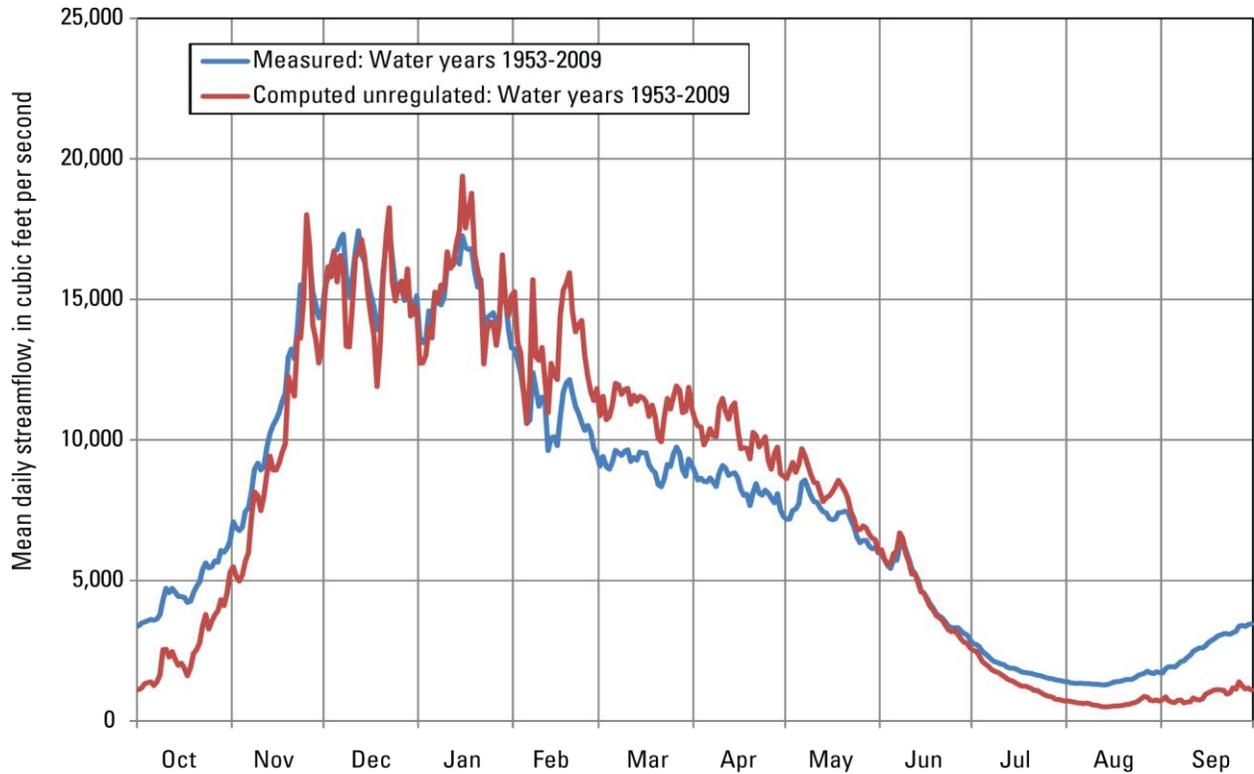
**Figure 27.** Graph showing mean daily streamflow in Reach 7 at Santiam River at Jefferson , Oregon (14189000), water years 1953–2009.

years 1953–2009) at the Jefferson (14189000) gage showed that February–May streamflows decreased and July–November streamflows increased under regulated streamflow conditions

(fig. 27). Because the Jefferson (14189000) gage is farther downstream from the dams, the effect of streamflow regulation caused by the dams is less pronounced than at the upstream gages.

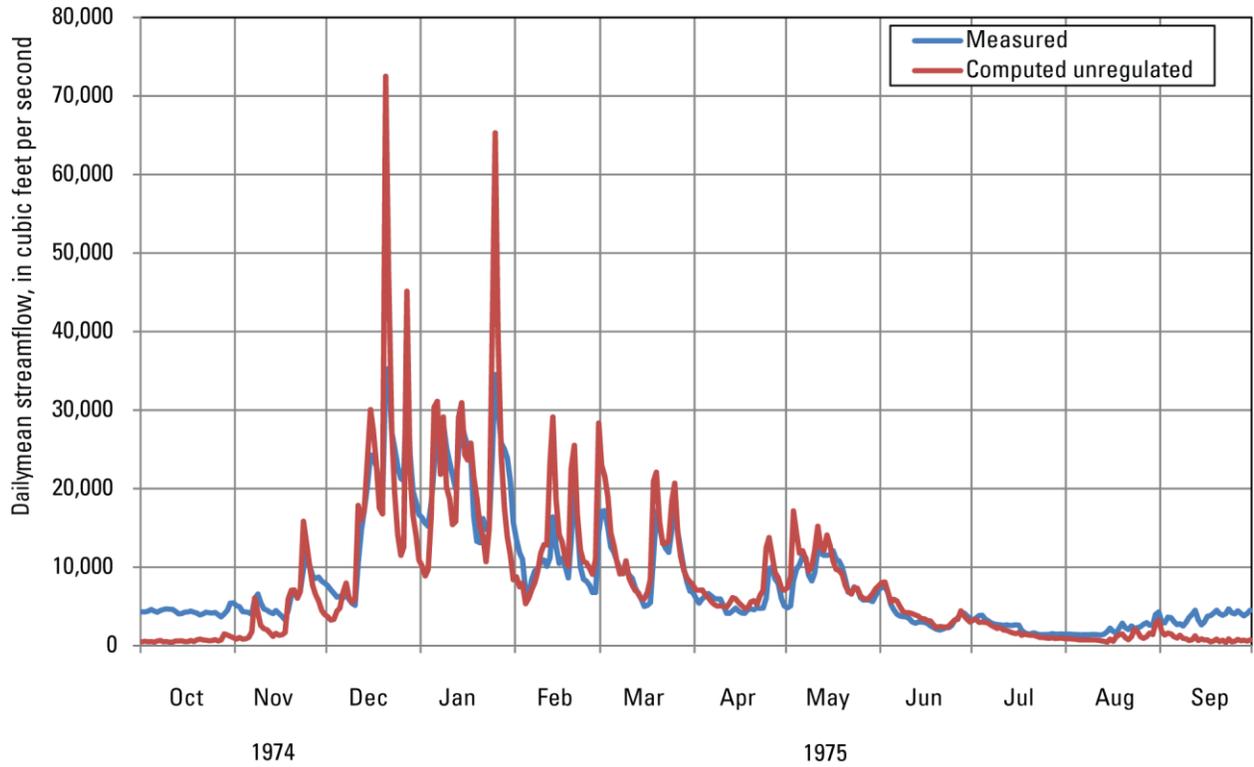
**Figure 28.** Graph showing daily mean streamflow in Reach 7 at Santiam River at Jefferson, Oregon (14189000), water year 1975.

dam operation that is noticeable in the hydrographs for North Santiam River at Niagara (14181500) and Middle Santiam River near Foster (14186500), which are both immediately downstream from Big Cliff and Green Peter Dams, respectively, does not appear in the Jefferson (14189000) hydrograph.

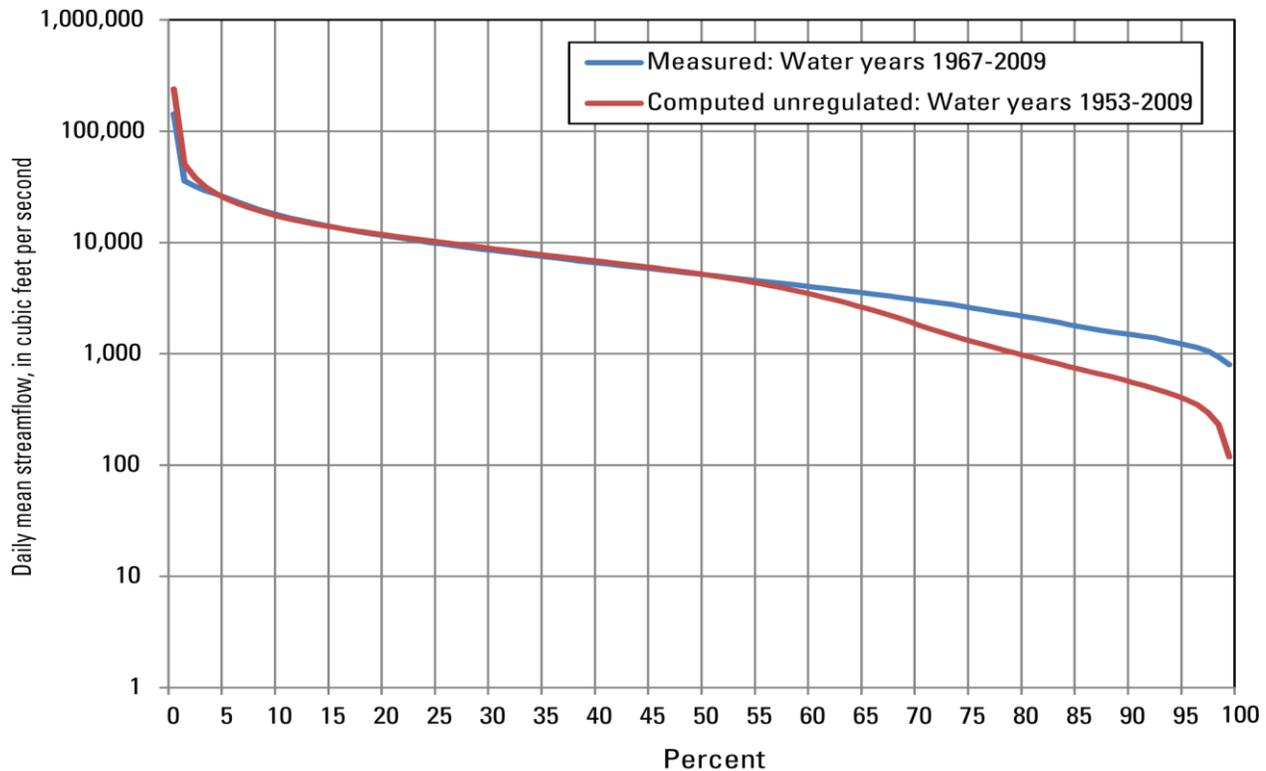
**Figure 29.** Graph showing percent of daily mean streamflows equaled or exceeded in Reach 7 at Santiam River at Jefferson, Oregon (14189000), water years 1953–2009.

flows at the Jefferson (14189000) gage decreased in the late winter and spring (February–May) and increased in the summer to early winter (June–January) as a result of dam regulation (table 11). The 5-percent streamflow exceedance increased slightly (less than 5 percent), whereas the 95-percent streamflow exceedance increased by 211 percent (fig. 29, table 12).

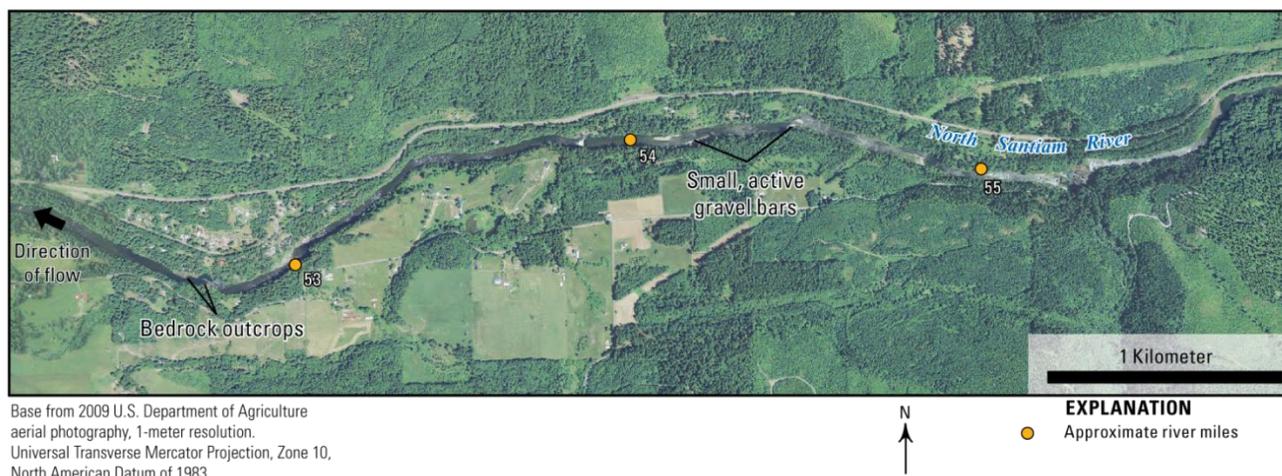
**Figure 30.** Aerial photograph showing channel and flood-plain morphology in study Reach 1 of the Santiam River basin, Oregon, on the North Santiam River.

The upper 2.8 mi of Reach 1 is bounded by Detroit and Big Cliff Dams. Downstream from the dams, the North Santiam River transitions from a narrow channel confined by steep bedrock valley walls to a broad, alluvial river with numerous side channels and gravel bars before joining the South Santiam River near Jefferson. Between Big Cliff Dam (RM 58.1) and the USGS gage at Niagara (14181500) (RM 57.3), the North Santiam River flows predominantly over bedrock and coarse bed material through a narrow canyon with few gravel bars. Downstream from the bedrock rapids near the town of Niagara (RM 55.0), the flood plain widens to about 0.6 mi, and active gravel bars begin to appear, though they are small (2,000–3,000 yds<sup>2</sup>) and typically more than a mile apart (fig. 30). There are several large (up to 16,000 yd<sup>2</sup>) densely vegetated mid-channel bars near the downstream end of Reach 1 near the Little North Santiam River confluence. Channel and flood-plain confinement owing primarily to basin topography throughout Reach 1 limit channel complexity and flood-plain processes; however, small, relict secondary channel features such as those between RM 40 and RM 44 may provide off-channel habitat at high flows.

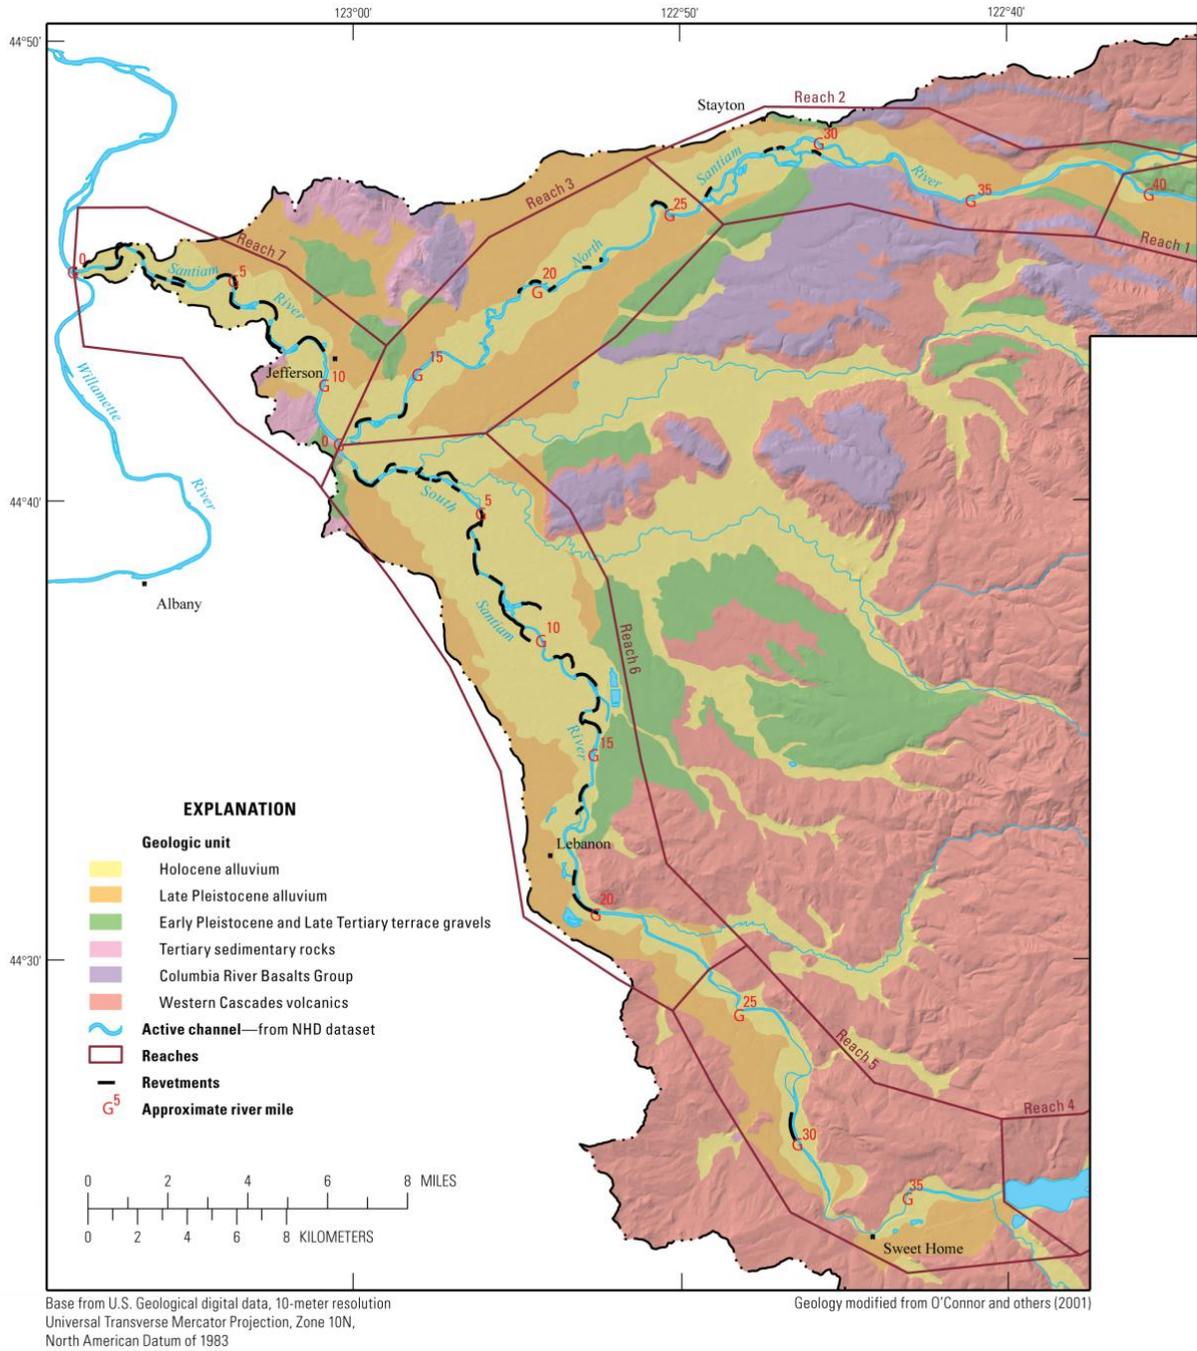
**Figure 31.** Surficial geology and revetments for alluvial segments of the Santiam River, Oregon, study area. Late Pleistocene alluvium is a combination of units Qff2, Qg1, and Qg2; Holocene alluvium is a combination of units Qalc, Qalf, Qau, and Qbf; all other units shown from O'Connor and others (2001).

Downstream from the Little North Santiam River, the flood plain of the North Santiam River along Reach 2 widens from 0.2 mi to nearly 1.5 mi as the channel adopts an increasingly complex, multi-threaded morphology (fig. 31). Just below the upstream boundary of Reach 2, the river flows through a short, confined segment where the flood plain is about 0.2 mi wide and is closely flanked by Pleistocene terraces (fig. 31). Within this segment, historical channel change has likely been minimal, and a specific gage analysis by Klingeman (1973) found little indication of aggradation or incision between 1935 and 1965 at the USGS streamflow gage at Mehama (14183000) (RM 38.7). Farther downstream, the

North Santiam River below RM 35 flows through a broad flood plain and historically probably displayed an anastomosing planform, meaning the river had multiple converging and diverging channels separated by large, semi-stable islands much like the upper Willamette River above Harrisburg as described in Gregory and others (2002b). Presently, many of the secondary channel features along Reach 2 are densely vegetated, and flow is mainly confined to a single channel, except for RM 26–33, where the active channel is over 0.25 mi wide and accommodates a diverse array of side channels, alcoves, islands, and gravel bars (fig. 31).

bank erosion, channel complexity, and bar growth (fig. 31). Between the confluence of the South and North Santiam Rivers and RM 10, the channel is confined by sedimentary rocks (fig. 31). Large, bare, active gravel bars are intermittent but can exceed 100,000 yd<sup>2</sup>, especially in the lower 5 mi of Reach 7 near its confluence with the Willamette River (fig. 35). Throughout the reach, there are many relict bar surfaces and secondary channel features that presently have dense vegetative cover. However, these features may be activated during exceptionally high flows (fig. 35).

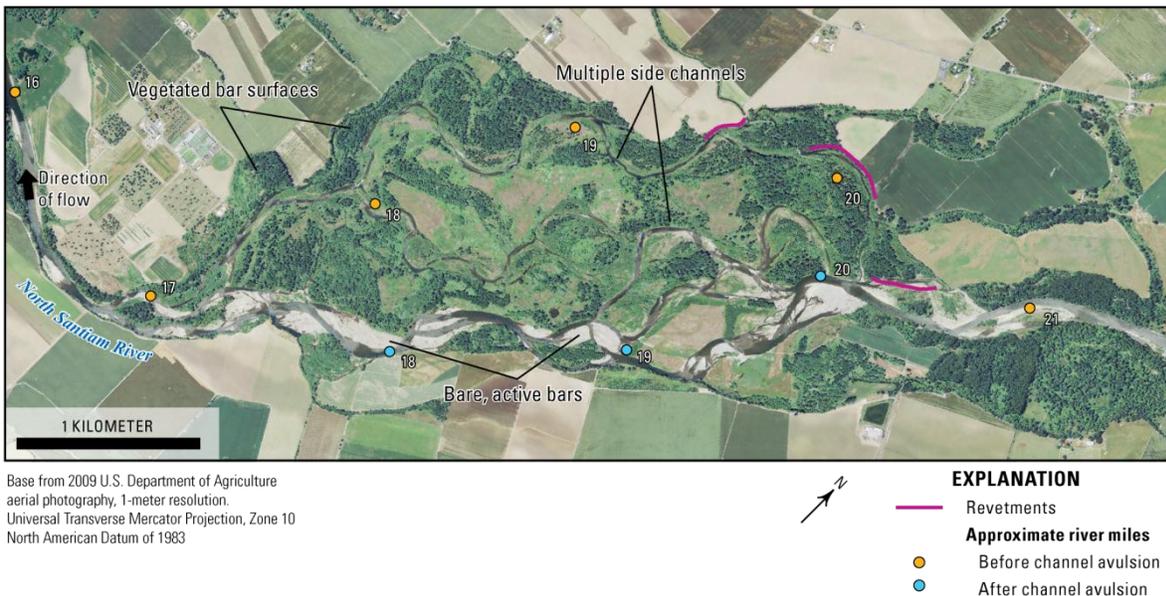
**Figure 32.** Aerial photograph showing channel and flood-plain morphology in study Reach 3 of the Santiam River basin, Oregon, on the North Santiam River.

found throughout the entire reach. An example of a segment in Reach 3 containing modern channel complexity and relict channel features is shown in figure 32. Because there is little revetment along the North Santiam River in Reaches 2 and 3 (fig. 31), channel processes including meander migration, bar growth and creation, and maintenance of secondary channel features are mainly determined by the flow and coarse-sediment regimes. These processes have been altered by upstream dams.

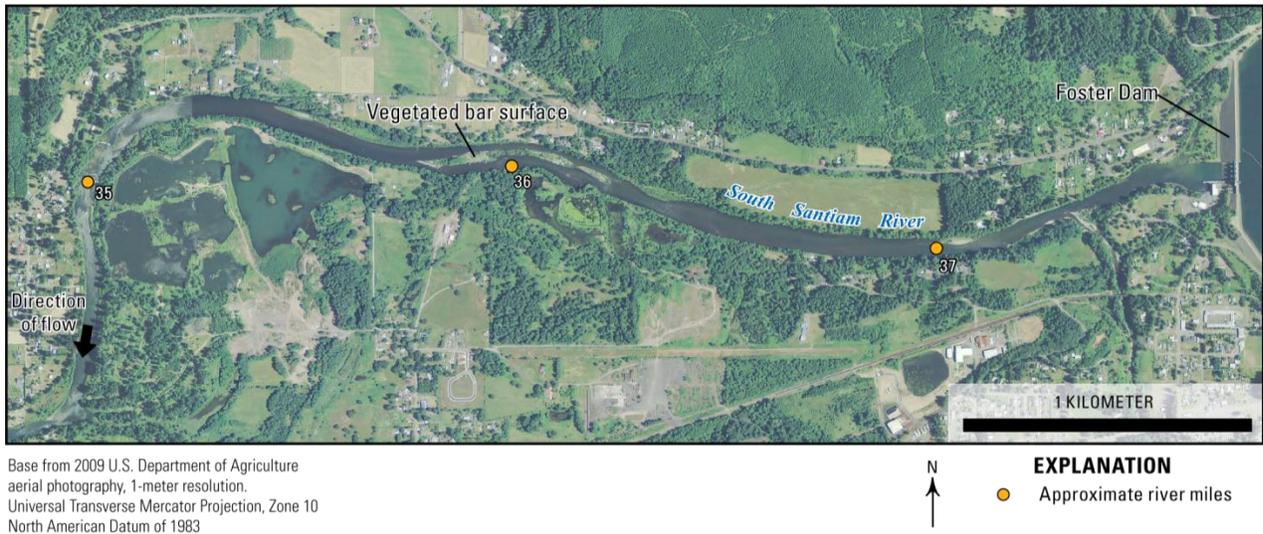
**Figure 33.** Aerial photograph showing channel and flood-plain morphology in study Reach 5 of the Santiam River basin, Oregon, on the South Santiam River.

analysis at the USGS gage at Waterloo (14187500) (RM 23.3) near the boundary between Reach 5 and Reach 6 indicates minimal change in bed elevation between 1935 and 1965 (Klingeman, 1973) underscoring the overall stability of this segment of the South Santiam River. There is only one area with moderate channel complexity along Reach 5 (between RM 28 and RM 29) where the river is flanked on both sides by Holocene alluvium and has multiple channels. Active gravel bars are sparse throughout Reach 5 and are relatively small (less than 1,500 yd<sup>2</sup>). The reach has a number of densely vegetated bar surfaces such as the island at RM 36 (fig. 33).

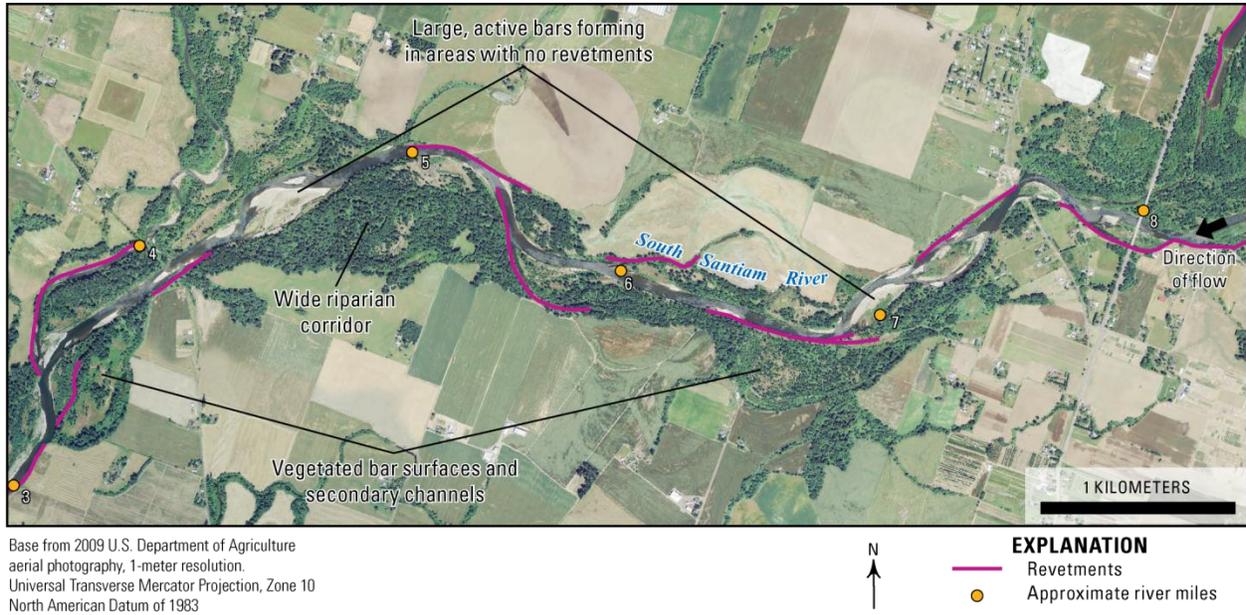
**Figure 34.** Aerial photograph showing channel and flood-plain morphology in study Reach 6 of the Santiam River basin, Oregon, on the South Santiam River.

Foster and Big Cliff Dams resulted in substantial reductions in channel complexity and gravel-bar area. For example, Fletcher and Davidson (1988) reported a 56-percent reduction in the area of gravel bars between 1936 and 1981. The 2009 orthophotographs show numerous bare, active gravel bars up to 25,000 yd<sup>2</sup>, downstream from RM 18 in areas lacking bank revetment (for example, RM 4.5 in fig. 34). Gravel bars and channel complexity is much less where one or both banks are stabilized with revetment (Fletcher and Davidson, 1988; as depicted between RM 5 and RM 6 in fig. 34). Downstream from RM 18, extensive formerly active bar surfaces and relic secondary channel features are presently stabilized with dense vegetation (for example, RM 5–7 in fig. 34).

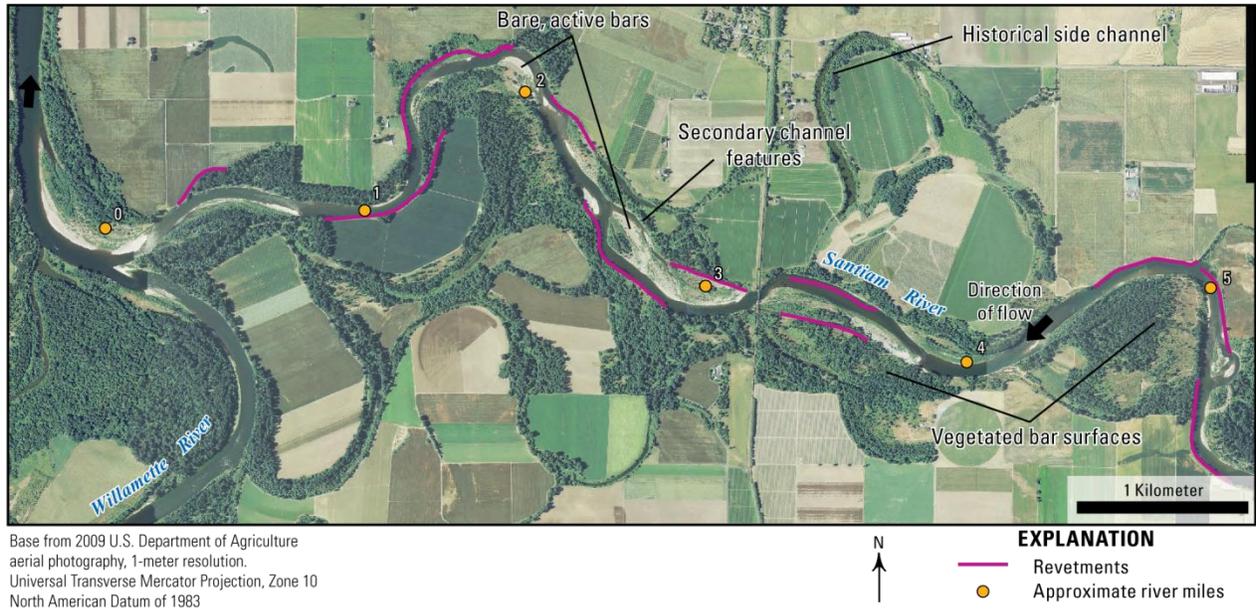
**Figure 35.** Aerial photograph showing channel and flood-plain morphology in study Reach 7 of the Santiam River basin, Oregon, Santiam River main stem.
